Service

Category Audio/Visual/Telematics

| YEAR(S) | MODEL(S) | ADDITIONAL INFORMATION |
|---|---|---|
| 2018 | Camry, Camry HV | |

Entune Audio Head Unit Software Update (Panasonic)

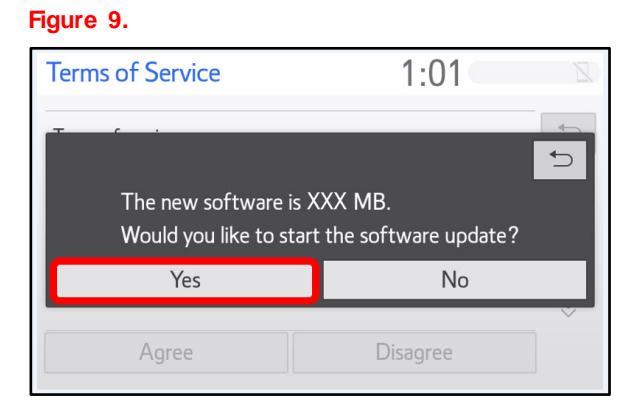
12. Select Yes on the "Would you like to start the software update?" pop-up.
