94 Front side markers sporadically or permanently do not work

94 17 93 2049691/1 December 12, 2017.

Model(s)	Year	VIN Range	Vehicle-Specific Equipment
ſ	R8	2017 - 2018	All	Not Applicable

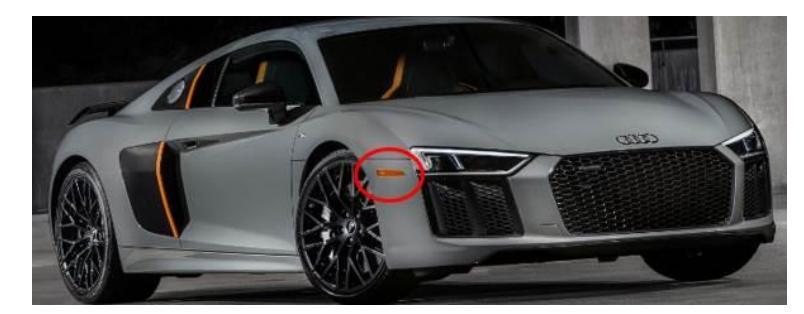
Figure 1. Front side marker light.

R8 side marker light sporadically or permanently does not work.

Only the front side marker lights are affected (Figure 1) with part number: 4S0-945-071/4S0-945-072.

Under certain circumstances the R8 front side marker light can fail or the onboard supply control module, J519 (address word 0009) detects an open-circuit fault and a warning is displayed in the instrument cluster. The one of the following DTCs are logged:

Improved software introduced into Series Production from CW 45/17.

2. Update the onboard supply control module, J519 (address word 0009) using the SVM action code as listed in the table below, if necessary:

If the affected side marker still does not work despite the software update then replace it.
