Technical Bulletin

15 17 02 July 7, 2017 2045454 Supersedes Technical Bulletin 15-16-02 (V151602) dated October 18, 2016 to update Tiguan labor operation number.

MIL ON, Fault Code P0016 Camshaft Position Sensor Stored in ECM Fault Memory

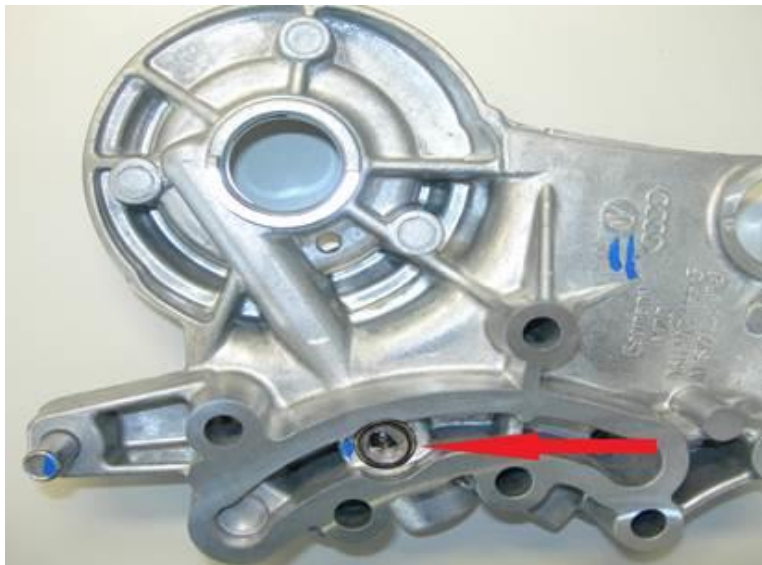
The strainer screen in the camshaft bearing bracket can tear and cause camshaft adjuster issues.

Figure 2. Torn strainer

- Check the non-return valve in the camshaft bearing bracket (Figure 2. red arrow).

In case of damage as shown in figure 2, proceed as follows:

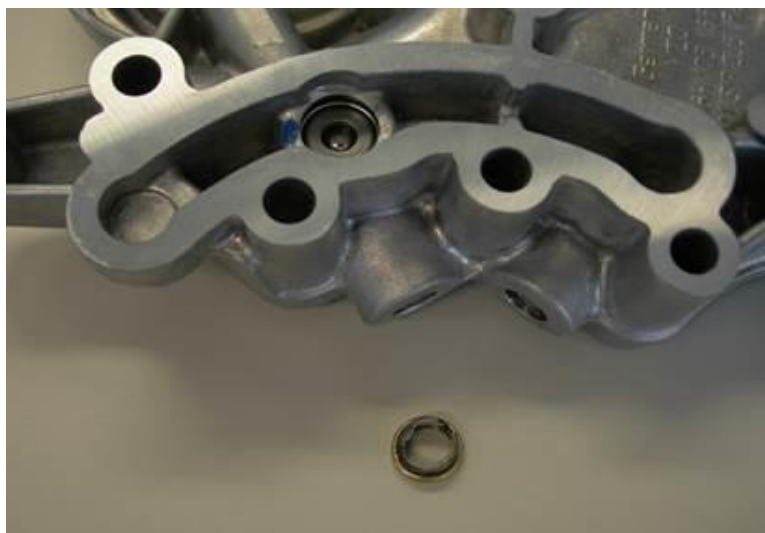
Figure 4. Camshaft bearing bracket with metal non-return valve (without strainer)

The remnants of the strainer for the non-return valve must be removed from the oil duct. Remnants can clog up the oil duct in the camshaft bearing bracket or drift into the camshaft bearing. This can damage other components. Check the oil sump for debris and thoroughly clean if necessary.

Metal non-return valve (Figure 4.):

- The camshaft bearing bracket can be reused after removing the strainer.

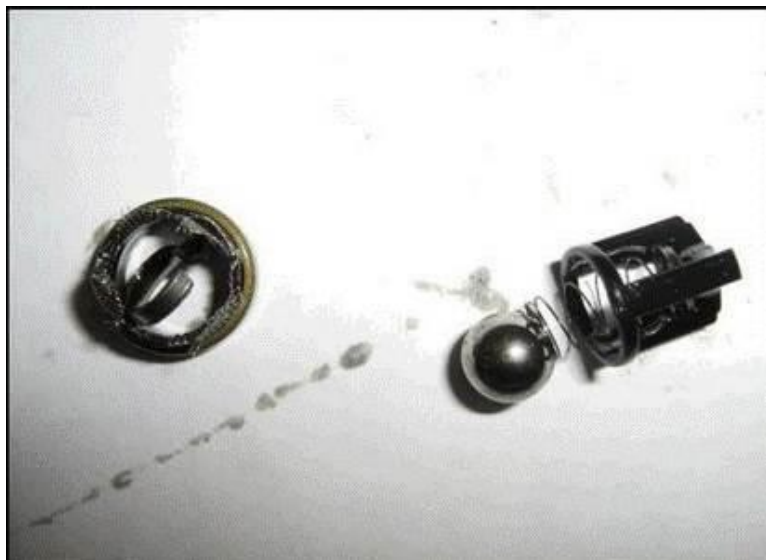
Figure 5. Plastic non-return valve

The remnants of the strainer for the non-return valve must be removed from the oil duct. Remnants can clog up the oil duct in the camshaft bearing bracket or drift into the camshaft bearing. This can damage other components. Check the camshaft adjuster for debris and thoroughly clean if necessary.

Plastic non-return valve (Figure 5.):

- Replace the camshaft bearing bracket according to the repair manual/parts catalog.

Check the camshaft adjuster control valve for debris and if necessary clean it thoroughly.

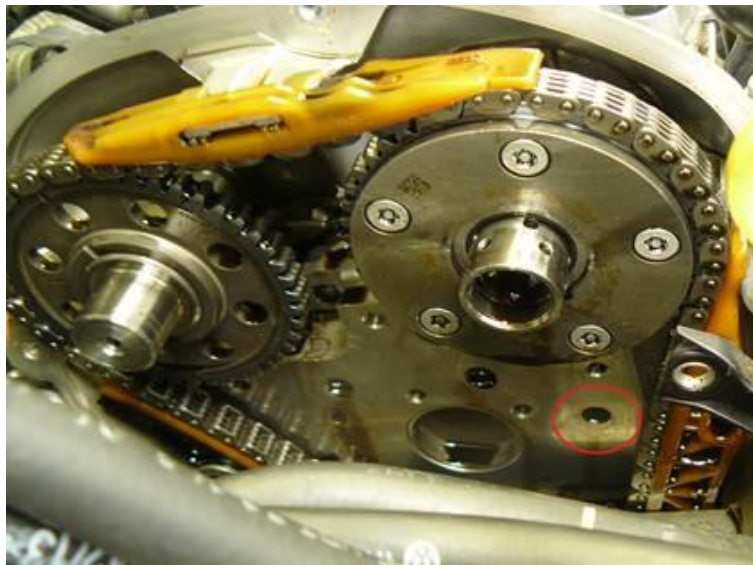
Figure 6. Test point of oil duct (red circle) to non-return valve in cylinder head

Check and if necessary replace the non-return valve in the cylinder head (Figure 6. red circle).

- The non-return valve in the cylinder head can only be checked if the bearing bracket for camshafts has been removed.

If check valve requires replacement the cylinder head must be removed. The brass colored check valve is located in the left front underside of cylinder head. To remove check valve a small hook or screw driver may be used to pull check valve from cylinder head. The valve is only held in position by an o-ring, which is part of the valve assembly.

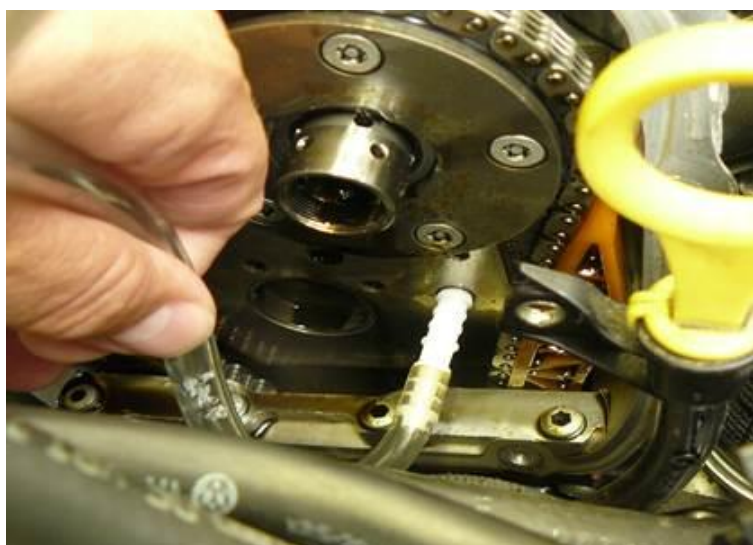
Figure 7. Press pressure line with adapter of VAS 6213 firmly into oil duct hole

- Apply 0.5 bar on the non-return valve. **The pressure must not drop within 1 minute:**
 - If the applied pressure remains stable for 1 minute, no further work on the non-return valve is necessary in the cylinder head.
 - If the applied pressure **Does Not** remain stable for 1 minute, the non-return valve in the cylinder head has to be replaced.
