# Service Bulletin

File in Section: 00 - General Information

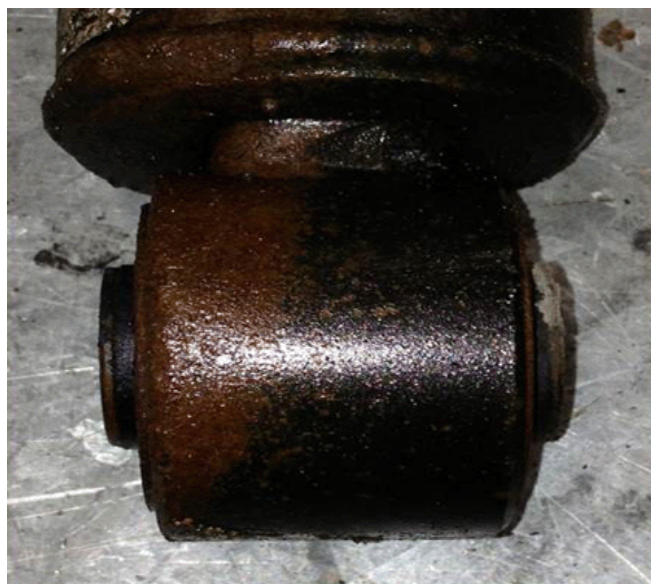
A droplet is formed on the end of the stud and the surrounding area is also covered with fluid.

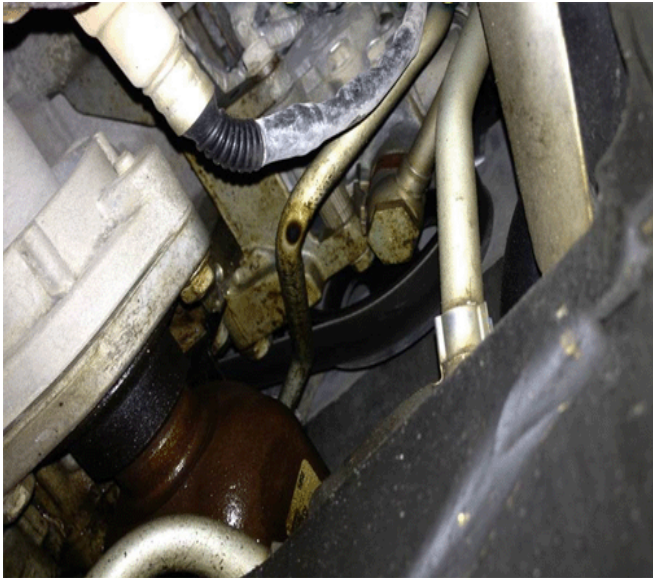
For more information on the diagnosis and replacement of shock absorbers, refer to the latest version of bulletin 05-03-08-002: Information on Diagnosis and Replacement of Shock Absorber and Strut Due to Fluid Leak.

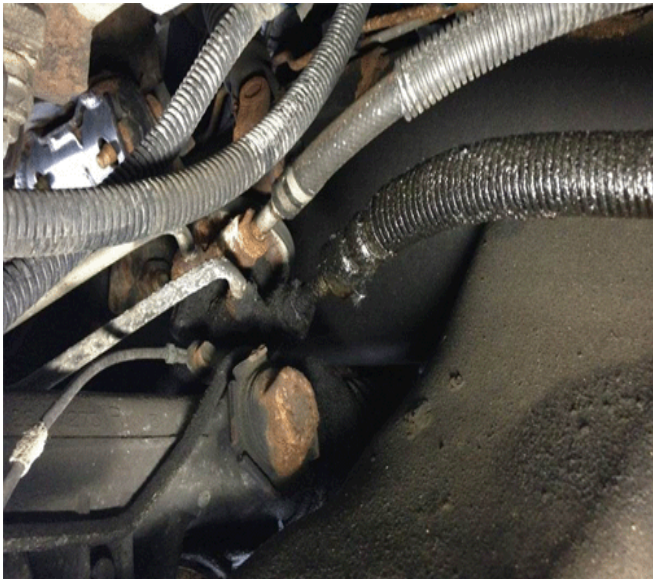
This is also a leak because there is a droplet formed on the bottom of the power steering line and fluid has dampened the drive axle.

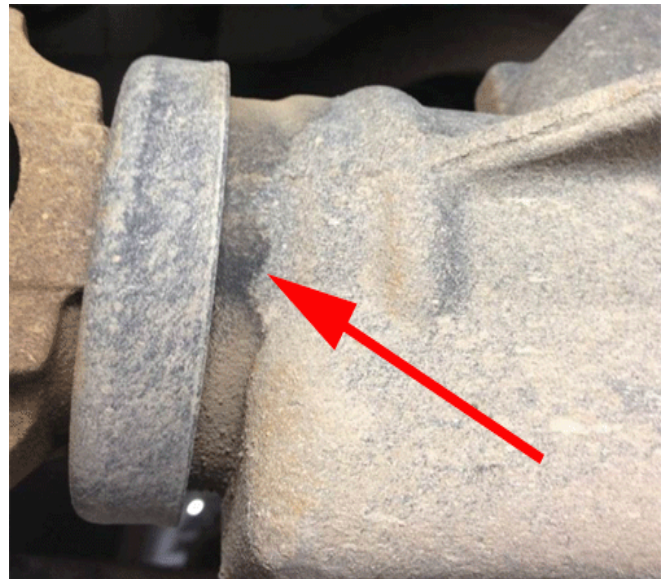
The engine illustrated above shows residual oil staining from assembly. There are no drips or leak paths present.

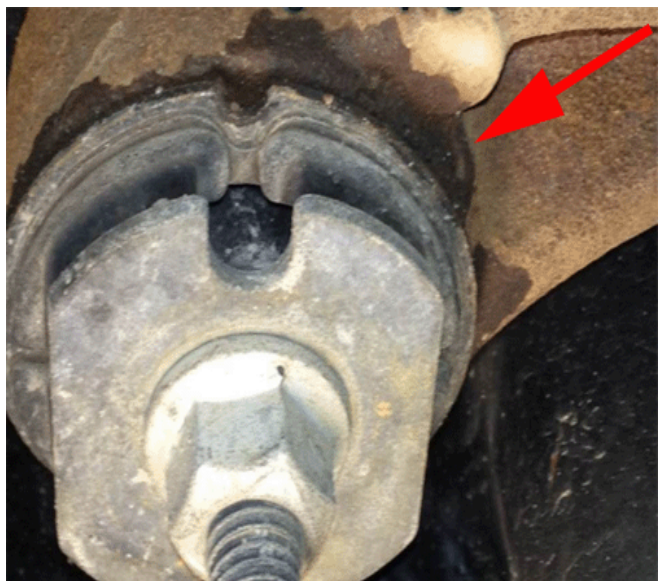
You can see the darker area where fluid has attracted dirt. There are no droplets at the bottom of the seal area.

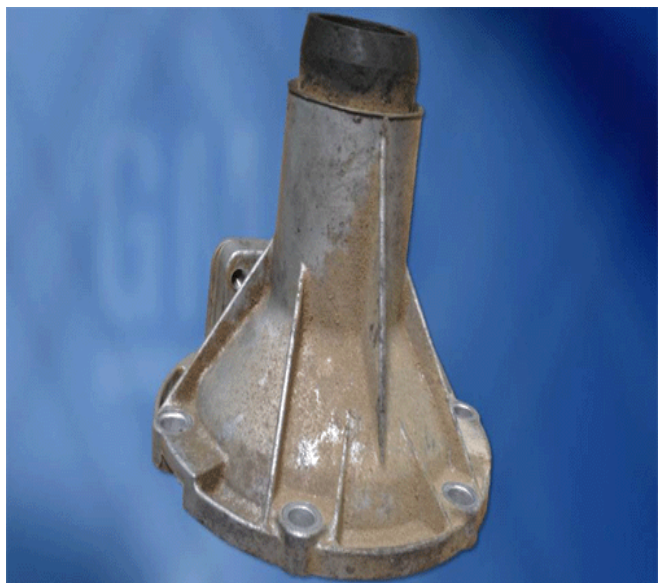
There is slight staining around the mount, but there are no droplets formed and fluid has not dripped onto other components.
