96E6 UPDATE – Q7 Update Package Traffic Sign, Unable to Start and Service Msg (NVLW)

September 08, 2018

Model(s)	Year	VIN Range	Vehicle-Specific Equipment
Audi Q7	2017	See Elsa	None

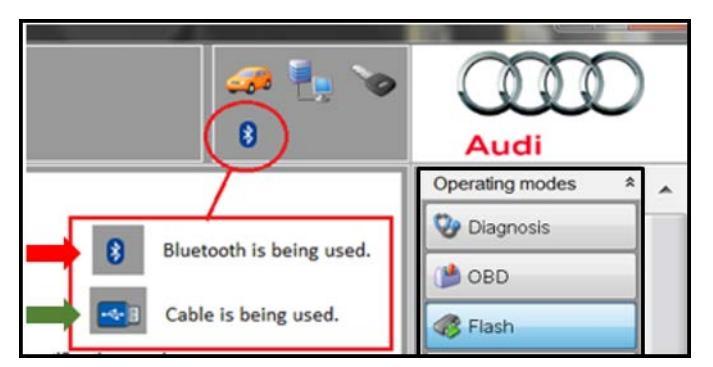
- 1. Follow all instructions in TSB 2011732: 00 Software Version Management (SVM), operating instructions and TSB 2047812: SD Creator: How to setup and use the SD Creator for obtaining vehicle software updates via the MirrorServer.
- 2. Attach an appropriate battery charger to the vehicle.
- 3. Attach the scan tool to the vehicle using an USB cable.
- 4. Confirm that the scan tool is communicating with the diagnostic head by USB <Green Arrow>. If the Bluetooth symbol is shown <Red Arrow> then disconnect the diagnostic head from the vehicle and then reattach the USB cable to the diagnostic head and then reattach to the vehicle.

5. Switch on the hazard warning lights.

- 6. Using <u>"Flash"</u>, perform the update using the SVM action code, 96E6A080.
- 7. After the Flashing test plan has completed upload log online.

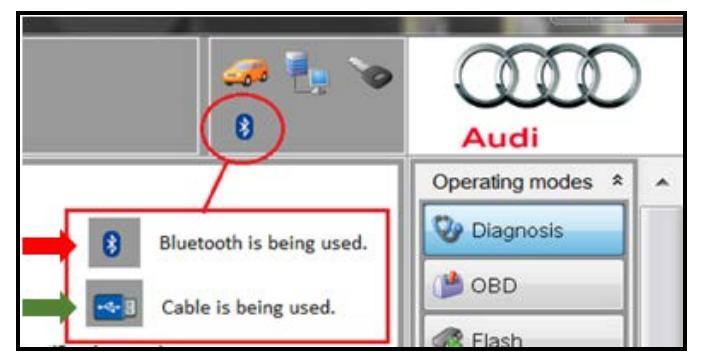
4. Confirm that the scan tool is communicating with the diagnostic head by USB <Green Arrow>. If the Bluetooth symbol is shown <Red Arrow> then disconnect the diagnostic head from the vehicle and then reattach the USB cable to the diagnostic head and then reattach to the vehicle.

- Insert the appropriate SD Card in the SD1 slot. SD Card can be created by using the SD Creator software.
 Criteria 03: 8S0 906 961 Q
- 6. Using Flashing, perform the update using the SVM action code, **96E6B080**.
- 7. After the Flashing test plan has completed upload log online.
