Emissions Recall – USA ONLY Code: 24CX

Subject	Inlet Air Box Housing Snow Flap Replacement & Oxygen Sensor Inspection/Replacement
Release Date	June 26, 2017
Revision Summary	Updated work instructions.
Affected Vehicles	U.S.A.: 2012-2014 MY Volkswagen Passat 2.0L TDI (GEN 2)
	Check Campaigns/Actions screen in Elsa on the day of repair to verify that a VIN qualifies for repair under this action. Elsa is the <u>only</u> valid campaign inquiry & verification source.
	 ✓ Campaign status must show "open." ✓ If Elsa shows other open action(s), inform your customer so that the work can also be completed at the same time the vehicle is in the workshop for this campaign.
Problem Description	The snow flap in the inlet air box housing may remain partially to fully open. Should this occur, excess warm air could enter the air intake through the snow flap inlet.
	The oxygen sensor will be checked during this service and, if measured degradation tolerances are met, the sensor will be replaced.

Subject: Emissions Recall 24CX - Inlet Air Box Housing Snow Flap Replacement & Oxygen Sensor Inspection/Replacement 2012-2014 Model Year Volkswagen Passat 2.0L TDI (GEN 2)

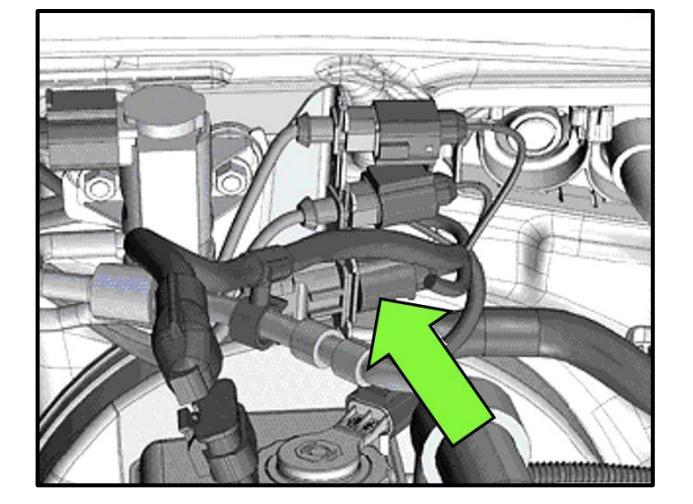
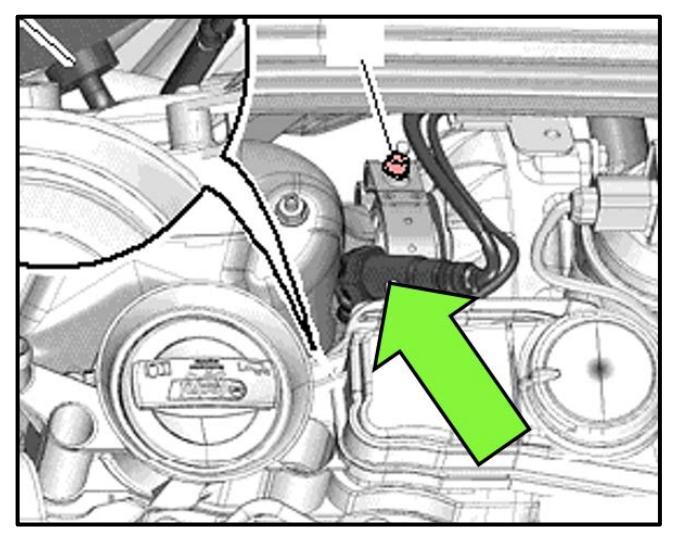
- During the 23U4 Campaign, the test plan runs a self-check operation on the Heated O2 Sensor -G39-. You were instructed during the 23U4 Campaign to select "Complete/Continue" <1>, as further repair and claiming instructions would be presented in the 24CX Campaign.
 - If the test plan **DID NOT** display the message noted to the left during the 23U4 Campaign, then the heated O2 sensor passed the test plan self-check and does not require replacement.
 Proceed to Section D and replace the snow flap.
 - If the test plan **DID** display the message noted to the left during the 23U4 Campaign, then the Heated O2 Sensor -G39- has failed the self-check and requires replacement. **Proceed to the next step** and replace the heated O2 sensor.

- Remove the engine cover.
- Disconnect electrical connector <arrow> for the heated oxygen sensor -G39-.
- Free up the wiring harness.
- Loosen and remove the original heated oxygen sensor -G39- <arrow> from diesel particulate filter using the ring wrench 7-piece set -3337-.

- Install new heated oxygen sensor -G39- <arrow> (part number 03L 906 262 B) into diesel particulate filter using the ring wrench 7-piece set -3337- and torgue to 50 Nm.
- Reconnect electrical connector and reinstall engine cover.

Risk of Damaging Sensor Grease only the threads with Hot Bolt Paste (G 052112A3). The Hot Bolt Paste must not get into the slots on the sensor body.

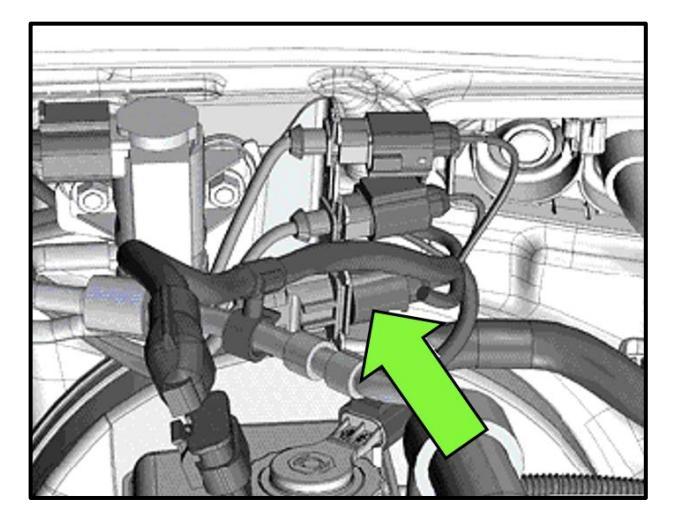
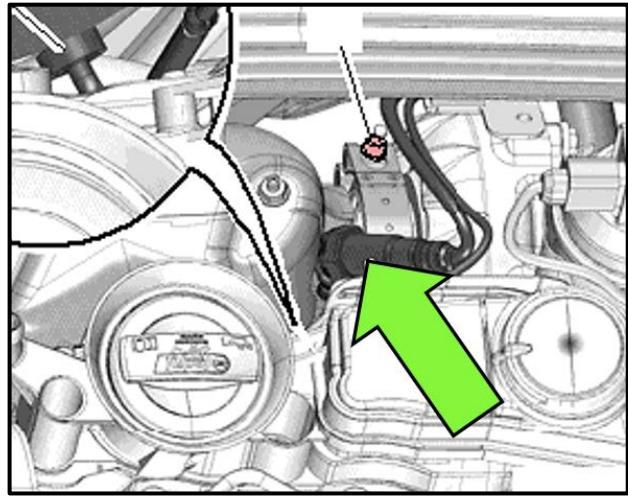
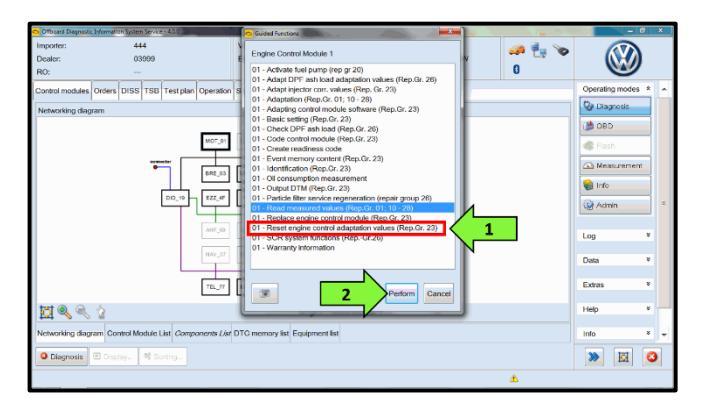
- The target value for a good heated O2 sensor is LESS than 0.0195. Any sensor reading a value higher than 0.0195 will require replacement.
- The recorded "IDE04674 O2 sensor 1 bank 1, adjusted oxygen value" Measured Value may be listed in Exponential Values. Exponential values require solving for the exponent value.
- The "E-x" behind the Measured Value is the exponential value. To solve for the exponential value, the decimal place must be moved the number of spaces expressed by the value "-x". Examples:
 - 3.5E-4 = 0.00035 (-4 indicates that the 0 decimal moves four places to the left), sensor is OK. (This example shown to the left).
 - 14.3E-4 = 0.00143 (-4 indicates that the 0 decimal moves four places to the left), sensor is OK.
 - 21.2E-3 = 0.0212 (-3 indicates that the 0 decimal moves three places to the left), sensor is BAD.

- If heated O2 sensor replacement is required by • the test results, remove the engine cover.
- Disconnect the electrical connector <arrow> for • the heated O2 sensor -G39-.
- Free up the wiring harness.
- Loosen and remove the original heated O2 sensor -G39- <arrow> from diesel particulate filter using the ring wrench 7-piece set -3337-.
- Install new heated O2 sensor -G39- <arrow> (part number 03L 906 262 B) into diesel particulate filter using the ring wrench 7-piece set -3337- and torque to 50 Nm.
- Reconnect electrical connector and reinstall engine cover.

Risk of Damaging O2 Sensor Grease only the threads with Hot Bolt Paste

(G 052112A3). The Hot Bolt Paste must not get into the slots on the sensor body.

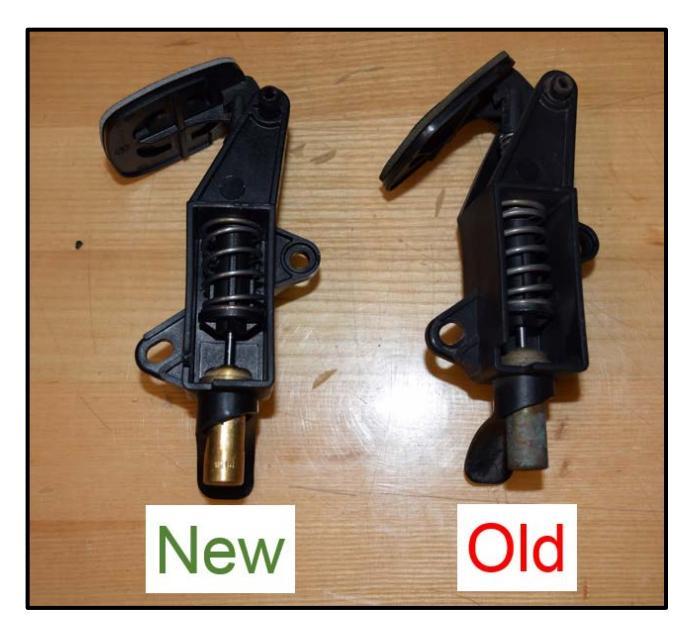
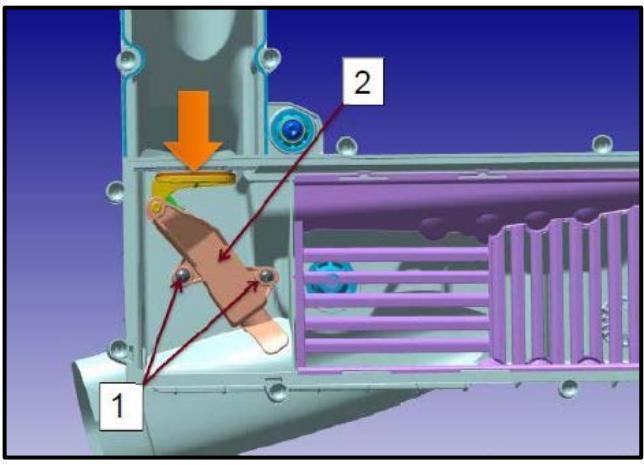
The new snow flap when at rest and at normal room temperature (70 F or 21 C) may appear to be extended in the closed position further than the old flap. This condition is normal.

- Install the new snow flap by pushing the flap in the direction of the arrow towards the closed position for easier installation.
- Install and tighten the two screws <1> to 1.6 Nm.
