# Service Bulletin

File in Section: -  
 Bulletin No.: 17-NA-296  
 Date: September, 2017

**Subject:** Noise Originating from Front Suspension When Traveling Over Bumps

| Brand: | Model: | Model Year: | | VIN: | | Engine: | Transmission: |
|---|---|---|---|---|---|---|---|
| Chevrolet | Spark | 2016 | 2017 | | | All | All |

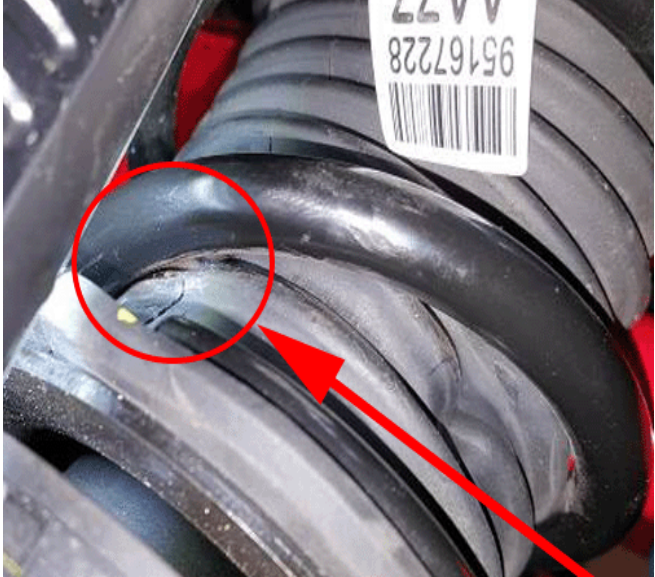
| <b>Condition</b> | Some customers may comment on a noise originating from the front of the vehicle when traveling over bumps. |
| <b>Cause</b> | <p style="text-align: right; font-size: small;">4867096</p> |

| <b>Correction</b> | If wear marks are observed like shown above, replace the coil spring with new part. |

If you encounter a vehicle with the above concern and witness marks are observed, replace the affected spring. Refer to *Strut, Strut Component, or Spring Replacement* in SI.
