Mazda North American Operations Irvine, CA 92618-2922

Subject: 2018 CX-9 - MAINTENANCE MONITOR ENGINE OIL DATA RESET	Service Alert No.: SA-071/17
	Last Issued: 11/28/2017

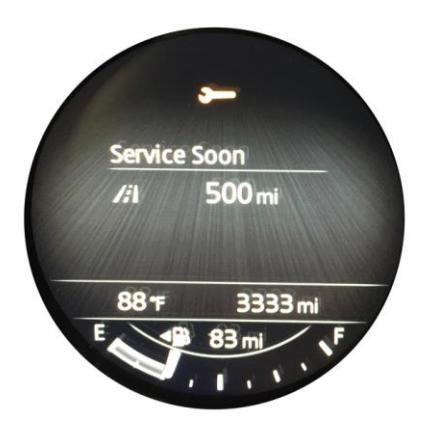
The 2018 CX-9 Maintenance Monitor engine oil data reset procedure (for oil change) is different than other models due to a specification problem. It must be reset in 2 places - in MAZDA CONNECT and in the instrument cluster. It is important to reset in both places at every oil change to avoid unnecessary customer return.

NOTE: If the reset procedure is not performed in both places, a maintenance message will be displayed in the instrument cluster after the customer leaves the dealer.
