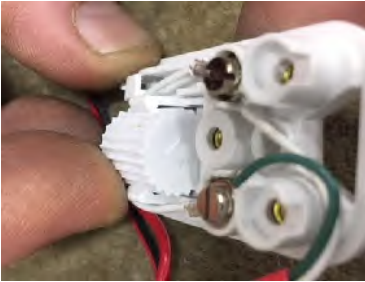
Picture 1

Please make sure that you need to stop pressing the extend button when the awning reaches its maximum. There are 2 areas that we wanted you to check. The first one will be at the front of the awning when you extend it. That is the awning sensor (pictures 1 & 2). If you can open the awning NOT to its maximum so that it will NOT retract rightaway, remove the screw (shown in picture 2) to see the inside wheel. There will be an arrow on that wheel (shown in picture 1) and that arrow should be pointing upward. If this wind sensor was installed horizontally on the awning. When you removed the cover, the arrow should be straight up, if NOT, you need to point it 12 o'clock.

If NOT, I would advised you to contact Fiamma at 407-672-0091 for diagnosis before you bring it to an RV dealer.
