# Technical Service Bulletin

| Subject:<br>REAR DOOR WEATHERSTRIP COMES OFF | Bulletin No.: 09-004/18 |

2016-2018 CX-9

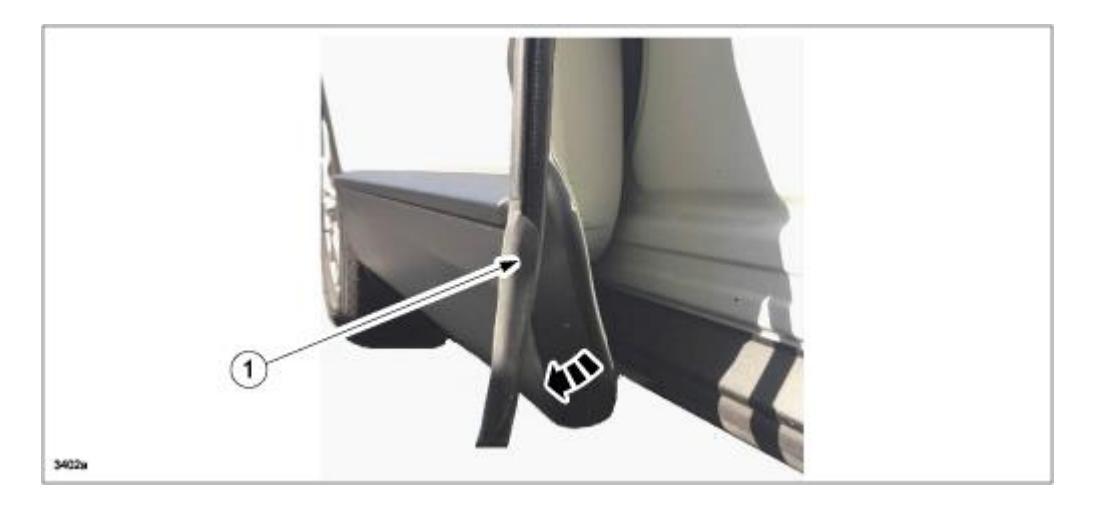
Some customers may complain that the door weatherstrip (1) comes off at the front / lower part of the rear door(s). This concern is caused by insufficient weatherstrip gripping force.

Customers having this concern should have their vehicle repaired using the following repair procedure.
