THUMPING / RATTLING NOISE FROM ENGINE COMPARTMENT	Service Alert No.: SA-010/18
	Last Issued: 02/22/2018

2017 CX-5

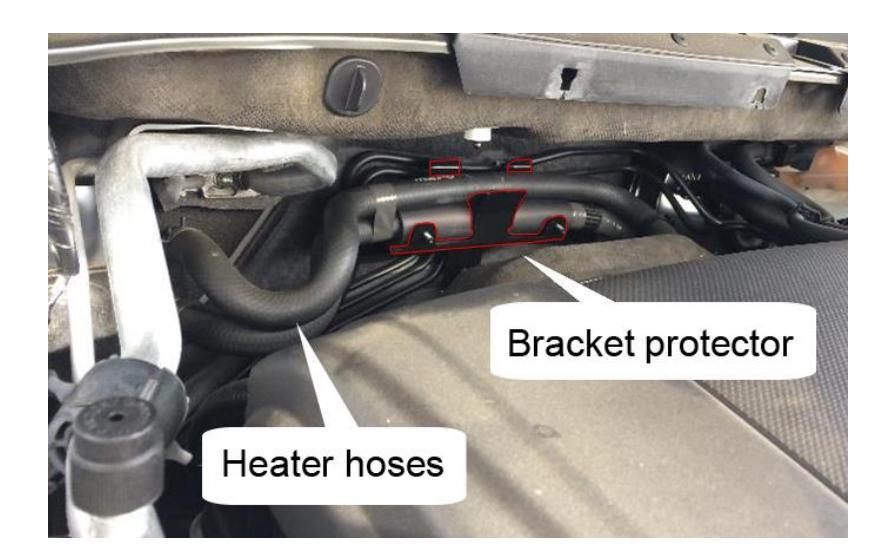
The noise may be caused by loose fitting heater hoses vibrating the heater hose bracket protector.
