Technical Service Bulletin

Mazda North American Operations Irvine, CA 92618-2922

Subject: BATTERY TEST PROCEDURE REQUIREMENTS USING THE GR8- 1291	Bulletin No.: 01-009/18	
	Last Issued: 03/26/2018

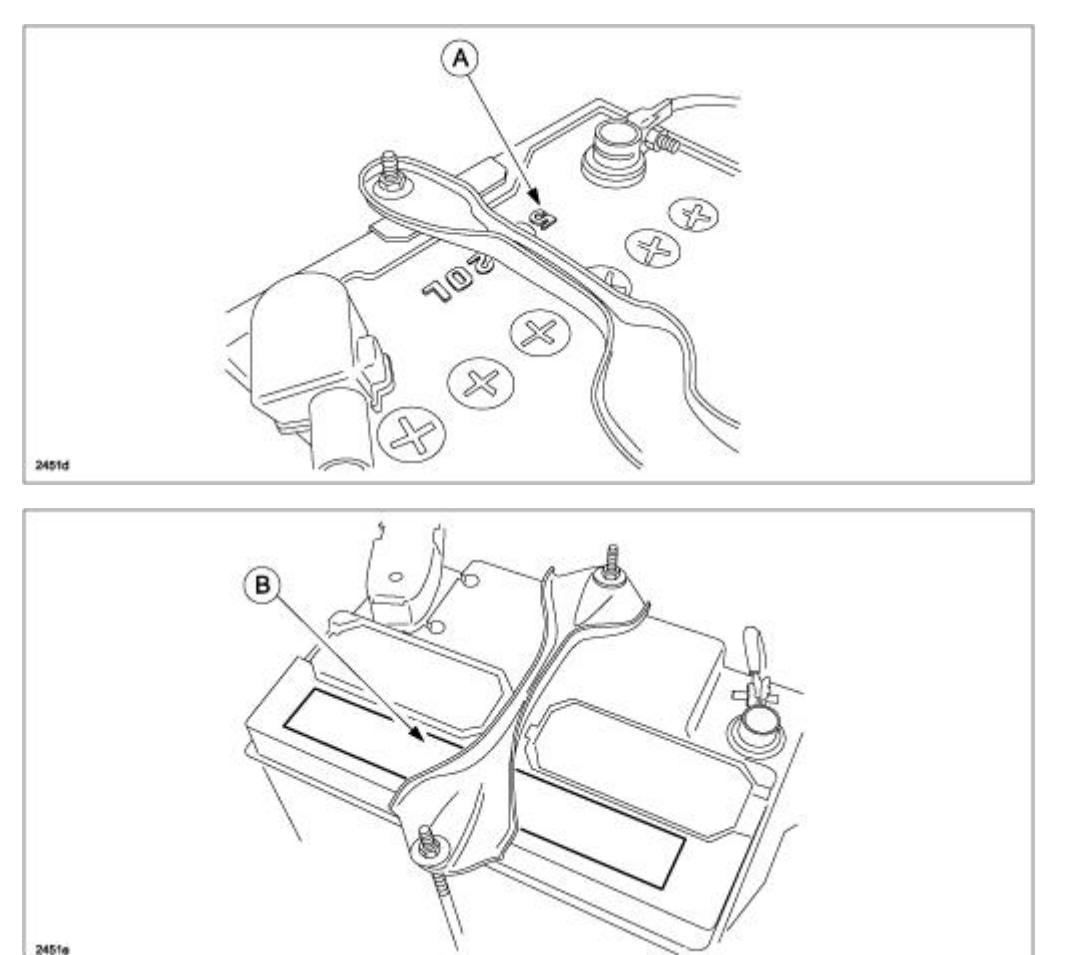
- Select the correct rating system for the battery by identifying the correct JIS code (A) stamped onto the batter top or CCA code (B) printed on the battery label.
- The battery hold down may need to be removed in order to read the JIS code.
