# Technical Service Bulletin

SHOCK ABSORBER REPLACEMENT GUIDELINES

Bulletin No.: 02-006/18

Last Issued: 03/26/2018

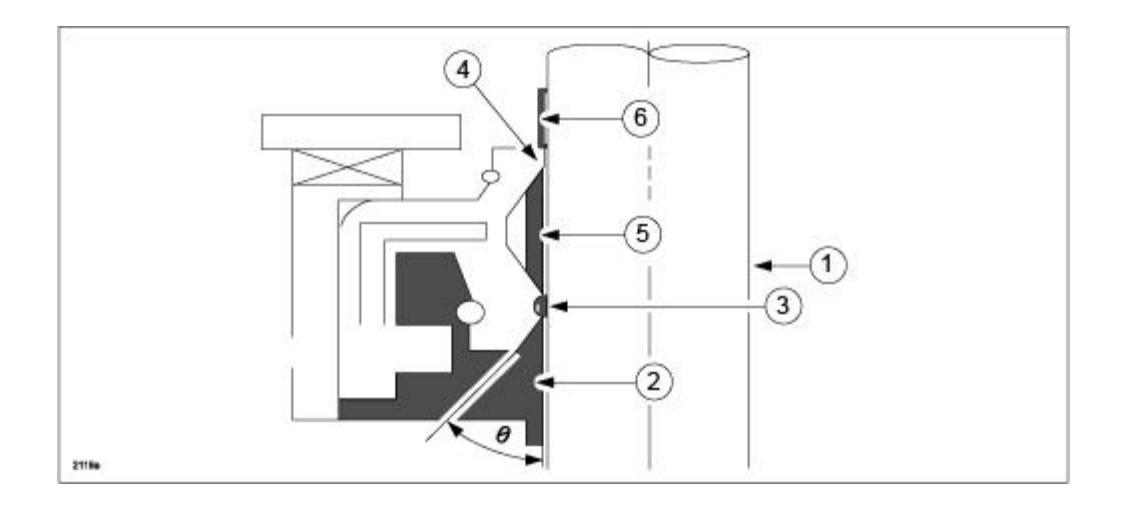
Oil seepage is caused by the following factors and is not a problem:

- A small amount of oil seeps outside through the dust lip during normal operation.
- The oil film thickness is uneven due to production variation of rod and seal.

When the rod (1) receives input from the road and extends upward, most of the oil (2) on the rod is scraped off by the main lip (3) and some remains inside the dust lip (4). When the rod extends further, then most of the remaining oil (5) on the rod is scraped off by the dust lip, and a small amount of oil seeps out (6).
