SI B34 05 15 Brakes February 2018 Technical Service

TICKING NOISE FROM THE FRONT AXLE WHEN CORNERING

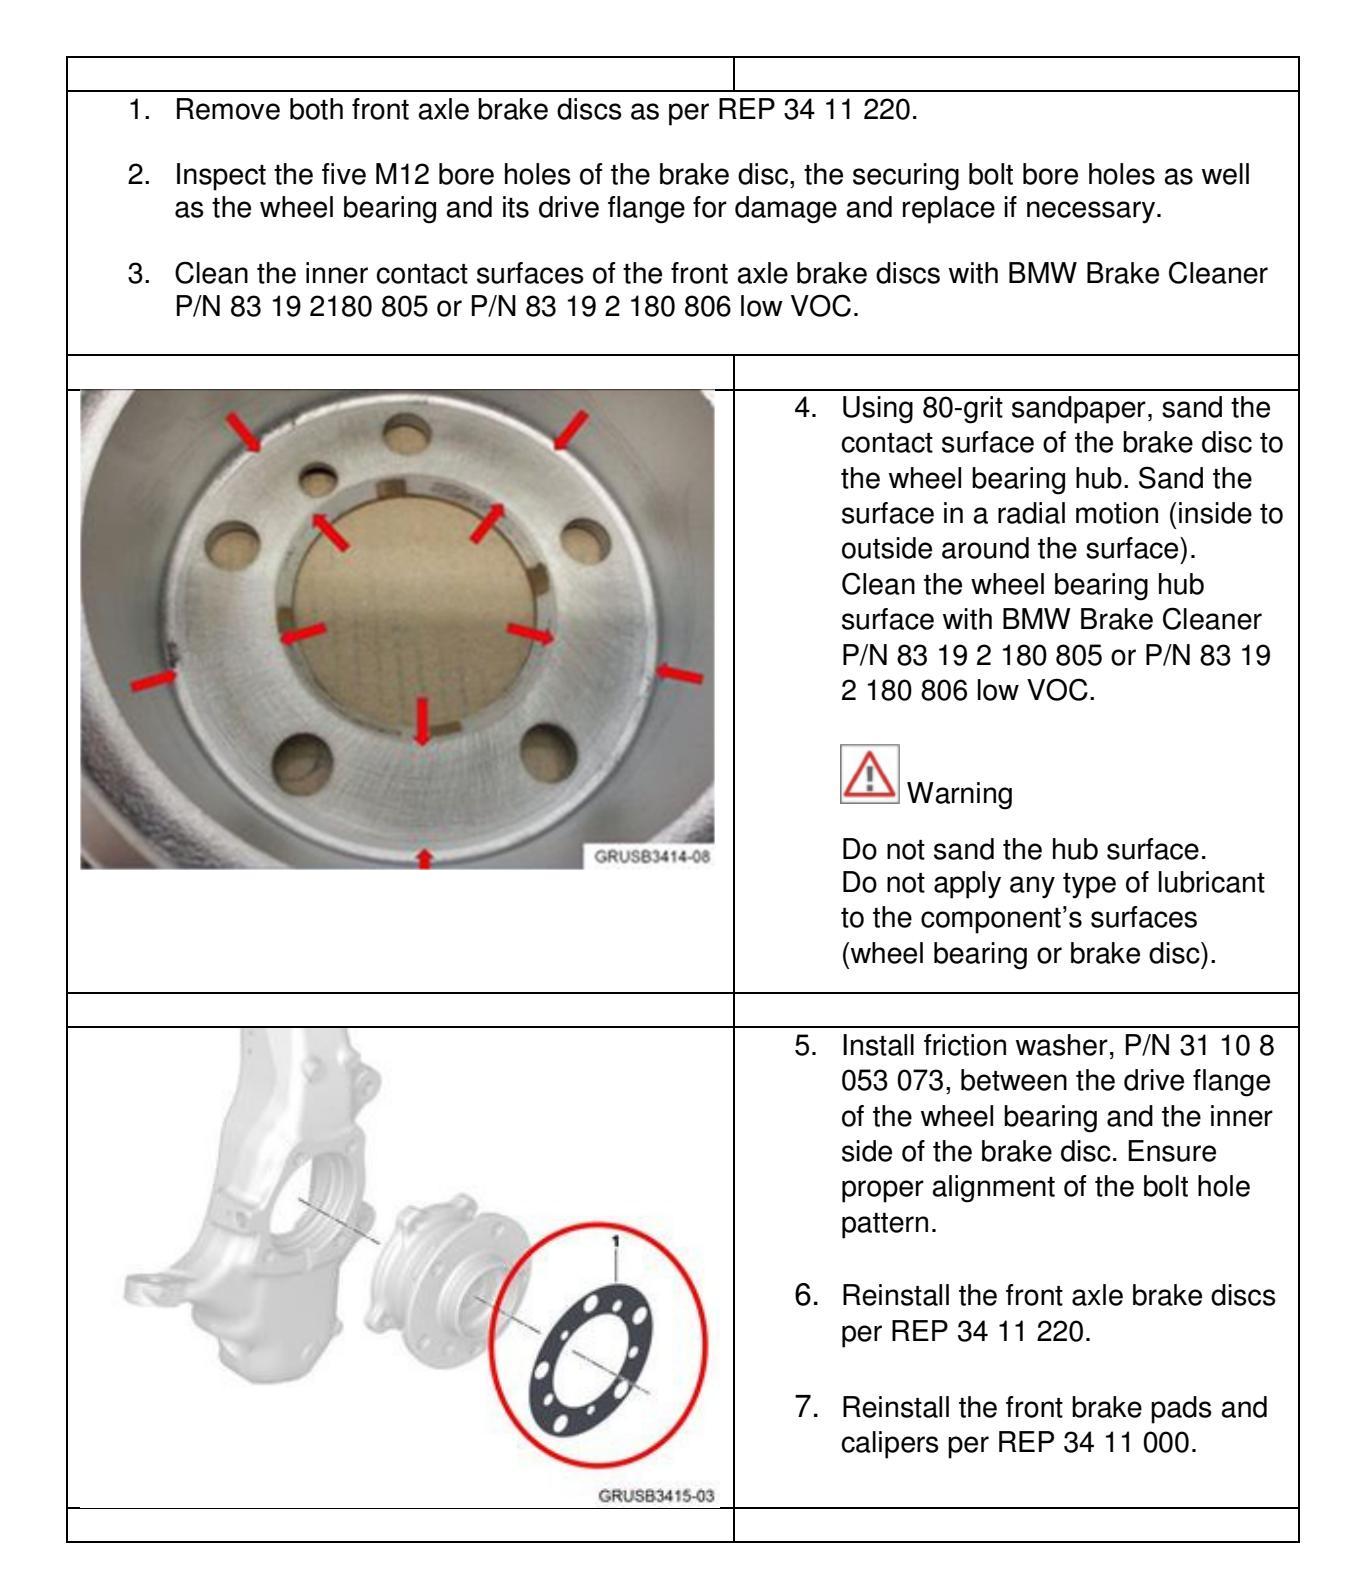
Front Wheel Cleaning and Friction Ring Installation Procedure

Movement between the inner contact surfaces of the brake disc and drive flange of the wheel bearing hub.

Attachment A	February 2017	(SI B34 05 15)
	GRUSB3417-01	8. Clean the rims on the inside on the bearing surface to the brake disk with a sand paper (80-grit) in the radial direction.
	GRUSB3417-02	 Install guide pins into wheel hub to hold friction ring in place.
	GRUSB3417-03	Note: de pins can be made by removing head of a wheel bolt and then ting it (A); or sourced locally from vendors (B).
