Technical Service Bulletin

LACK OF POWER, NO WARNING LIGHTS ON

Bulletin No.: 01-003/18

2016-2018 CX-9 vehicles with VINs lower than JM3TC*****216875 (produced before Nov. 10, 2017)

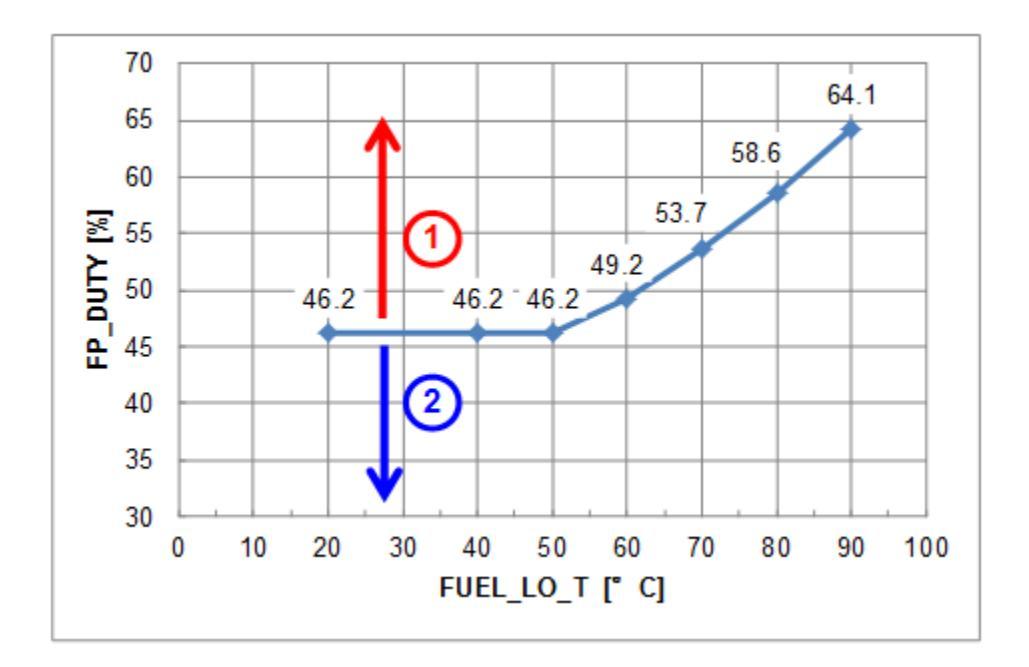
5. Mark a point on the graph for the PID data and verify if the point is located above the line (in the poor performance area (1)) or below the line (in the normal performance area (2)).

For example, if FP_DUTY is 55% and FUEL_LO_T is 40 °C, the point is located in the poor performance area (1).

5. If the PID data is the poor performance area (1), replace the low pressure fuel pump. If not, the low pressure fuel pump does not need to be replaced.
