Service Bulletin

n No.: 18-NA-078 Date: March, 2018

Subject: 2nd Row Center Seat Belt Not Retracting Fully or Unable to Extract

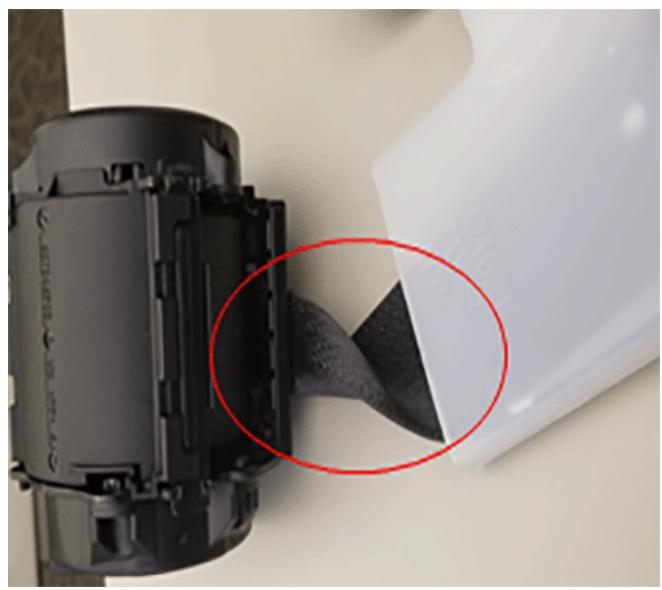
4960937

Note: As shown in the graphic above, most commonly, the twist is found to be between the retractor and the belt sleeve.

2. Check for any visible twist in the seat belt. In some cases, the twist will not be visible if it is inside the retractor.
