PORSCHE

Technical Information

Service 34/16 ENU 9638

Eliminating Symptoms in Body Interior: Replacing Front Camera (Front Camera Functions Fail/SY3416)

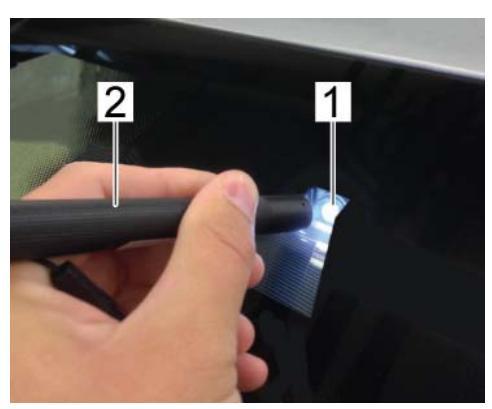
Shine the flashlight (or light on smartphone – ⇒ Shining flashlight on front camera -2-) directly onto the lens of the front camera (⇒ Shining flashlight on front camera -1-).
 ⇒ The flashlight/smartphone light can be set to any brightness, but the brightness must be constant.

• If the mean value of the contrast values is greater than 80, the front camera is faulty and must be replaced. ⇒ Workshop Manual '963819 Removing and installing front camera'
