Document ID: IK1600247

Title: Hood Gap and Alignment Tolerances

Applies To: ProStar/LT, 7000 Series, 9000 Series, HX, HV, MV.

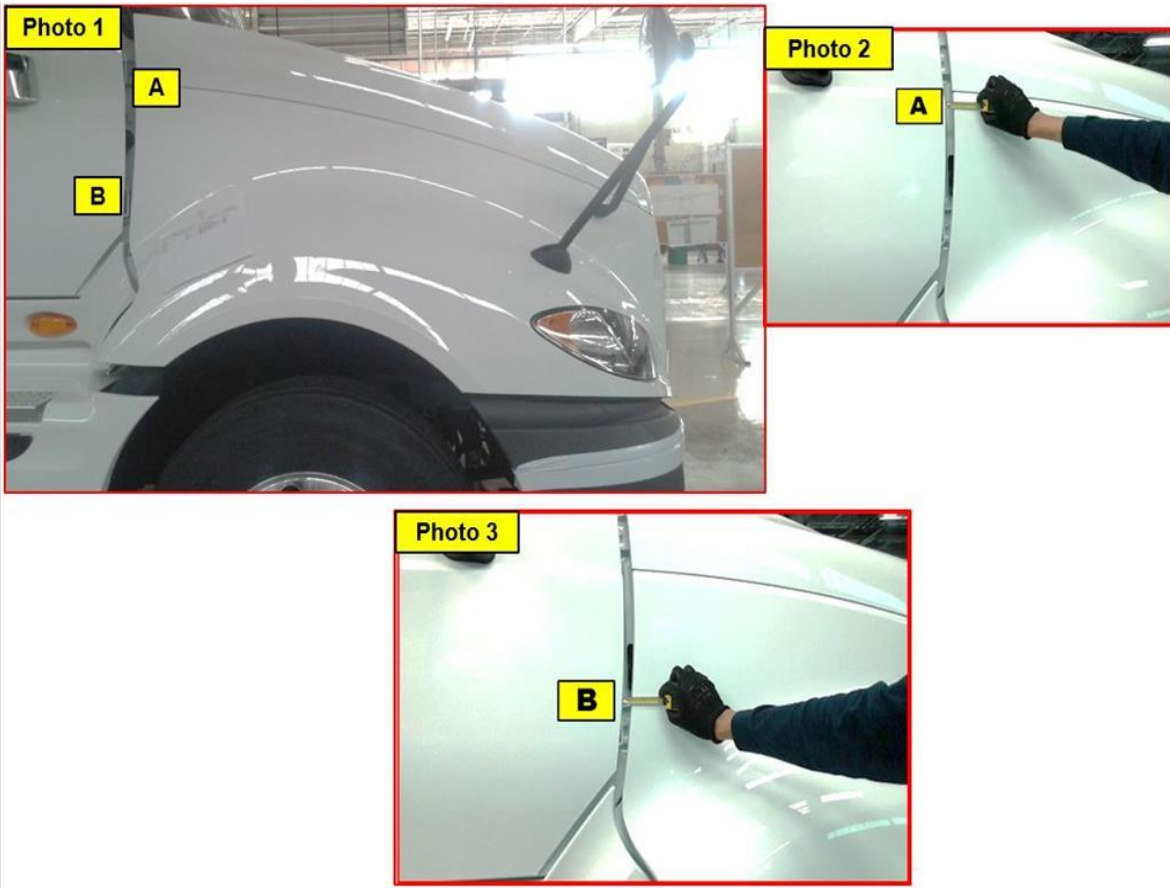
Figure 1: LT/ProStar/8000

Photo 1: Overall view of right side gap showing Point A & Point B.
 Photo 2: Measurement at Point A.
 Photo 3: Measurement at Point B.

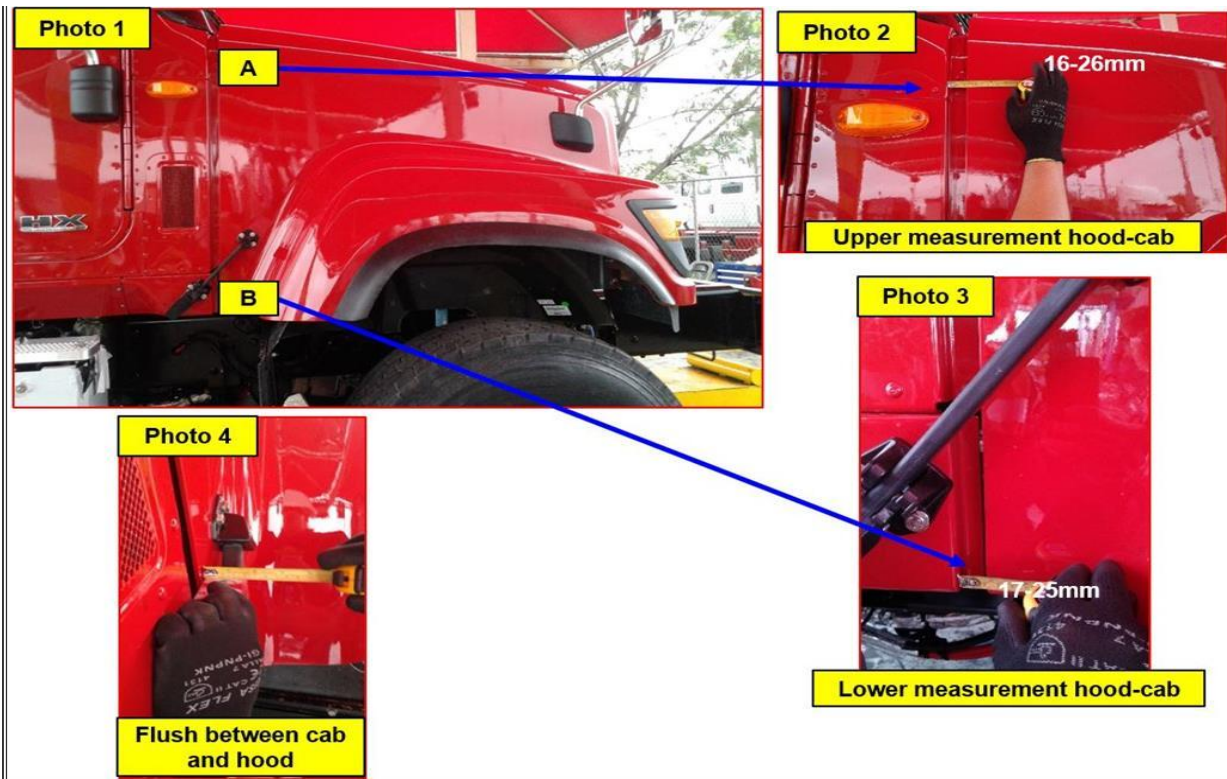
Figure 6: HX 515 Hood Gap & Alignment

Photo 1: Overall view of right side hood to cab gap. Left side is the same but opposite.
 Photo 2-3: Measurement of hood to cab verticle gap at hood seam location.
 Photo 4: Gap flushness.

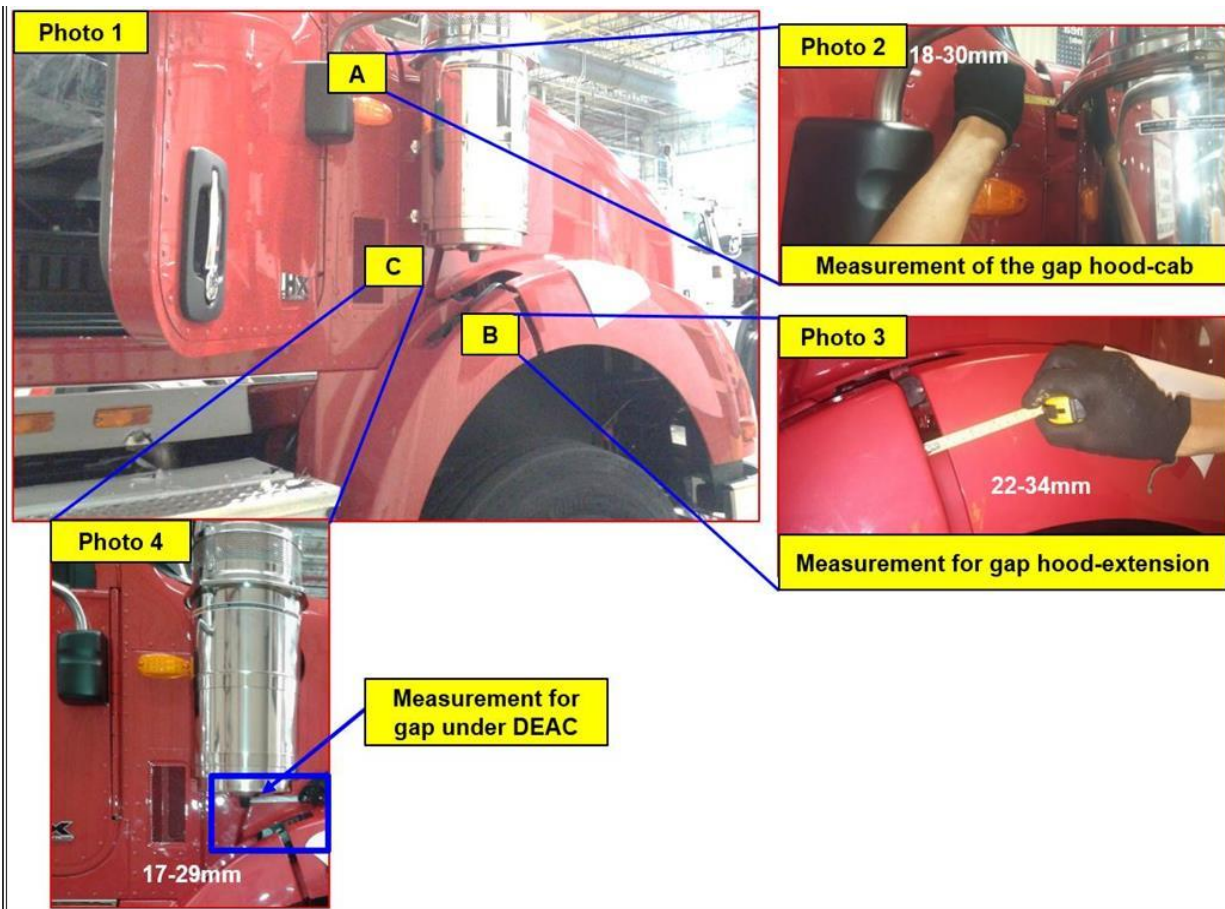
Figure 7: HX 620 with DEACs Hood Gap & Alignment

Photo 1: Overall view of right side hood to cab gap. Left side is the same but opposite.
 Photo 2-3: Measurement of hood to cab verticle gap at hood seam location.
 Photo 4: Gap flushness.

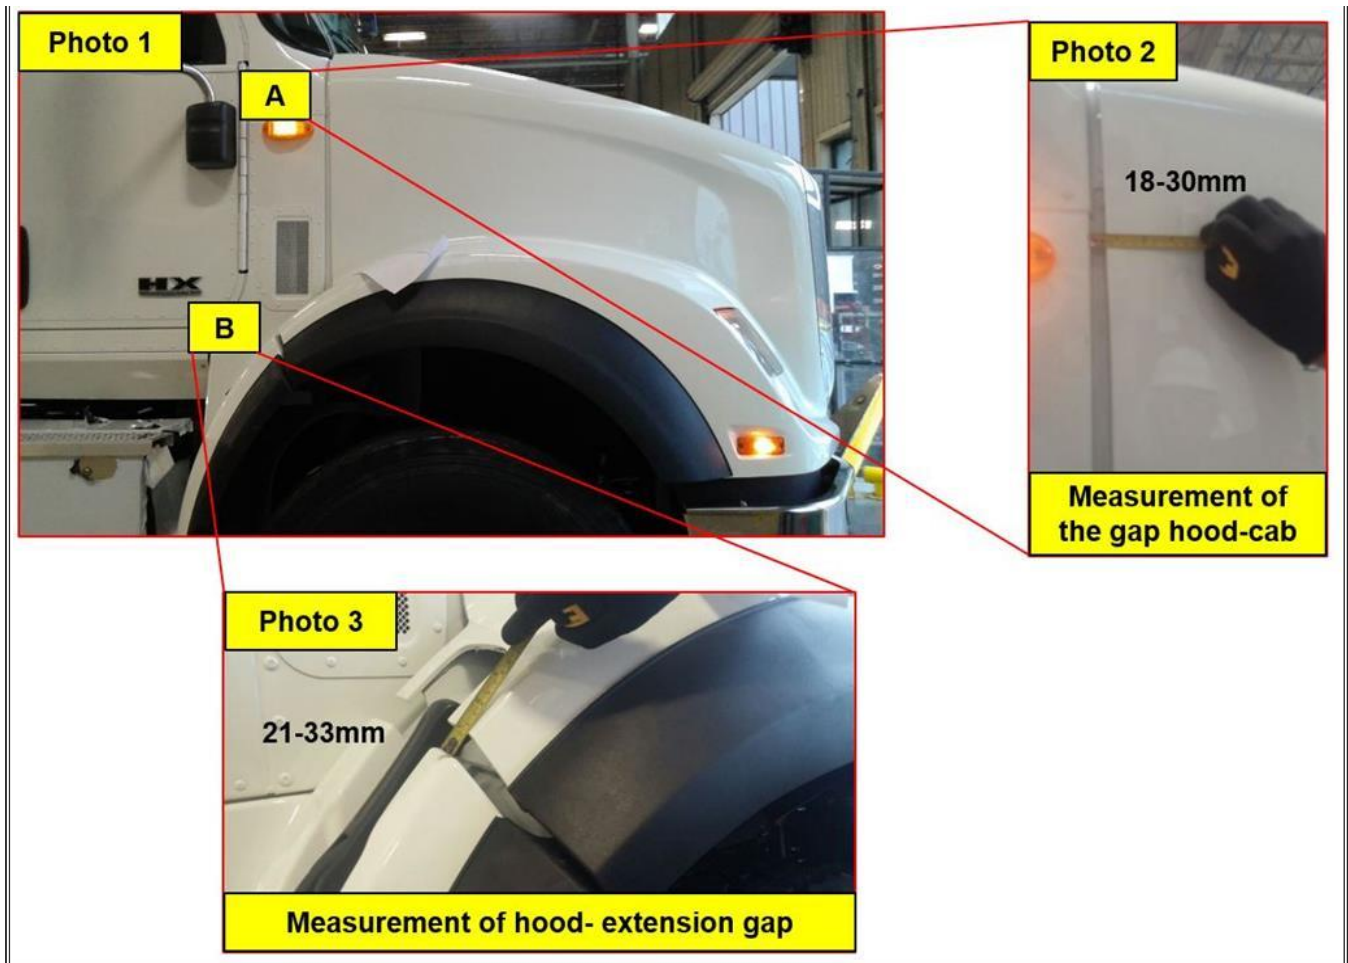
Figure 8: HX 615 & 620 with Extension without DEACs Hood Gap & Alignment

Photo 1: Overall view of right side hood to cab gap. Left side is the same but opposite.
 Photo 2-3: Measurement of hood to cab verticle gap & Fender seam location.
