Outlander Sport

Vehicle Technical Info

Volume 242 - September 2018

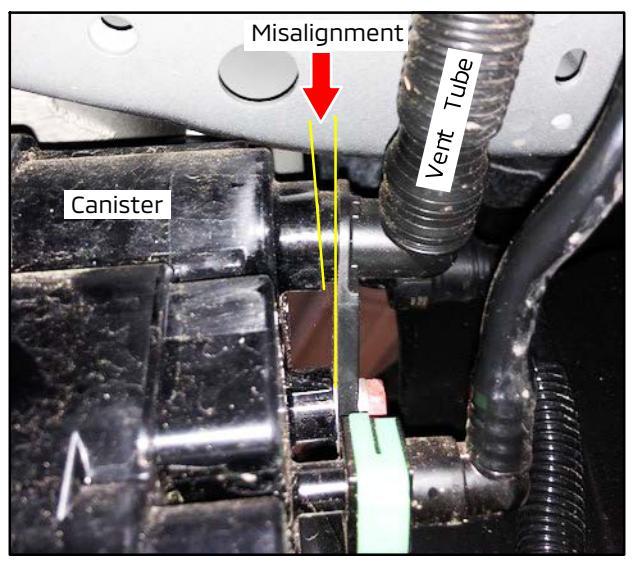
MIL ON FOR EVAPORATIVE EMISSIONS LEAK WITH DTC P0442, P0456, OR P0455 – 2018-19 Eclipse Cross.

Should you encounter the subject condition on affected vehicles, inspect the connection between the main canister and vent tube. Dealers have reported this connection being misaligned which can cause a small leak (see photo).

To correct the condition, unbolt and remove the fitting, inspect the O-ring and if necessary, replace with a commercially available part. Reattach the fitting, keeping it in proper alignment with the canister as the bolt is tightened. Confirm no leaks are present by performing a smoke test or an EVAP Leak Monitor using the scan tool.

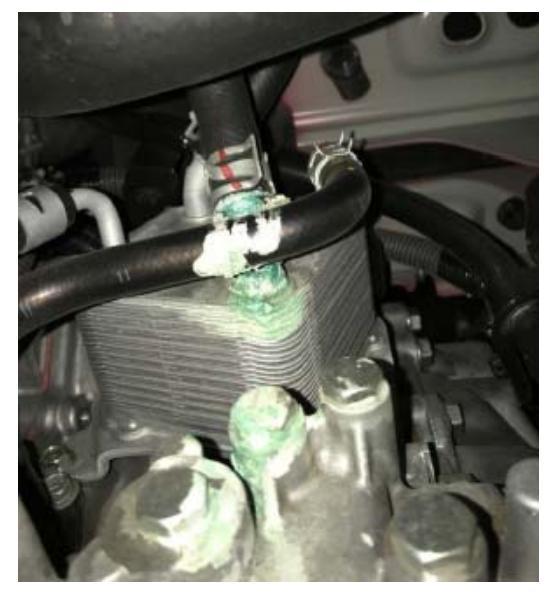
(View looking up from the bottom of the vehicle)

TIN-18-23-004: COOLANT LEAKING FROM WATER HOSES AT CVT8 FLUID COOLER – 2016-18 Outlander Sport/RVR.

"Dealers have reported coolant leaking from the water hoses at the CVT8 fluid cooler (see photo below). Normal dealer repairs have been to replace the water hose and/or clamps on the affected area.

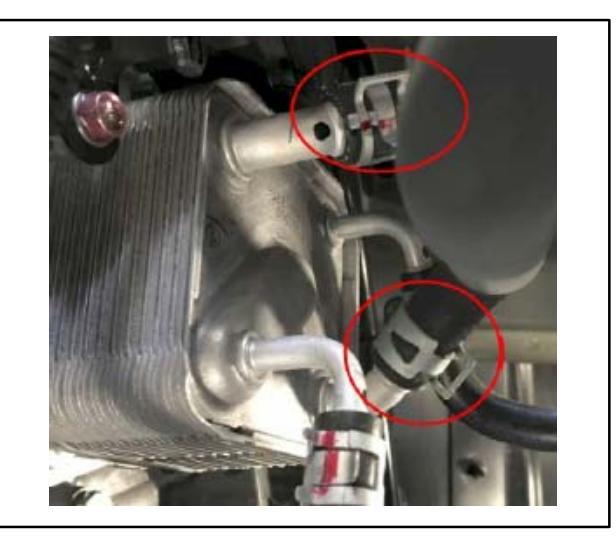
In order to investigate this condition further, MMNA is looking to collect 3 complete sets of CVT8 fluid coolers with the water hoses and clamps **<u>undisturbed</u>**. Please <u>do not remove</u> the water hose clamps and hoses indicated by the circled areas in the photo below (the other hoses are for the CVT8 oil, not coolant). This is important since MMC needs to perform a duplication test to confirm the area of leakage.

Please open a Techline case, attach photos of the condition, and contact Techline (800-446-6064) to review the findings. Product Support will then contact the dealership to arrange return of the original parts to MMNA."

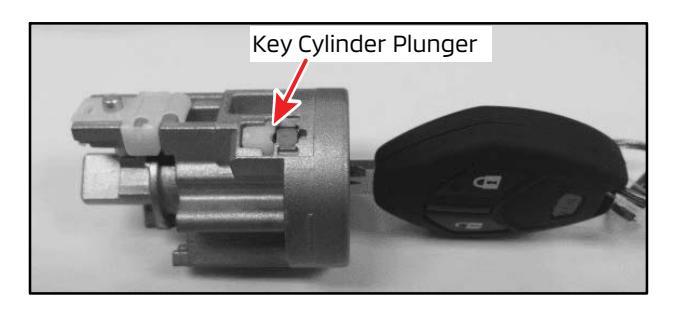
If the vehicle incorrectly indicates "KEY IN IGNITION" or chimes after the ignition key has been removed, one of 2 components may be the cause. The Lock Cylinder & Key Set or Engine Starting Switch Attaching Switch may not be functioning correctly (refer to part numbers in table below).

The key cylinder plunger may not return to the proper position when the key is removed or the key indicator switch may have an electrical malfunction. In some cases these may be intermittent conditions. Test the function of this system by removing and inserting the key several times to recreate the customer complaint. This is necessary to help determine if the first of the 2 functional checks is the root cause of the concern.

Step 2. Remove the key cylinder lock from the housing and inspect the key cylinder plunger. Remove and insert the key into the cylinder several times to determine if the key indicator plunger properly retracts into the cylinder housing when the key is removed. Lightly lubricate the plunger and retest. If foreign material is present on the plunger, also apply lubricant into the key opening to loosen any foreign material inside the cylinder.

If the plunger does not operate freely, replace the key cylinder. The repair is complete.

If the plunger functions properly, reinstall the Lock Cylinder & Key Set into the housing. Go to step 3.

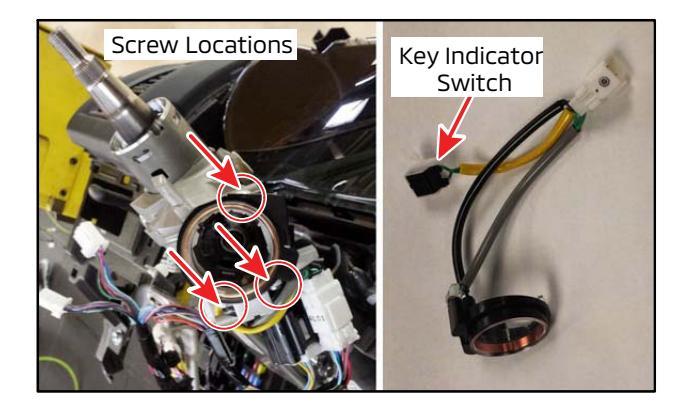
Step 3. Reconfirm if the key indicator is working correctly by inserting/removing the key several times.

If the malfunction continues, replace the Engine Starting Switch Attaching Switch (P/N 4408A155). Remove 3 screws (marked with circles below; 1 for the antenna and 2 on the micro-switch), detach the switch, replace, and reassemble. Check for proper function.
