# **Emissions Recall Code: 23V2**

Subject	3.0L TDI Engine – Emissions System Modification
Release Date	July 26, 2018
Affected Vehicles	U.S.A.: 2011-2012 MY Audi Q7 3.0L TDI Generation 1.2
	Check Campaigns/Actions screen in Elsa on the day of repair to verify that a VIN qualifies for repair under this action. Elsa is the <u>only</u> valid campaign inquiry & verification source.
	✓ Campaign status must show "open."
	<ul> <li>If Elsa shows other open action(s), inform your customer so that the work can also be completed at the same time the vehicle is in the workshop for this campaign.</li> </ul>
Problem Description	3.0 TDI vehicles were equipped with undisclosed Auxiliary Emission Control Devices which are not permitted by emissions regulations.
Corrective Action	Install updated engine control module (ECM) software, transmission control module (TCM) software and hardware to bring affected vehicles into regulatory compliance.
Code Visibility	On or about July 26, 2018, affected vehicles will be listed on the Inventory Vehicle Open Campaign Action report under My Dealership Reports. A list will not be posted for dealers who do not have any affected vehicles. The campaign code will show

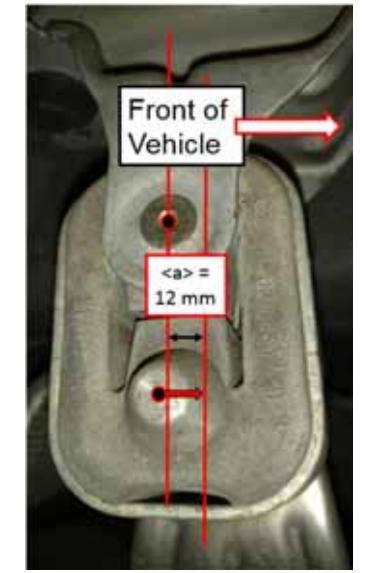
<A> = Rear Resonator Hanging Straps

In order to reduce harmonic vibration, the rear muffler/resonator straps require 12 mm of forward tension, as shown in the sub-photo. Pull forward on the rear muffler/resonator pipe and insert the pipe deeper into the Dual Clamp until this dimension is achieved.

> Once the desired dimension of <a> = 12 mm is achieved, tighten the Dual Clamp to 23 Nm.
