"Low Engine Oil" Alert Displayed

Service Category	Vehicle Interior		
Section	Meter/Gauge/Display	Market USA	Lexus Supports ASE Certification

YEAR(S)	MODEL(S)	ADDITIONAL INFORMATION
2018	LC500	VDS(s): HP5AY

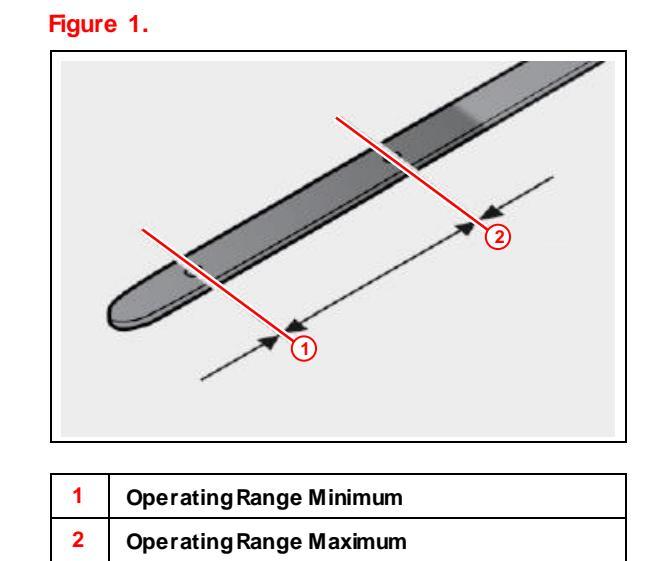
On level ground, the oil level should be within the operating range as shown. Is the oil level within the operating range?
