# **Preliminary Information**

## PIT5520B Floor Center Console Compartment Sliding Door Latch Broken or Inoperative

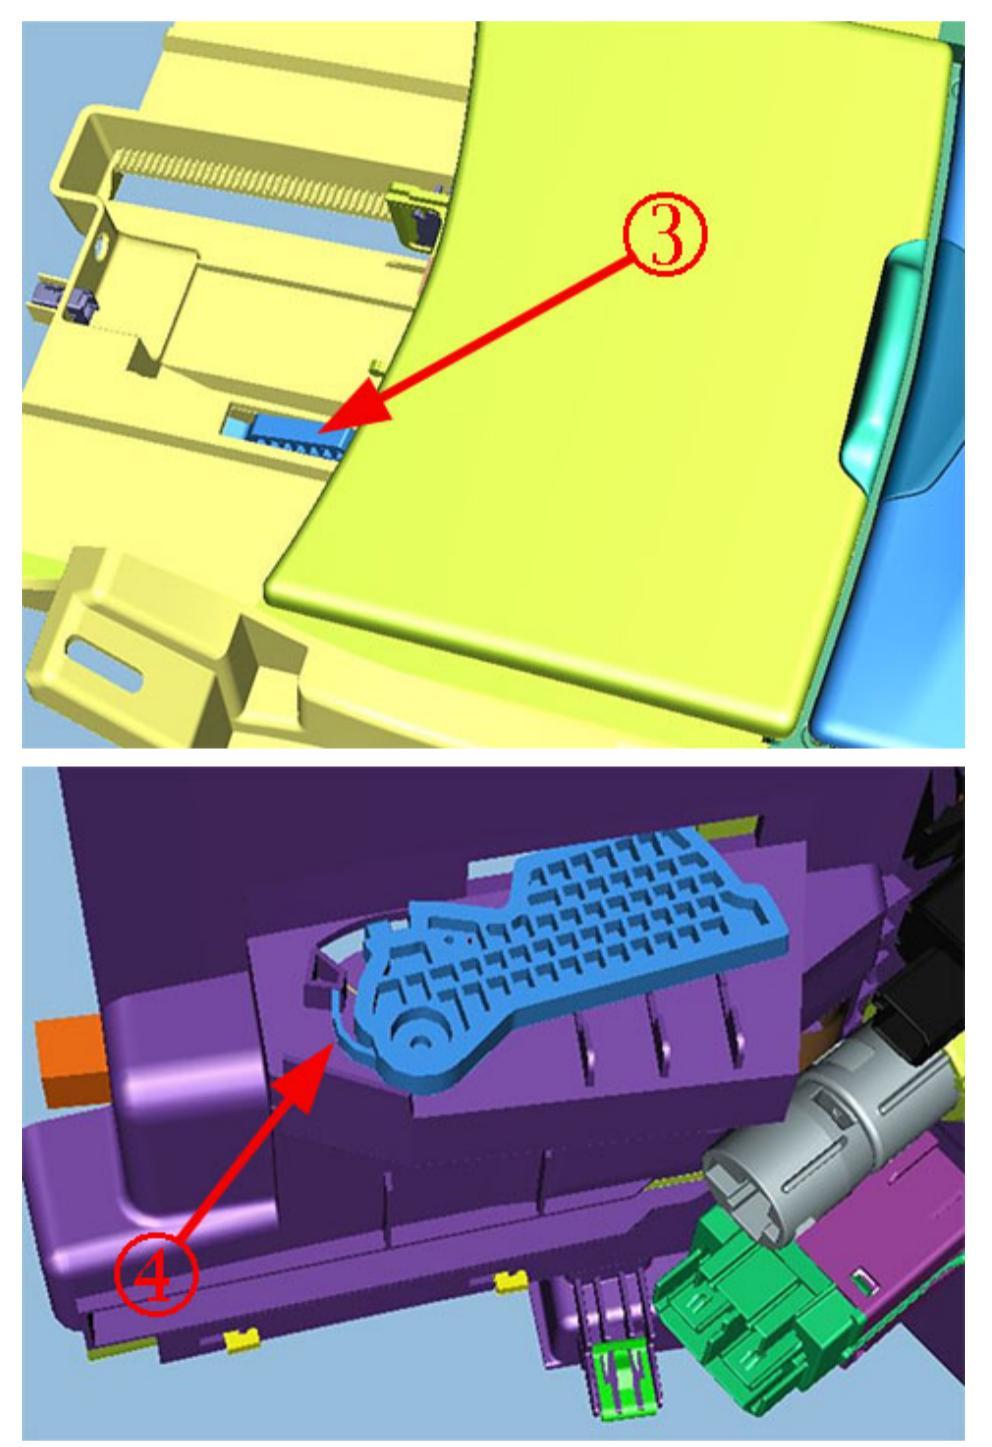
Dressel		Model Years:	VIN:		E	Torradiation		
Brand:	Model:		from	to	- Engine:	Transmissions:		
Cadillac	Escalade	2015 - 2019	All	All	All	All		
Involved Region or Country:		North America						
Additional RPO/s:		N/A						
		Some customers may comment that the floor center console sliding compartment door (1) is broken. Upon inspection it may be found that the door will not latch open, or may be locked in the closed position.						
Condition:								
Cause:		This issue is caused when the sliding door - which is intended to be a push-to-open / push-to-close, or "push-push" door – is pulled to close. The push handle on the sliding door may be misunderstood to be used as a pull handle to close the door. When the sliding door is pulled closed it can damage/break the latch (2).

TIP: If the sliding door is locked in the closed position the inertia lock (3) will need to be reset by depressing the release tab (4) on the underside of the console assembly, as shown below.

Do replace the compartment sliding door latch, GM Part # 23417257 and educate the customer on proper pushpush operation for the sliding door.

The sliding door latch (2) has been made available to repair this condition without having to replace the floor center console compartment assembly.

- Follow SI repair instructions titled "Front Floor Console Cup Holder Door Latch Replacement (Cadillac)", Document ID 4255612 to replace the latch.

- Educate the customer on proper push-push operation for the sliding door to prevent the latch from breaking again.
