**Availability:** ISIS, Bus ISIS, FleetISIS, Body Builder, IsSIR

**Major System:** ELECTRICAL SYSTEM

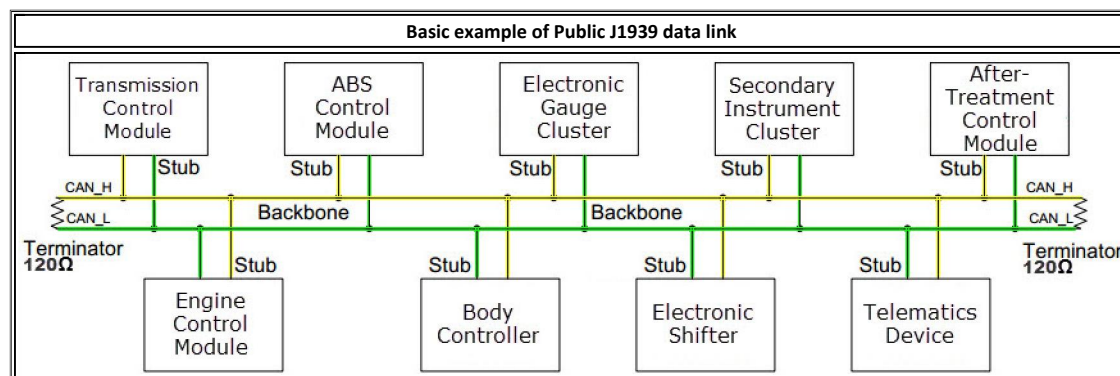
- The J1939 Splice Adapters (1024, 1025, 1026) are part of the backbone of the data link (The backbone will come in on 2 terminals and leave on 2 different terminals). The wiring from the connector to each module is a stub.
  - 2007 - [HPV \(medium duty\) 1939 Troubleshooting Card](#)
  - 2007 - [CE / BE Bus 1939 Troubleshooting Card](#)
  - 2007 - [ProStar 1939 Troubleshooting Card](#)

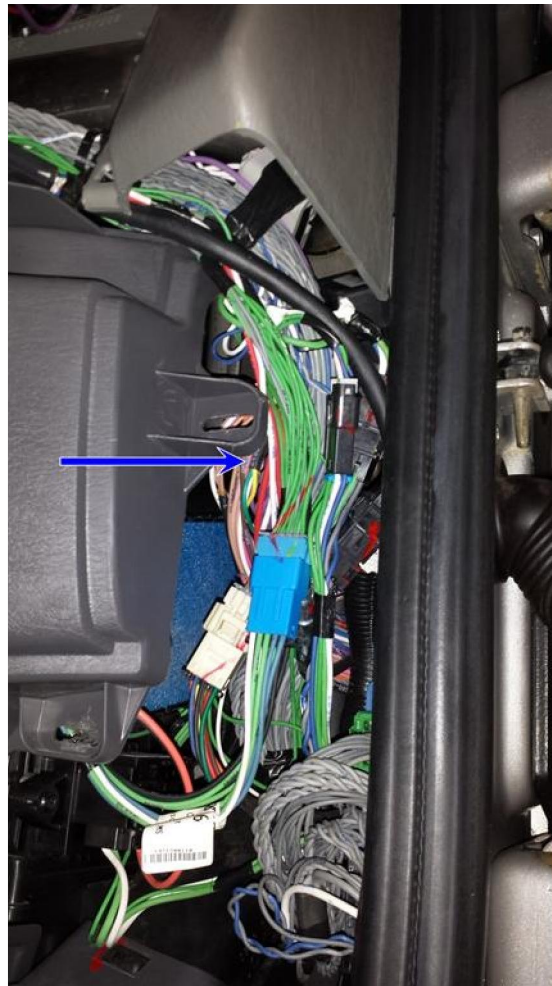
Close view of crimp location

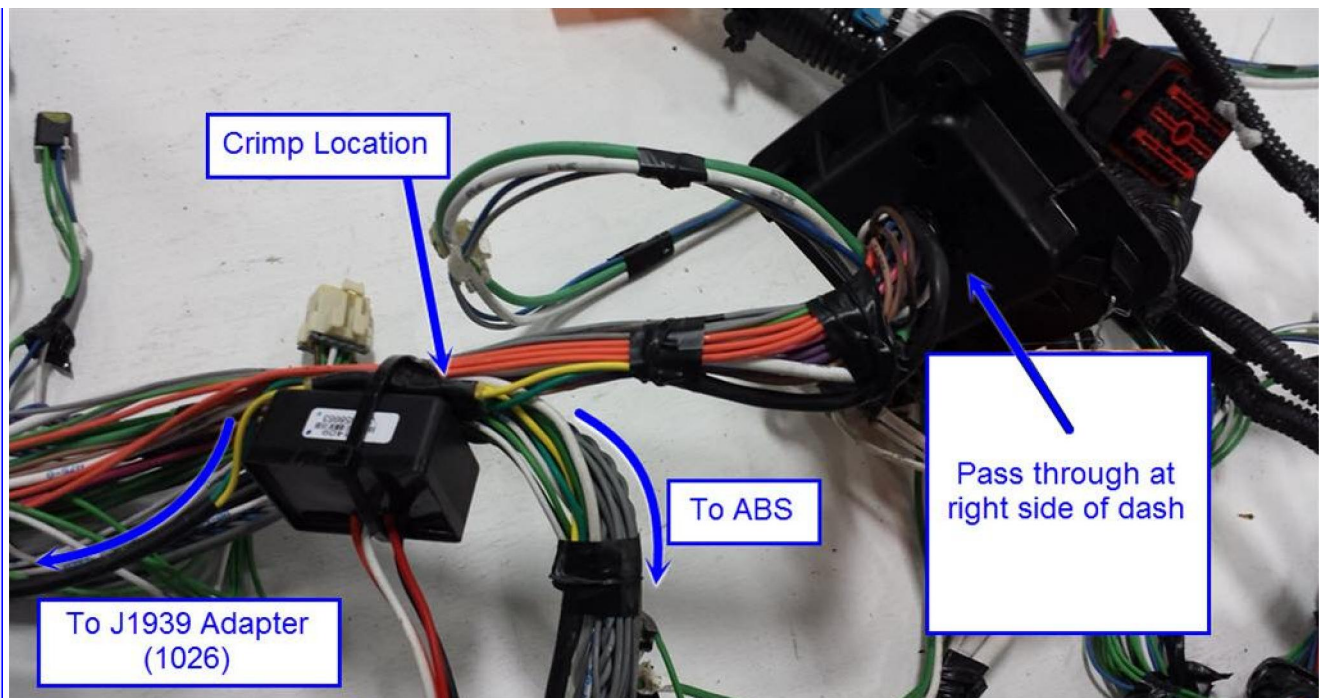
Wire condition at crimp to ABS module

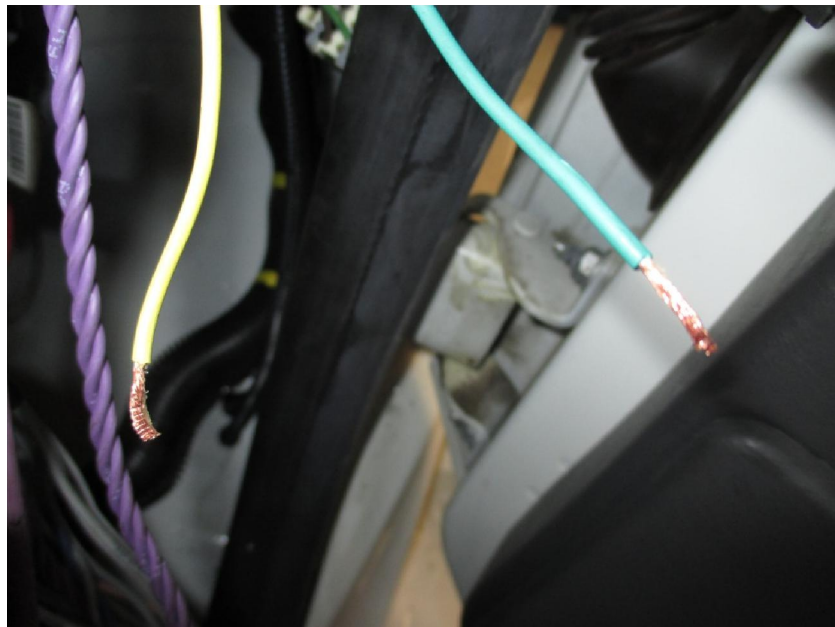
Wire condition at crimp to ABS module (2nd photo)

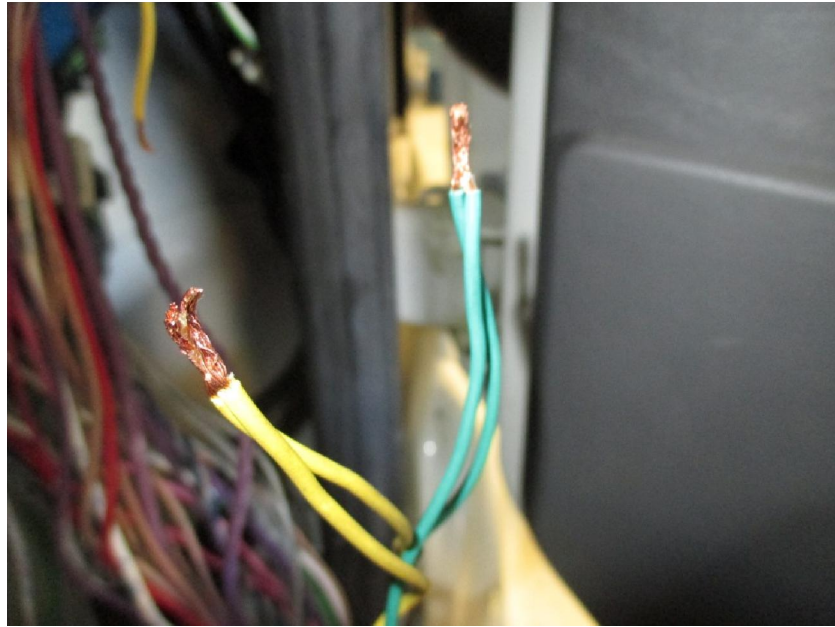
( [Back to Top](#) )
