February 1, 2019

Product Update: 2017-18 CR-V: Software and A/C Control Unit Update, DTC P0300, P0301, P0302, P0303, P0304, or P0172

Supersedes 18-114, dated January 11, 2019, to revise the information highlighted in yellow

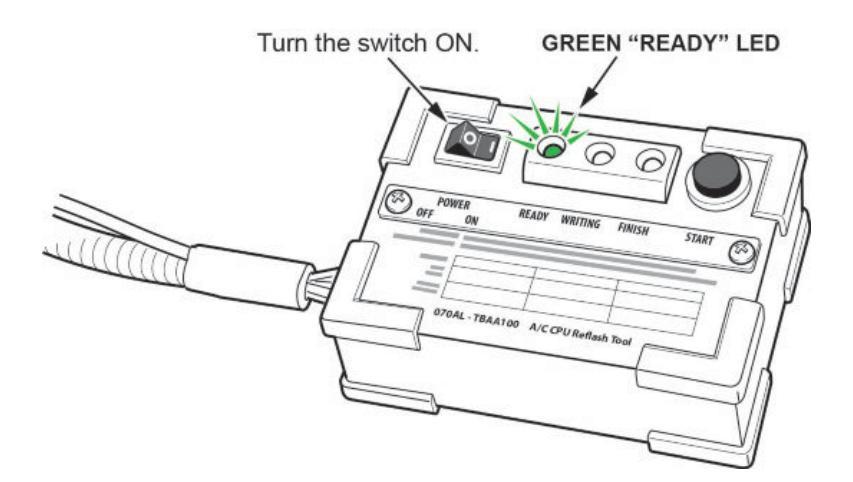
If the green LED starts flashing, there might be an issue with the tool. Use a different or known good cable or tool as needed and try again.

- 5.7. Once the solid green LED is on, press the black "start" button on the right-hand side to start the rewriting process.
- 5.8. A solid yellow LED should appear, which means that the tool is rewriting the A/C control unit.

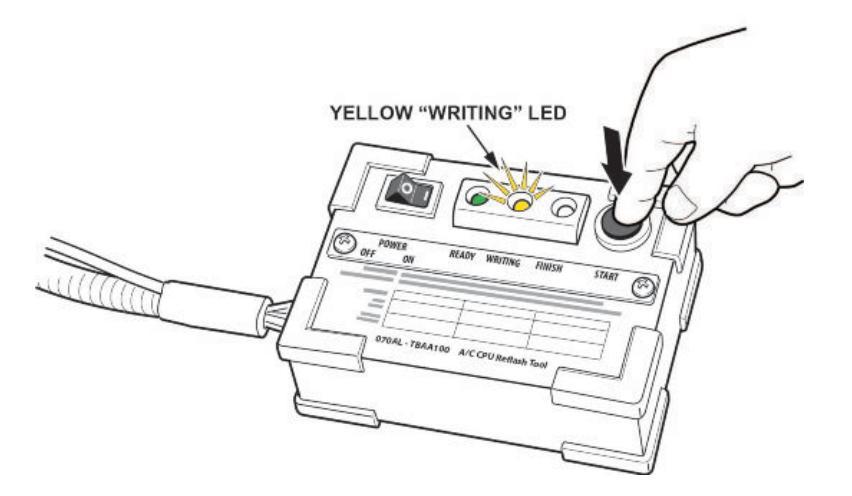
If the yellow LED is flashing, the vehicle may have been updated previously, is ineligible for the update, or the sub cable is worn out, replace it and try again. The 32 pin connector on the sub cable is expected to last about 50 connections.

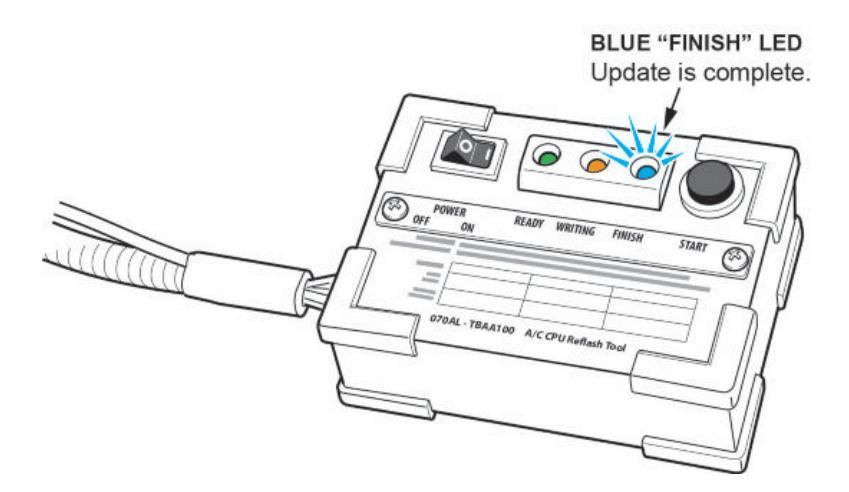
If the blue LED is flashing, the update has failed. Power off the tool and repeat the procedure again. If the error is consistent, replace the sub cable and try again. The 32 pin connector on the sub cable is expected to last about 50 connections.

5.10. Turn the tool **OFF**, connect the factory harness to the A/C control unit, and install the passenger's dashboard undercover.
