**Document ID:** IK1600247

**Title:** Hood Gap and Alignment Tolerances

**Applies To:** LT/ProStar/8000, Eagle/9000, HV/WorkStar/7000, HX/PayStar, MV/DuraStar/4000

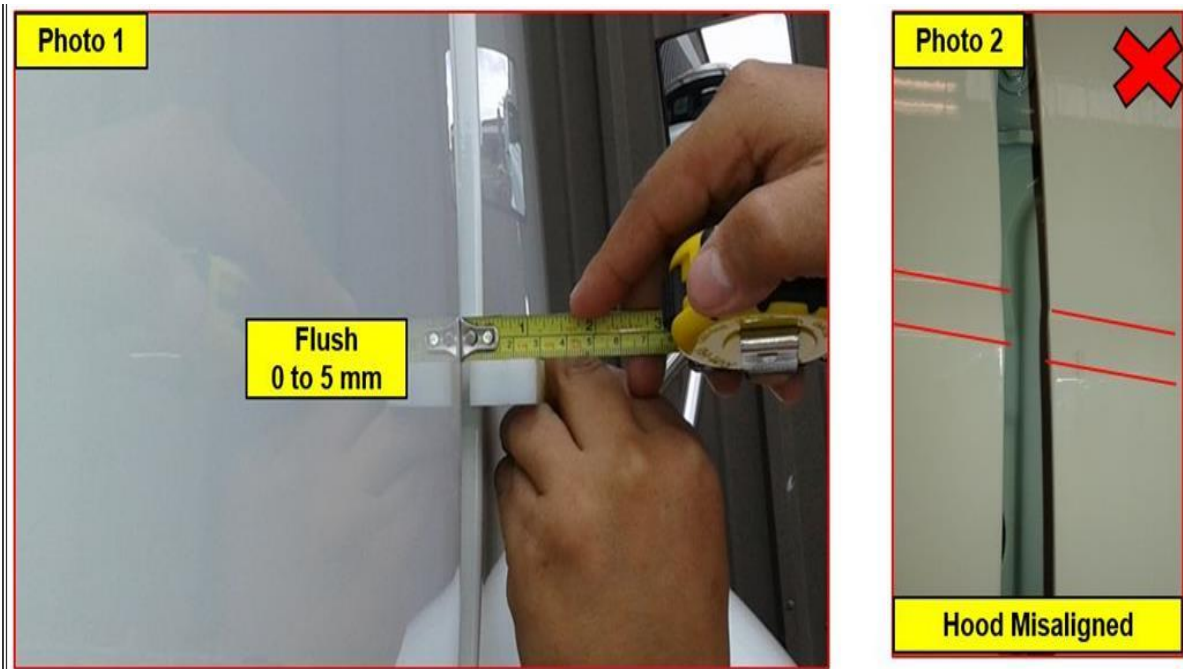
**Figure 2: LT & MV Gaps Only - Flushness & Character Line**

LT & MV Gaps Only	Requirement	Comments
Cab to Hood Flushness	0 - 5mm	See Photo 1 in Figure 2 below

Photo 1: Measuring Hood Flushness to Cab Door using plastic block & Tape Measure

Photo 2: Example of a misaligned hood. **(This photo depicts an unacceptable condition.)**

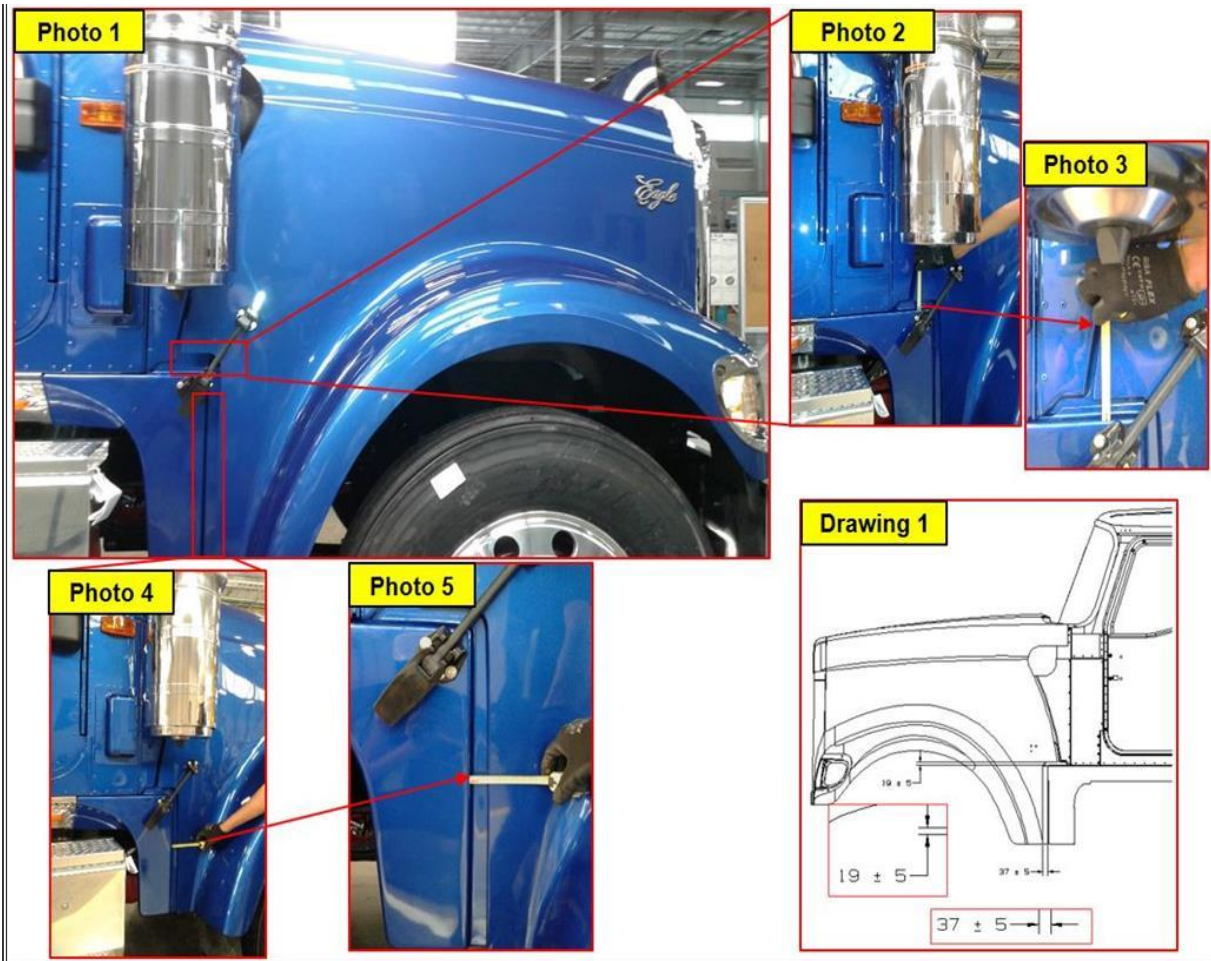
**Figure 3: Eagle & 9000 Series Hood Gap & Alignment**

Gap Location	Requirement	Comments
Horizontal Gap	32mm - 42mm	Reference Figure 3 below
Vertical Gap	14mm - 24mm	Reference Figure 3 below

Measuring the hood to cab gaps. (Right side is shown, Left side is the same but opposite)  
 Measure both Horizontal & Vertical gaps as shown in Figure 3. Refer to Photos 2-5 in Figure 3 for measurement technique.

Photo 1: Overall view of right side gap. Left side is the same but opposite.  
 Photo 2-3: Measurement of Horizontal Gap.  
 Photo 4-5: Measurement of Vertical Gap.  
 Drawing 1: Reference Only

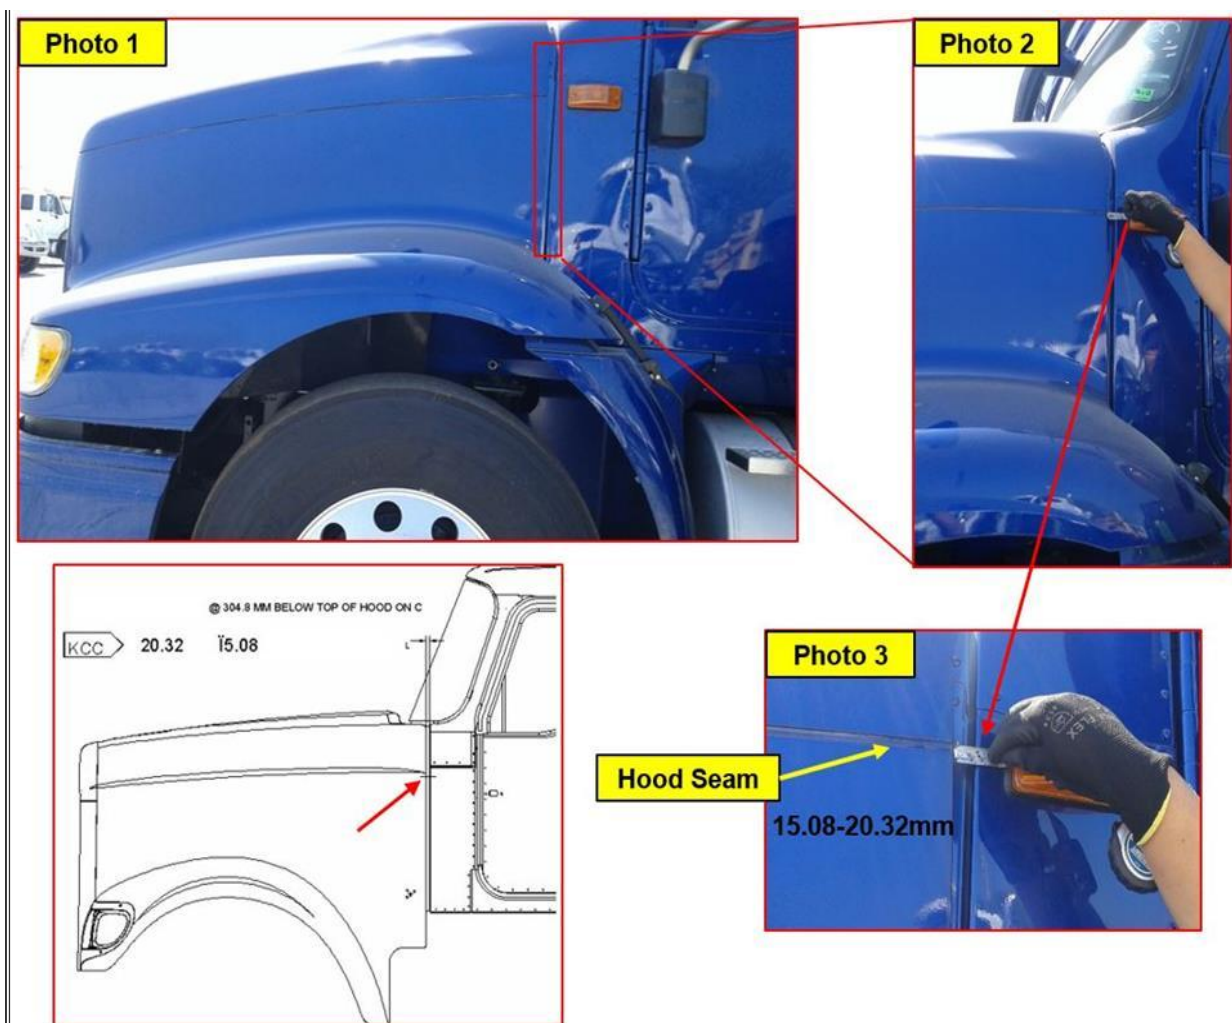
**Figure 4: 9000 Series Hood Gap & Alignment**

Gap Location	Requirement	Comments
Vertical Gap at Hood Seam	15.08mm - 20.32mm	Reference Figure 4, photo 3

Measuring the hood to cab gap. (Left side is shown, Right side is the same but opposite)  
 Measure both Horizontal & Vertical gaps as shown in Figure 4. Refer to Photos 2-5 in Figure 4 for measurement technique.

Photo 1: Overall view of left side hood to cab gap. Right side is the same but opposite.  
 Photo 2-3: Measurement of hood to cab verticle gap at hood seam location.

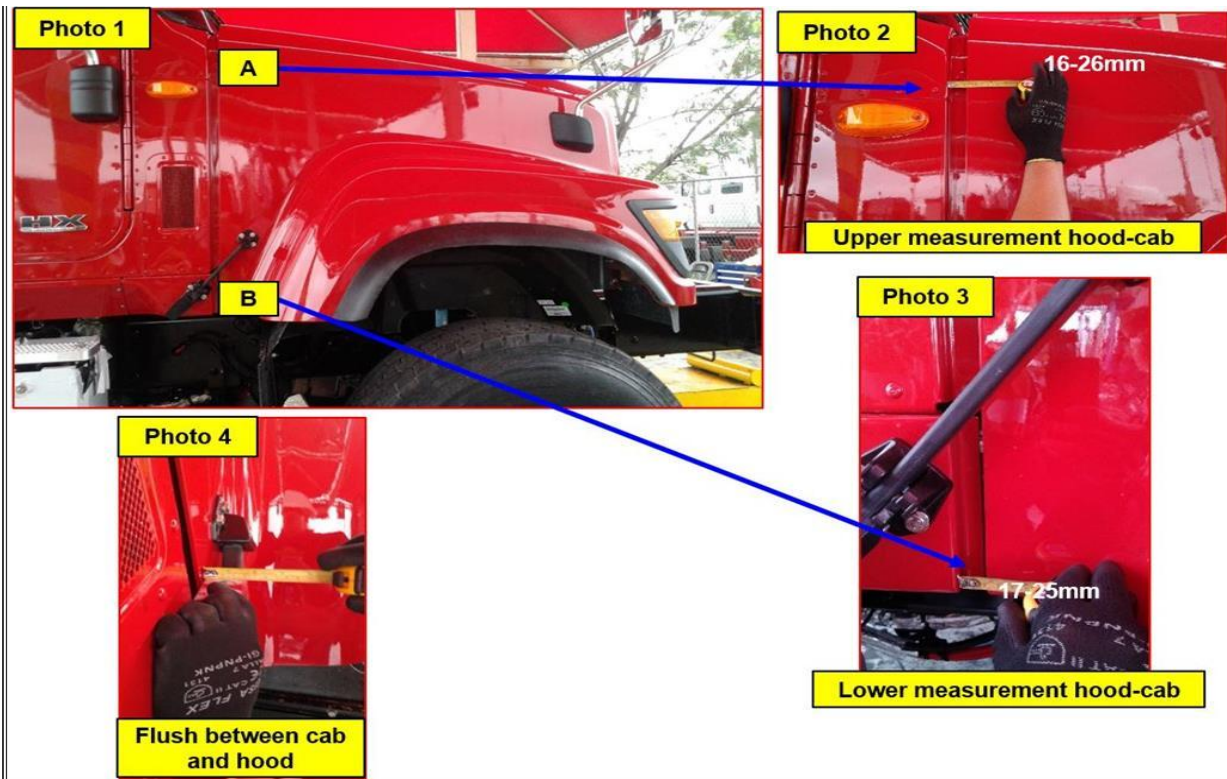
**Figure 6: HX 515 Hood Gap & Alignment**

Gap Location	Requirement	Comments
A	16mm - 26mm	See Figure 6, photos 1 & 2
B	17mm - 25mm	See Figure 6, photos 1 & 3
A to B Paralleism	5mm Max	Difference between A & B (both sides)
Flushness Cab to Hood	4mm Max	See Figure 6, Photo 4
Left Side Gap vs Rt Side Gap	4mm Max	Difference between the gaps from the left & right side of truck.

Measuring the hood to cab gap. (Left side is shown, Right side is the same but opposite)  
 Measure both Horizontal & Verticle gaps as shown in Figure 6. Refer to Photos 1-3 in Figure 6 for measurment technique.

Photo 1: Overall view of right side hood to cab gap. Left side is the same but opposite.  
 Photo 2-3: Measurement of hood to cab verticle gap at hood seam location.  
 Photo 4: Gap flushness.

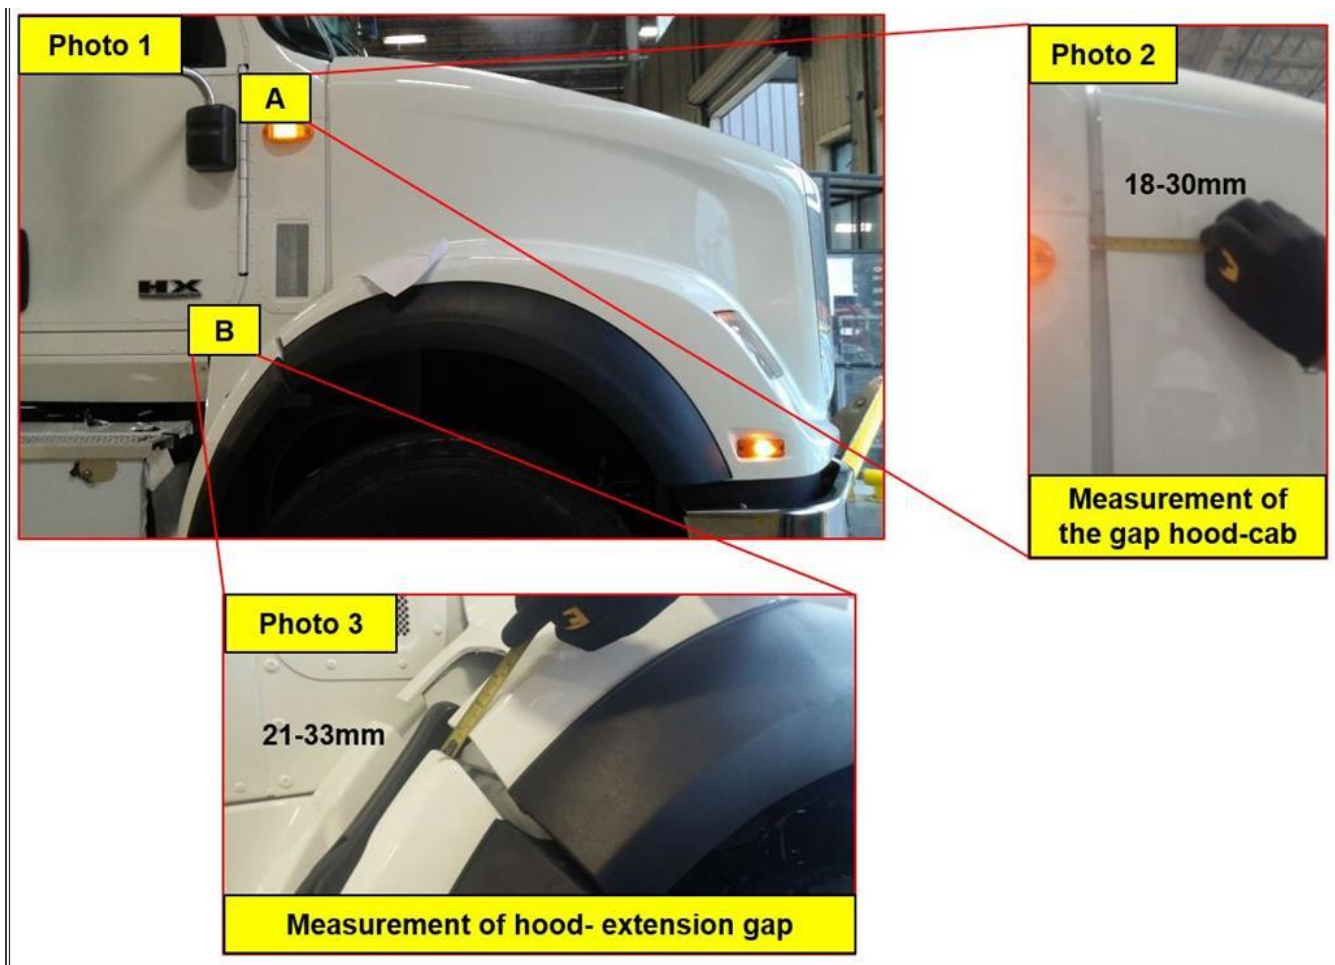
**Figure 8: HX 615 & 620 with Extension without DEACs Hood Gap & Alignment**

Gap Location	Requirement	Comments
A	18mm - 30mm	See Figure 8, photos 1 & 2
B	21mm - 33mm	See Figure 8, photos 1 & 3
Vertical Gap Paralleism	5mm Max	Difference between A & B (both sides)
Lt Side Gap vs Rt Side Gap	4mm Max	Difference between the gaps from the left & right side of truck.

Measuring the hood to cab gap. (Left side is shown, Right side is the same but opposite)  
 Measure both Horizontal & Verticle gaps as shown in Figure 8. Refer to Photos 1-3 in Figure 8 for measurment technique.

Photo 1: Overall view of right side hood to cab gap. Left side is the same but opposite.  
 Photo 2-3: Measurement of hood to cab verticle gap & Fender seam location.
