Bulletin No.: PIP5435A Published date: 02/7/2019

PIP5435A Pop Out Of Third Gear

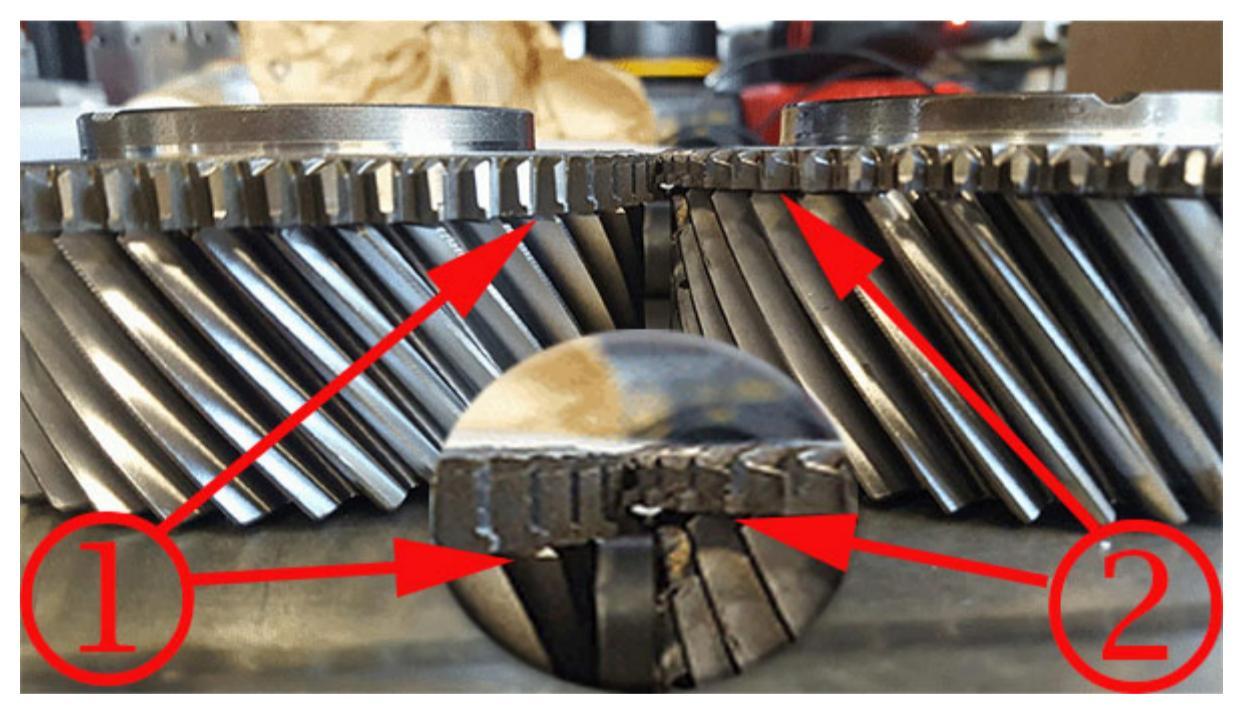
Involved Region or Country:	North America	
Condition:	Dealer may notice a hop out of third gear condition during pdi or customer may return with very low mileage with a hop out of third gear.	
Cause:	Mis-machined third gear installed into the transmission.

Below are pictures of the incorrectly machined gear (2) and the correctly machined gear (1). None of the incorrect gears (2) were ever shipped to or stocked by CC&A.

For vehicles that are noticed during normal PDI or customer has returned with a hop/jump out of third gear concern that has been verified, replace the third speed gear, synchronizer and shift collar.
