## Service Bulletin

#### Subject: Unable to Adjust Clock Manually

Brand:	Model:	Model Year:		Breakpoint:		Engino	Tranamiagianu
		from	to	from	to	Engine.	fransinission.
Chevrolet	Sonic	2018	2019	SOP	October 5, 2018	All	All
	Trax						
GMC	Terrain	2018	2018

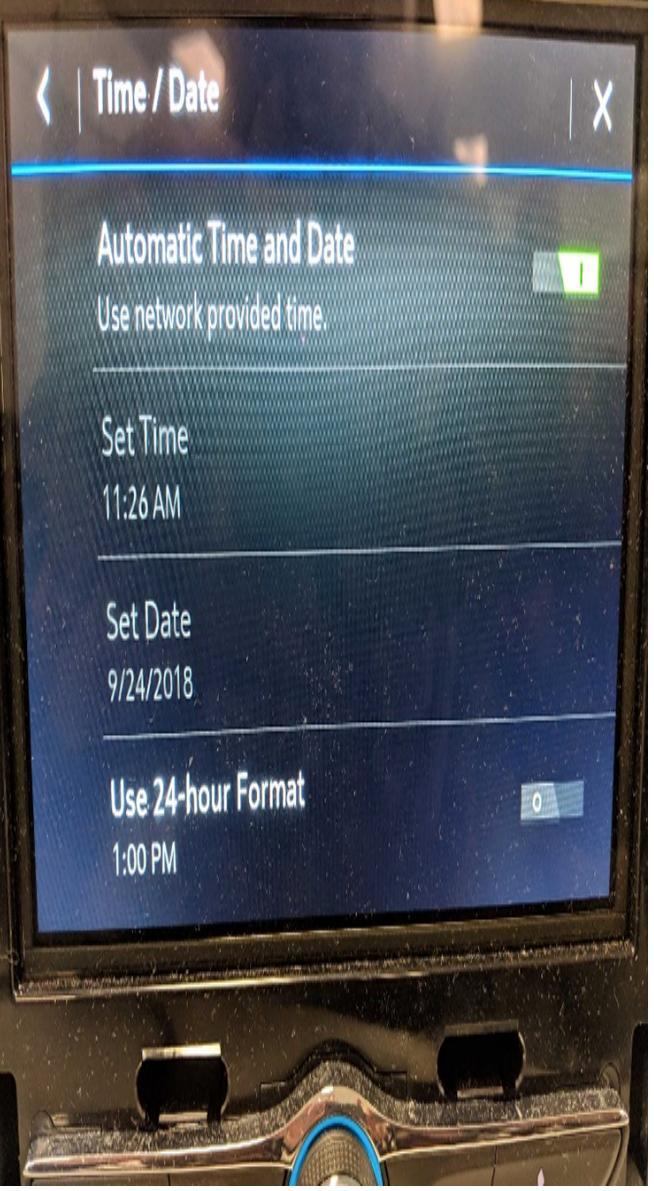
5168244

Menu displayed with OnStar Terms and Conditions accepted:

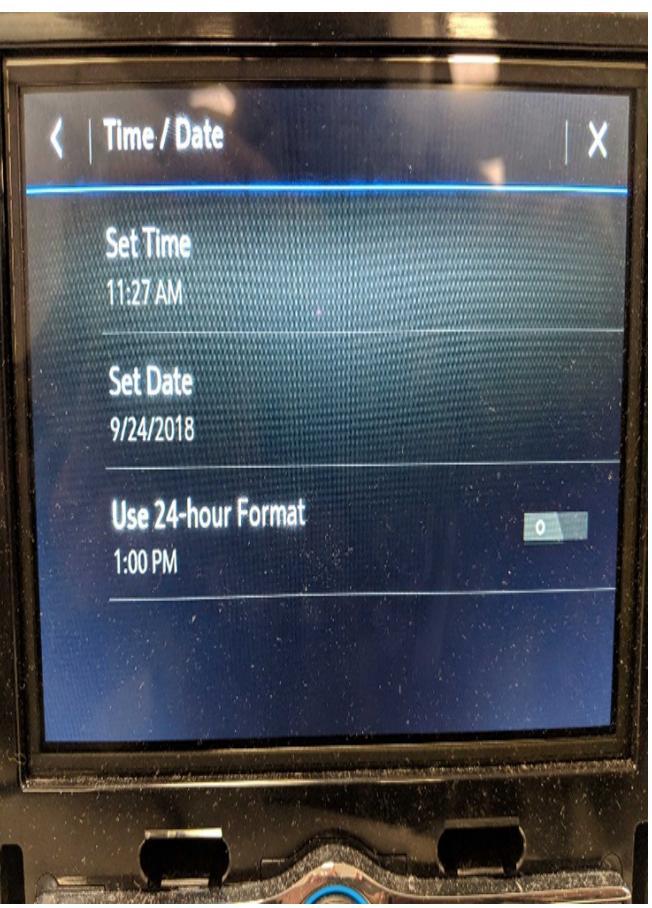
5168251

**Note:** If OnStar account Terms and Conditions are declined, the Auto Update option is removed from the Time/Date menu. A software anomaly allows the Auto Update option to remain enabled when the option is removed from the menu, preventing manual clock adjustments from occurring.

Menu displayed with OnStar Terms & Conditions declined:
