Countries: CANADA, UNITED STATES, MEXICO **Document ID:** IK1300159
Availability: ISIS, NotSIR **Revision:** 4
Major System: TRANSMISSION **Created:** 9/28/2017
Current Language: English **Last Modified:** 3/8/2019
Other Languages: NONE **Author:** David Horner
Viewed: 1669

Title: LT Fuller Advantage Series Transmission Power and Ground

Applies To: LT w/ A26 & X15

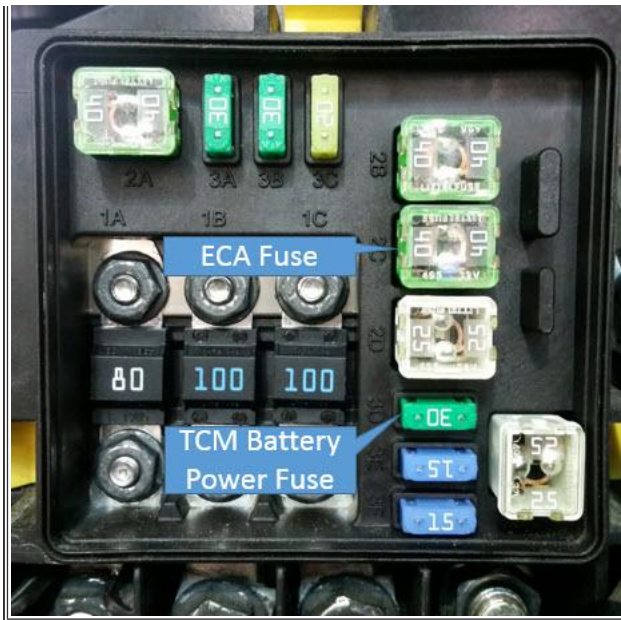
Figure #2: Under Hood PDM

Note PDM Torque Specs:

- M5 MIDIFUSE Tightening Torque 4.5 +/- 0.5 Nm
- M8 Torque 15 +/- 1.5Nm
- M10 Chassis / Feed Torque 28.5 +/- 1.5 Nm

1. While performing Eaton diagnostic steps be sure to inspect the power and ground connections at the Underhood PDM and the Ground Stud located by the engine starter.
2. Ensure the connections are clean (free of corrosion) and tight, Ground Stud Torque 43 N-m (31.7 ft-lb).

1. Clean and tighten any loose connections.
2. Clearly document in RO, with Road Ranger, and or Navistar tech service if loose connection was found.
3. Clear DTC's in all modules.
