# TECHNICAL SERVICE BULLETIN Center Console Rear Cup Holder Detached And/Or Center Console Rear Cup Holder Cover Panel Detached

**19-2002** 15 February 2019

Ford 2011-2019 Explorer 2013-2019 Police Interceptor Utility

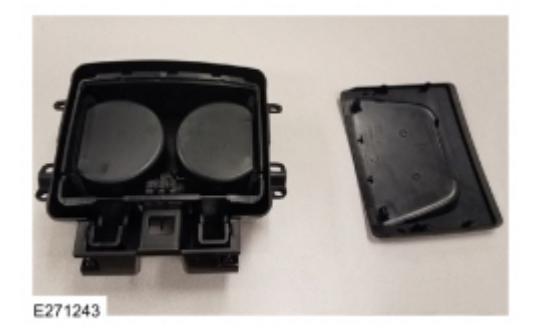
Figure 1

1. Is the cup holder cover panel detached from the cup holder? (Figure 1)

- (1). Yes proceed to Step 2.
- (2). No proceed to Step 5.

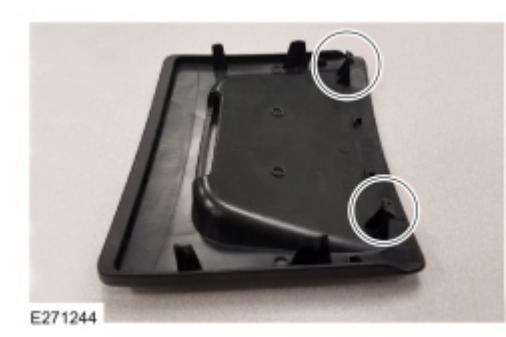
Figure 2

**2.** Inspect the mounting tabs on the cup holder cover panel for damage. Is damage present? (Figure 2)

(1). Yes - replace the cup holder assembly. Refer to Workshop Manual (WSM), Section 412-02, Removal and Installation > Rear Heating, Ventilation and Air Conditioning (RHVAC) Control Module.

(2). No - proceed to Step 3.

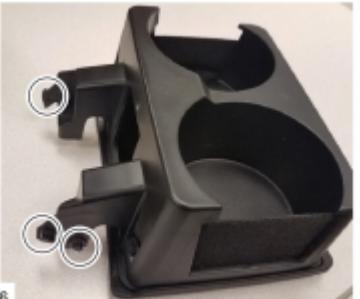
### Figure 4

- 4. Is the cup holder detached from the center console?
  - (1). Yes proceed to Step 5.
  - (2). No repair is complete.
- 5. Inspect the cup holder pivot posts and pivot stops for damage. Is any damage present? (Figure 4)
  - (1). Yes replace the cup holder assembly. Refer to WSM, Section 412-02. Repair is complete.
  - (2). No proceed to Step 6.
