SPECIAL SERVICE CAMPAIGN JLH

INTELLIGENT CLEARANCE SONAR (ICS) SYSTEM REPROGRAM

CERTAIN: 2018 LS 500 and LS 500h 2018 NX 300 and NX 300h 2018 RX 350L and RX 450hL 2017-2018 RX 350 and RX 450h

Update 4/9/2019: Note added on p. 5.

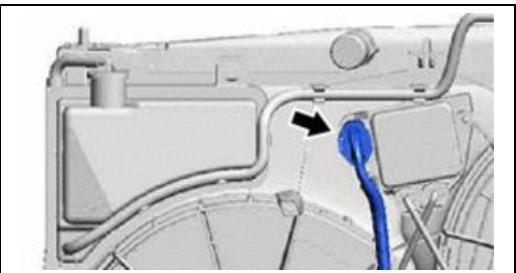
1. DISCONNECT COOLING FAN

Note: If the cooling fans run during the Calibration update procedure, the battery voltage will be inconsistent and could cause damage the control module.

RX 350 shown. Other models are similar.

a. Disconnect the electrical connector from the cooling fan ECU on the radiator shroud.
