Title: LT Fuller Advantage Series Transmission Power and Ground

Applies To: LT w/ A26 & X15

This document will provide the user with Fuller Advantage Series (FAS) Automated Transmission power and ground circuit information.

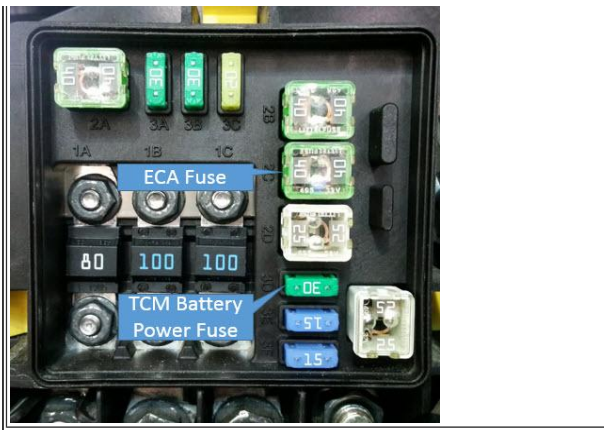
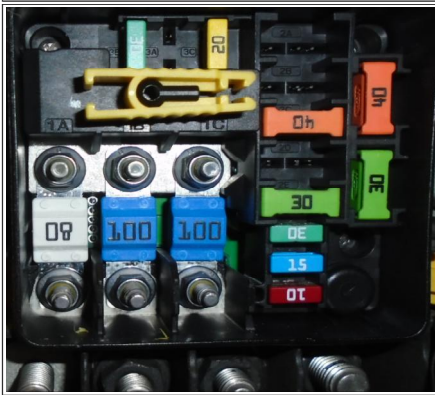
**Figure #2: Under Hood PDM**

1. While performing Eaton diagnostic steps be sure to inspect the power and ground connections at the Underhood PDM and the Ground Stud located by the engine starter.
  2. Ensure the connections are clean (free of corrosion) and tight, Ground Stud Torque 43 N-m (31.7 ft-lb).
-

- M5 MIDIFUSE Tightening Torque 4.5 +/- 0.5 Nm
- M8 Torque 15 +/- 1.5Nm
- M10 Chassis / Feed Torque 28.5 +/- 1.5 Nm

1. Clean and tighten any loose connections.
  2. Clearly document in RO, with Road Ranger, and or Navistar tech service if loose connection was found.
  3. Clear DTC's in all modules.
-
