TITLE: Water intrusion from sealing to climate unit in plenum area

REF NO:ISSUING DEPARTMENT:TJ 32040.2.1Technical Service			ARKET: s and Canada
3 US 7	PARTNER: 7510 Volvo Car USA	ISSUE DATE: 2019-05-14	STATUS DATE: 2019-05-20
FUNC GROUP:FUNC DESC:8700Air conditioning unit		Page ⁻	1 of 22

VOLVO	Volvo Car Customer Service	TJ Instruction VC	C-497457-2
Title	Air inlet housing	Page	1 (10)
Action	Adjustment	Operation number:	99400-2
			97174-2
			36050-2

VOLVO	Volvo Car Customer Service	TJ Instruction VC	C-497457-3
Title	Air inlet housing	Page	1(10)
Action	Adjustment	Operation number:	36050-2
			97174-2
			99400-2

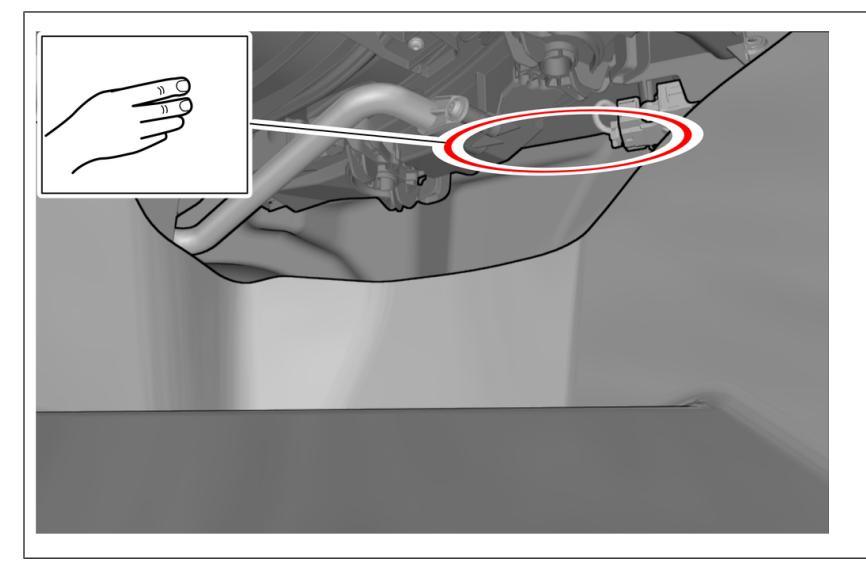
Note! Check for moisture in the area indicated.

Reach with your hand behind the fan housing and check for moisture between the insulating mat foam and the body wall.

If no faults are detected, to install, reverse the removal procedure.

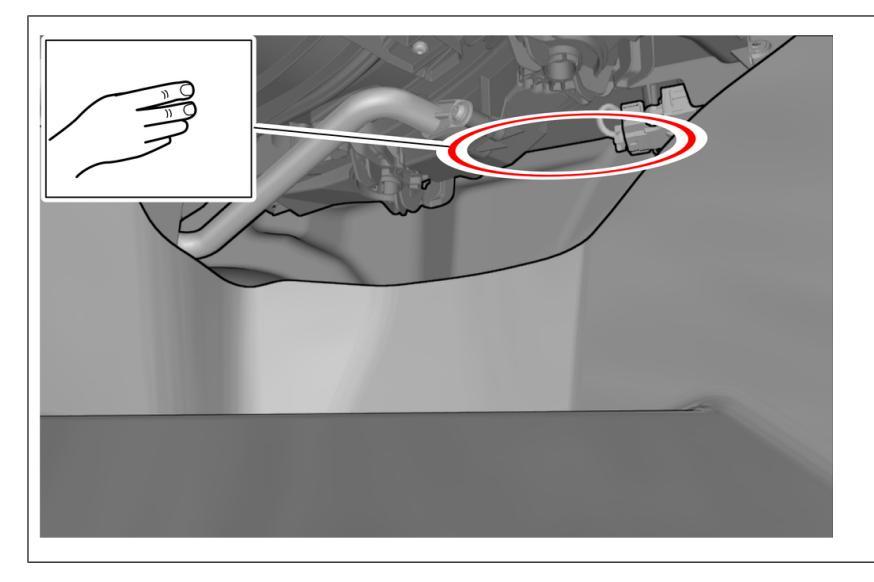
Note! Check for moisture in the area indicated.

Reach with your hand behind the fan housing and check for moisture between the insulating mat foam and the body wall.

If no faults are detected, to install, reverse the removal procedure.
