VAS581005P R1234yf Air Conditioning Service Unit Support

Technical Support **1913** USA Only

This document contains the VAS581005P Best Practice Guide and valuable MSS contact information that you will be receiving direct mail.

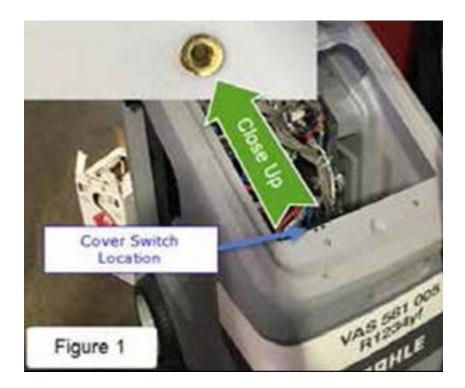
- 1. Be sure to always follow the unit on-screen instructions to ensure processes perform as expected.
- **2.** Accessories in-line UV Dye injectors have been evaluated and are known to be sources of leaks. Remove injector if VAS581005P self-leak test will not pass.
- 3. Spare parts and maintenance items are listed in the operational manual for convenience.
- 4. Always park couplers to the unit when not in use to prevent damage or contamination.
- **5.** If the unit does not power on, the breaker may have tripped. To reset, push the white breaker button on the lower rear of cabinet.
- **6.** If the service door is removed or opened, the unit will automatically stop all processes. The ventilation fan will remain in operation to ensure any R1234yf vapors are removed. See Figure 1.

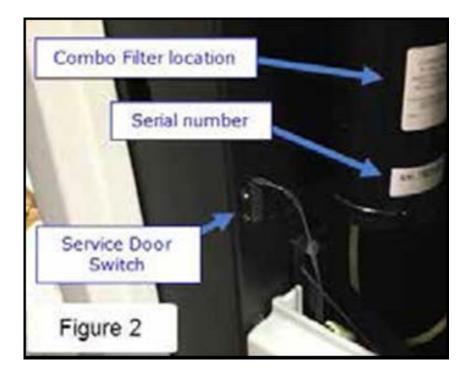
7. The VAS581005P is locked and disabled after 150 lbs of refrigerant is processed. A new filter and 6 digit code must be installed before service can resume. See Figure 2.
