INTRODUCTION:

PRODUCTION CHANGE INFORMATION:

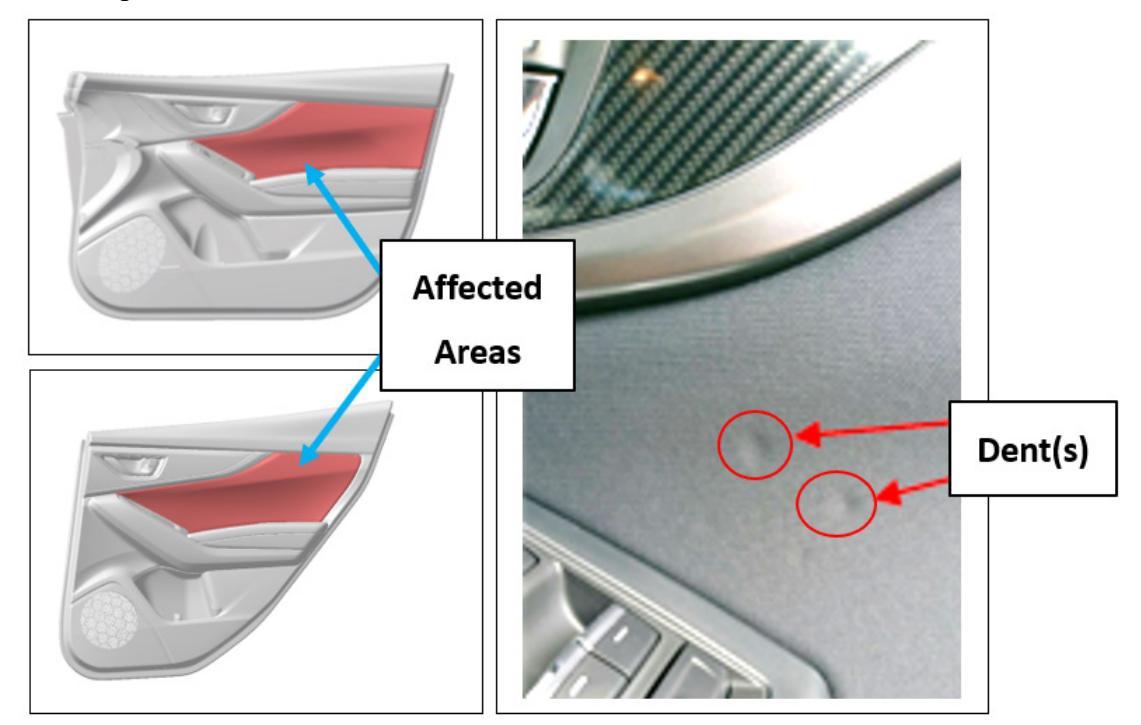
This bulletin announces a change to the interior door trim panels made to address a limited number of concerns regarding small dents appearing in the accent areas as shown in the illustrations below. These dents can occur when the foam layer on the inside of the trim panel covering material is pressed inward and comes in contact with adhesive used during assembly preventing a return to its original condition. An additional barrier has been added during manufacturing to keep the foam layer and adhesive separated.

The new trim panels were incorporated into production starting with VIN K8235591.

The service procedures for door trim panel replacement remain unchanged. Always refer to the applicable Service Manual and review the full requirements of the repair being performed. The Service Manual procedures contain information critical to performing an effective repair the first time and every time. This includes but is not limited to: important SAFETY precautions, proper inspection criteria, necessary special tools, required processes and related one-time-use parts needed for a complete and lasting repair.
