Technical Service Bulletin

LIGHT RESISTANCE AND/OR UNUSUAL NOISE WHEN TURNING STEERING WHEEL TO THE LEFT Last Issued: 07/22/2019

Bulletin No.: 06-005/19	Last Issued: 07/22/2019

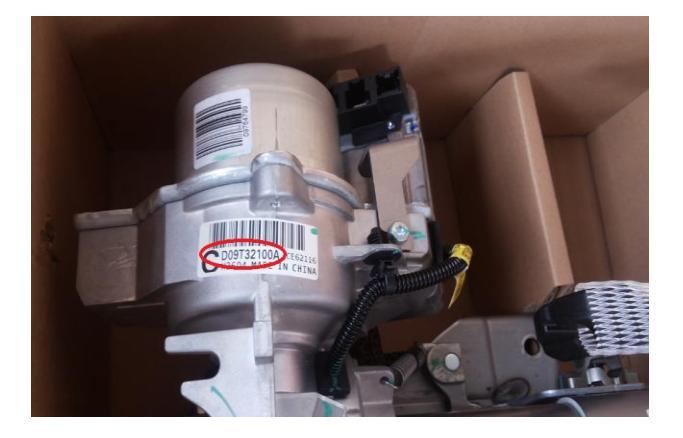
2. Inspect the label on the bottom of the steering motor. Record the 2nd, 3rd and 4th digits of the lot number.

NOTE: The red circle shown below is the steering motor part number.

Example: The lot number in the sample part below is "CE62116". The 2nd, 3rd and 4th digits are "E62".

3. Using the three (3) digits found from the lot number inspection, determine the necessary action using the table below.

2nd, 3rd and 4th Digits of Lot Number	Necessary Action
D**, E**, F** or G**	Proceed to Step 4 of this bulletin and replace the steering shaft with a modified part.
H1* to H9*, HA* to HB* (except HBX)	
HBX to HC*	
J**, K** or L**	This bulletin does not apply. The steering shaft is already modified, do not replace it. Refer to MGSS online for further diagnosis.
