S	ERV		: BU	LLET	IN
SERVICE MANAGER	© 2019 Subaru o	f America,	Inc. All	rights r	eserved.		
CLAIMS PERSONNEL	provided, right.						
PARTS MANAGER	Should Read and						
GENERAL MANAGER	IMPORTANT - All Service Personnel						
ATTENTION.

This bulletin announces reprogramming files to optimize the DMS control module and address a small number of inquiries regarding DTCs B112C and/or B112E. In some cases, when multiple functions are processed by the DMS control module at the same time, a task error may occur and cause the system's indicator lamp to illuminate yellow (as opposed to green during normal system operation).

NUMBER: 07-151-19R

REVISED: 08/08/19

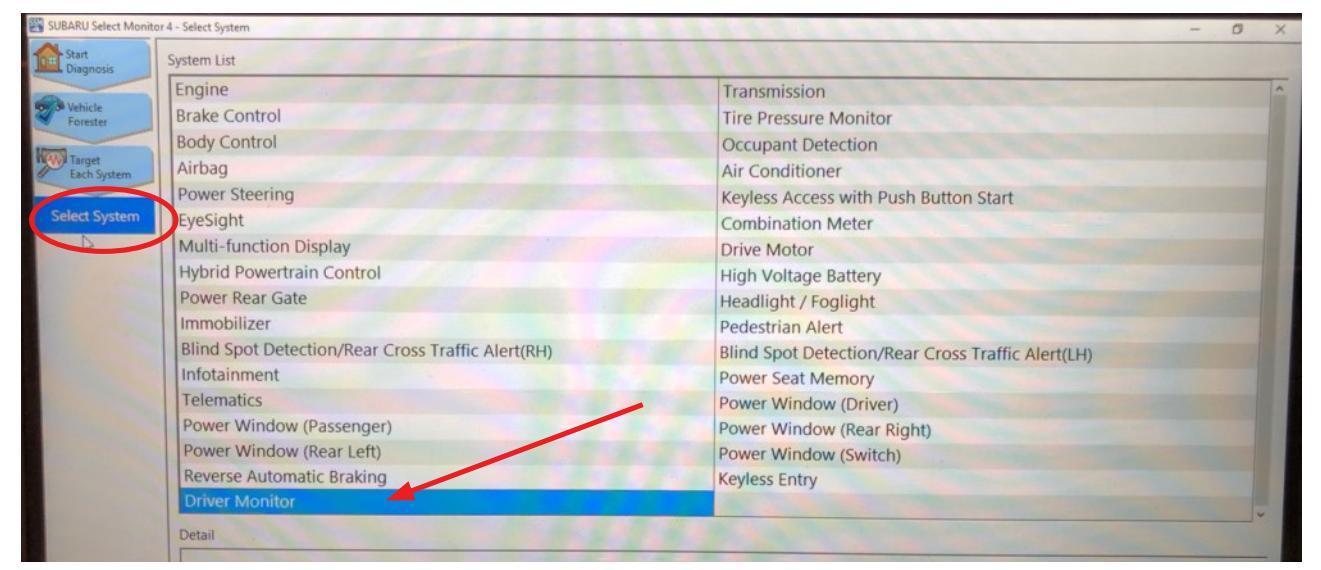
Go to: Diagnosis > Each System > Select Driver Monitor from the System List.

Select Work Support > ECU Parts Number to display the current version.

- 2) If the part number is 98401SJ010, proceed with reprogramming the DMS control module following the normal FlashWrite procedure below. If the DMS control module already has the latest part number, 98401SJ011, the procedure is complete. Proceed to the Warranty / Claim Information section and process a claim for inspection only. If the part number is different, diagnose the DTC per the applicable Service Manual. When reprogramming, select DMS from the CPU drop-down list.
- 3) After the reprogramming procedure is complete, turn the Ignition OFF, close all doors and the rear gate then wait for a few minutes until the indicator lamp for the DMS goes out. When the indicator goes off, the CAN bus is "asleep". NOTE: On push-button start models, the access fob must be away from the vehicle (out of range) or the system will not go to sleep.
