91 SOS Warning displayed in instrument cluster, DTC B18BE13 or B18BD13 stored in the telematics control module

91 19 82 2054038/2 August 26, 2019. Supersedes Technical Service Bulletin Group 91 number 19-41 dated February 28, 2019 for reasons listed below.

ſ	Model(s)	Year	VIN Range	Vehicle-Specific Equipment
ſ	A6, A7	2019	000001 - 068911	With ConBox

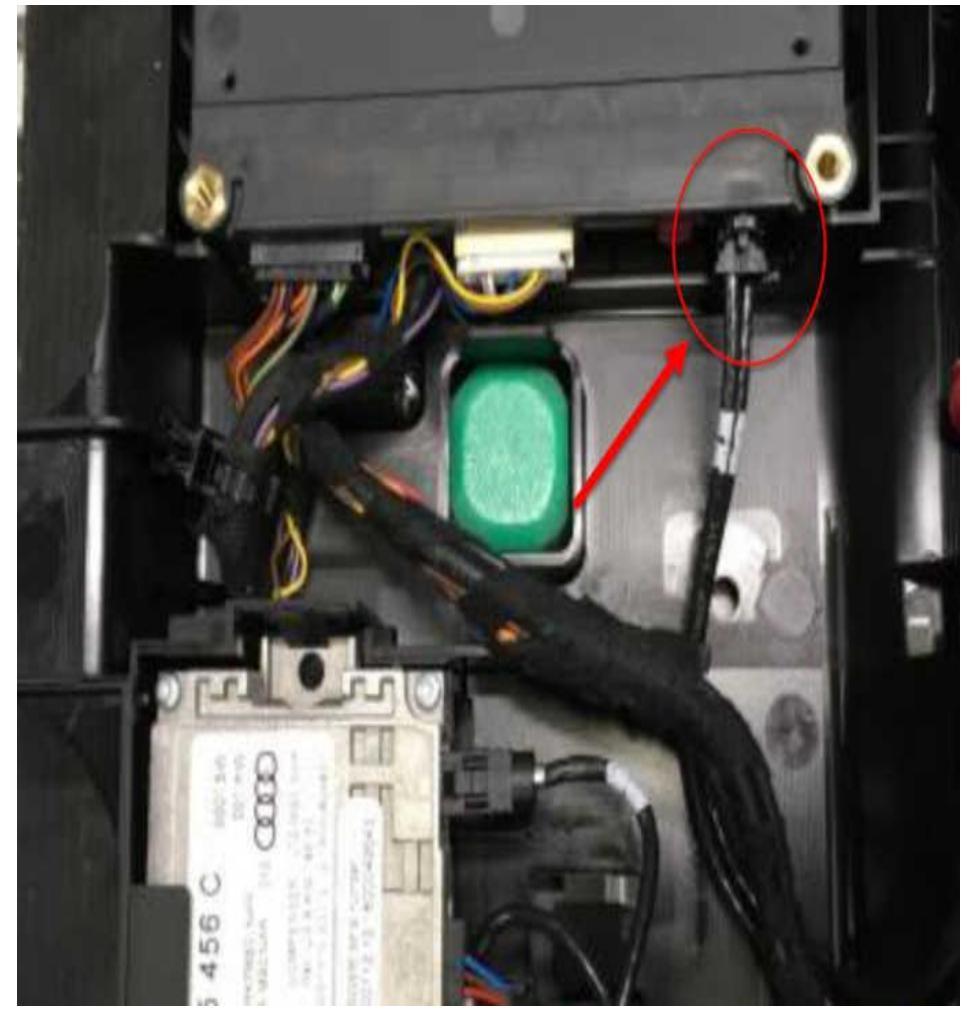
The 4 pole connector pins might have been widened during the assembly process.

Figure 1. Telematics Control Module (J949) Connector.

1. Remove the original 4 pole connector including its pins and remove a section of the vehicle's coaxial wiring for the applicable antenna circuit.

- 2. Replace the original 4 pole connector and cable with the new connector harness and pins.
- 3. Before plugging the new 4 pole connector in, make sure that the telematics control module, J949 (address word 0075) is mounted properly in its bracket.

Do not tilt the control module while plugging in the 4 pole connector. Tilting the control module while plugging the connector might damage the new pins.
