Countries:	BAHAMAS, BOLIVIA, BELIZE, C COLOMBIA, COSTA RICA, DOI EL SALVADOR, TRINIDAD ANE URUGUAY, VENEZUELA, MEX PUERTO RICO, CUraçao, GUAI HONDURAS, JAMAICA, KORE/	CANADA, CHILE, TAIWAN, MINICAN REPUBLIC, ECUAD) TOBAGO, UNITED STATES ICO, ARUBA, NICARAGUA, P M, GUATEMALA, GUYANA, H A, SOUTH KOREA, PANAMA	OR, , Document ERU, ID : AITI,	IK1200478
				Availability:	ISIS, Bus ISIS, FleetISIS, IsSIR		Revision:	14
				Major System:	ENGINES		Created:	3/23/2010
Knowledge B	lase			Current Language:	English		Last Modified:	8/13/2019
				Other Languages:	Français, Español,		Author:	Allan Hertko
				Viewed:	36671			
								Less Info
Hide Details				Coding Inform	nation			
Copy Link	Copy Relative Link	Bookmark	Add to Favorites	Print	Provide Feedback	Helpful	Not Helpful	
GO		View My Bookmarks	*	+	P	2752	1483	
Title: On vehic	le DOC Cleanin	g MaxxForce®	7 Engines

Applies To: 2007 - 2009 MaxxForce® 7,

A method to clean the DOC on the vehicle with NED in combination with ZTSE 6031 has been developed.

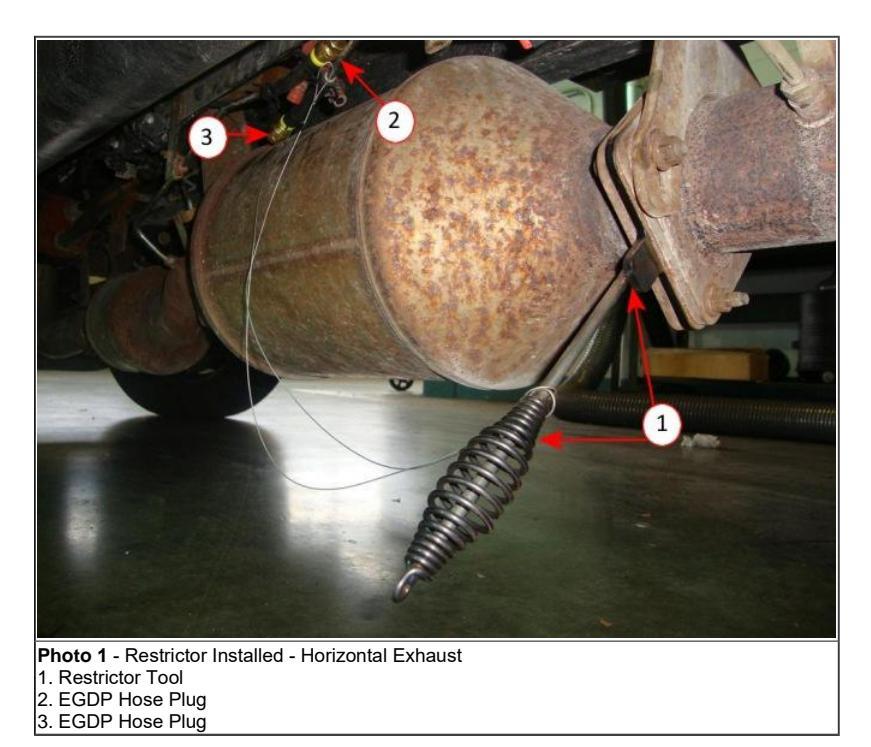
- 1. Remove the three M10 X 50 flange bolts at the rear of the DPF.
- 2. Insert Restrictor plate torque bolts to 40 lbf-ft. (School Bus and horizontal tailpipe only) See Photo 1

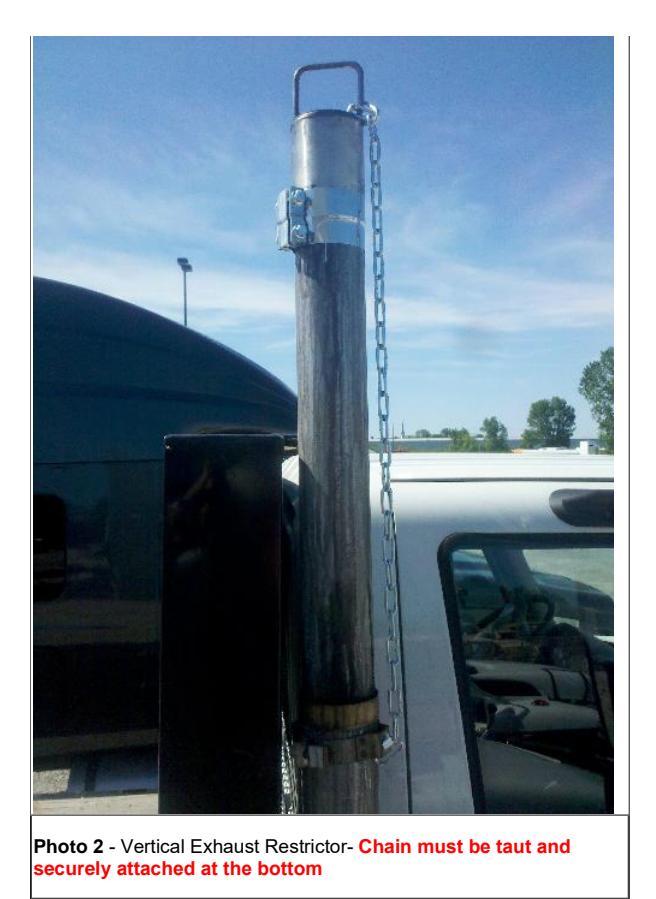
1

^{3.} For Vertical Exhaust install Restrictor Cap as shown in Photo 2 - Tighten clamps bolts to 60 ft. lbs.

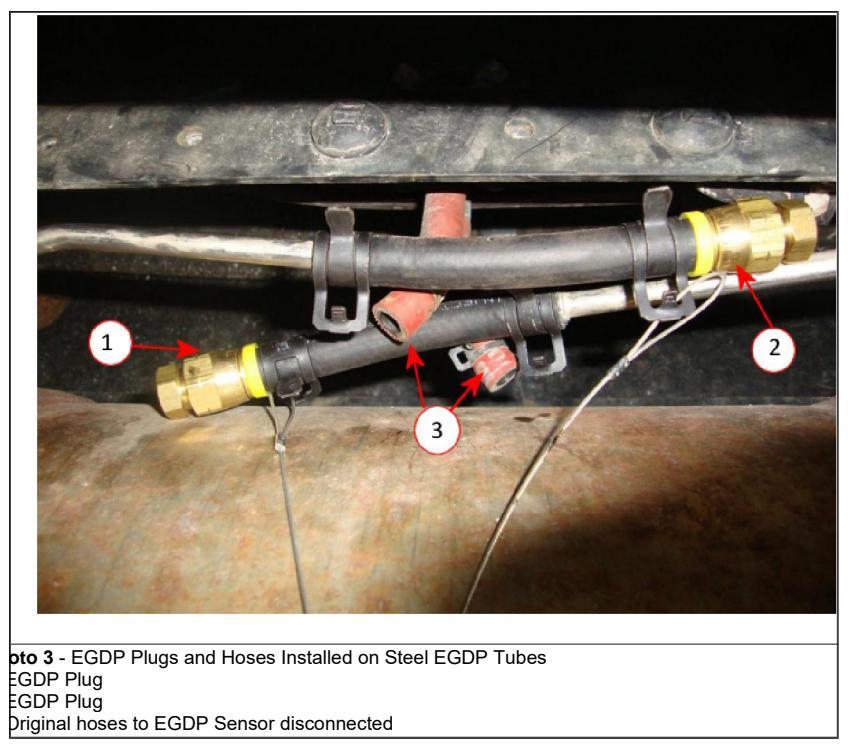
- 4. Disconnect both the EGDP tubes from the rubber hose at the EGDP Sensor
- 5. Install the 2 EGDP Plugs and hoses supplied with tool kit. See Photo 3
