LTB00972NAS3 TECHNICAL BULLETIN 14 JUN 2019

412-01

Climate Control System Blower Fan Stalls

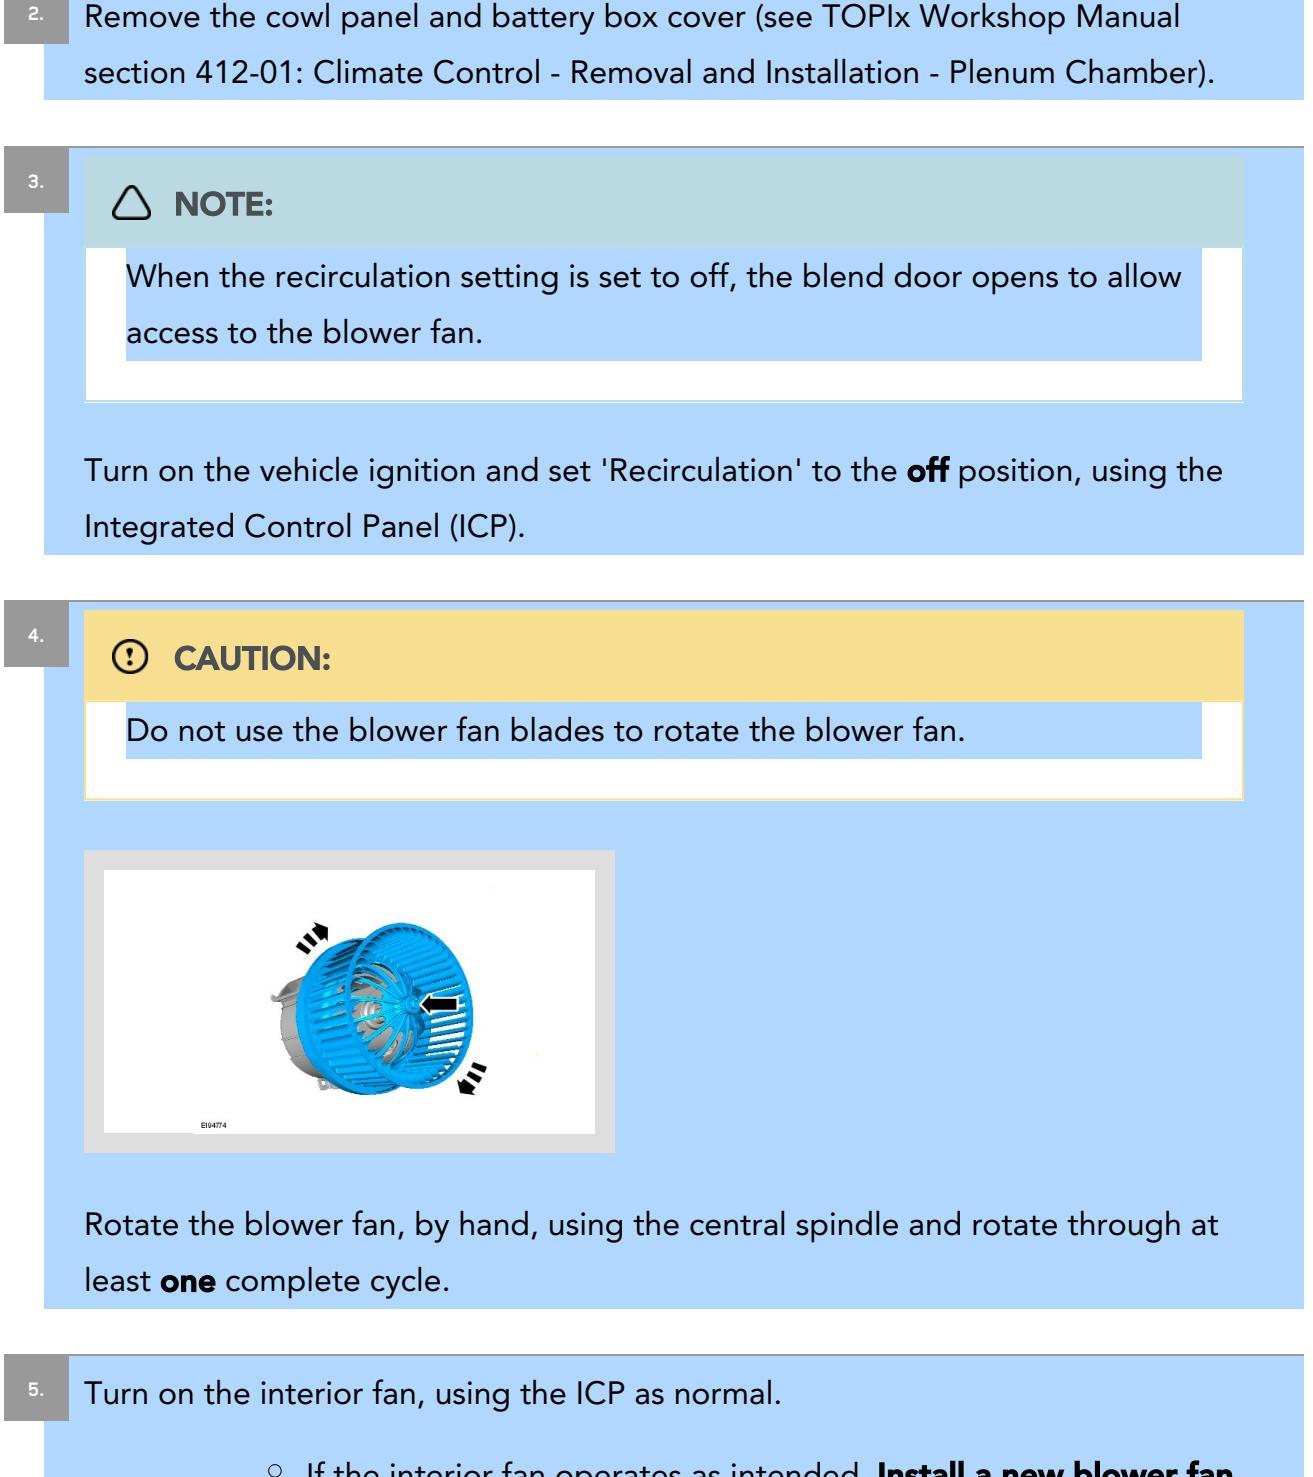
¹ Turn off the vehicle ignition and allow the vehicle to stand for at least ten minutes. This will allow the blower control module to cool and reset.

- If the interior fan operates as intended, Install a new blower fan (see TOPIx Workshop Manual section 412-01: Climate Control -Removal and Installation - Blower Motor).
- If the fan still does not operate, **do not continue.** Raise a Technical Assistance (TA), including all of the diagnostic steps completed so far.
