SERVICE BULLETIN

M1450

2019-08-20

M1450: MILWAUKEE-EIGHT EQUIPPED VEHICLES - LOSS OF POWER OR HIGH ENGINE BRAKING

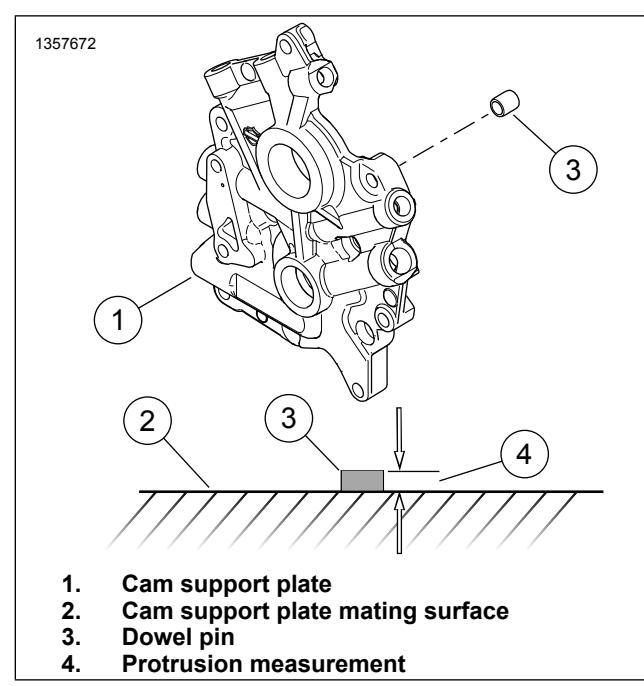
Figure 1. Cam Support Plate Dowel Pin Measurement

j. See Figure 1. Verify that the protrusion (4) of the dowel pin (3) on the cam support plate (1) is equal to or less than 3.3 mm (0.130 in).

If engine damage is observed: Contact regional Technical Service.

If engine damage is not observed: Install **new** oil pump and oil pump cover (Refer to Table 2.) then assemble engine and file the appropriate warranty claim. Refer to the applicable table, Table 3, Table 4, Table 5 or Table 6.
