# Technical Service Bulletin

A/C BLOWS WARM AIR DUE TO EVAPORATOR LEAK

Bulletin No.: 07-003/19

Last Issued: 09/10/2019

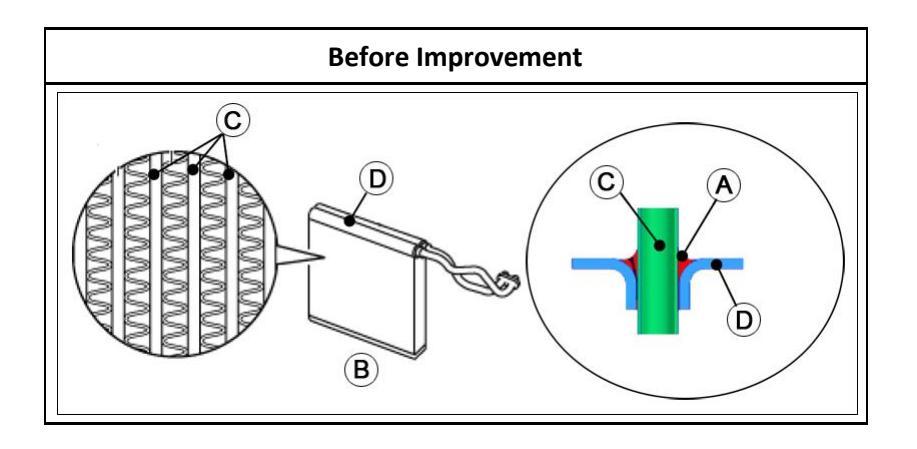
Some customers may complain about warm air from the climate control vents. This may be caused by improper brazing (A) of the evaporator (B), causing a refrigerant leak from the joint between the tubes (C) and the header (D).

Customers having this concern should have their vehicle repaired using the following repair procedure.

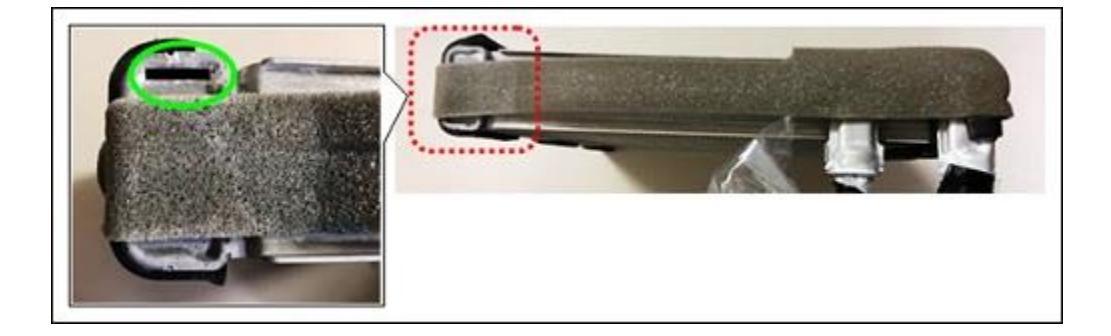
- O-Rings for Expansion Valve come with the new evaporator.
- Modified part can be distinguished by its black marking at the cap as shown below.
