Technical Service Bulletin

92 Windshield wiper on left side makes contact with the left A-pillar

92 19 21 2056133/1 September 11, 2019.

Model(s)	Year	VIN Range	Vehicle-Specific Equipment	
Q3	2019 – 2020	All	Not Applicable

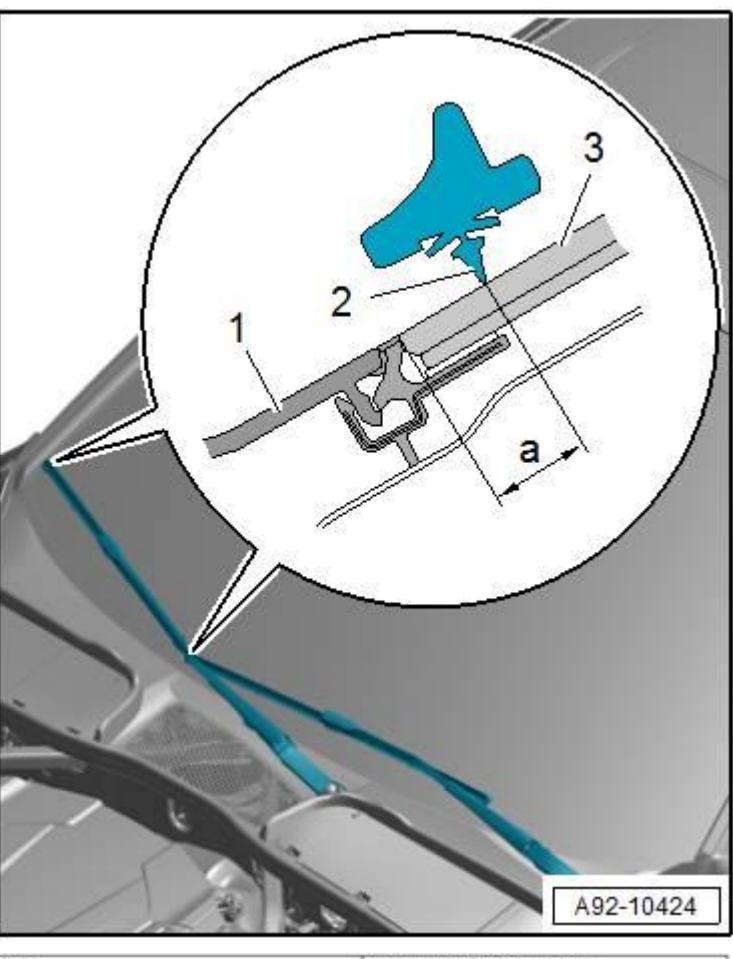
• The 'parked' wiper arm position is checked to the specified dimension of 44.1mm (+10mm) on the left and 41.5mm (+10mm) on the right. It is found to be within specification on both sides (Figure 1).

Side	Adjustment Dimension -a- in mm	
Driver side	44.1 *10	
Front passenger side	41.5 *10

Figure 1. Windshield wiper adjustment specifications.

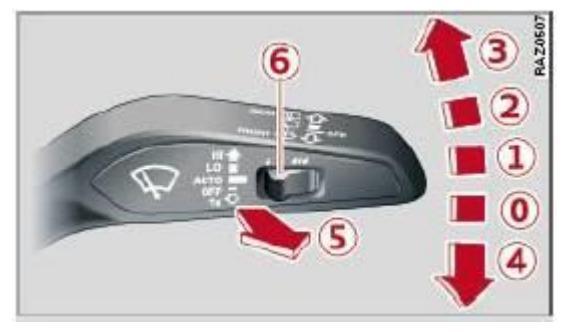
When the vehicle is traveling at a speed between 4 km/h (~3 mph) and 100 km/h (~62 mph) and the windshield wiper system set to position 2 (slow wiping) or 3 (fast wiping) the windshield wiper motor extends the wiping stroke every third stroke. On the third stroke, the left wiper blade will make slight contact with the left A-pillar (Figure 2).

Figure 2. Windshield wiper operating modes.

None. This is an intended function implemented to clear additional debris from the wiper blade. This function is not active below speeds of 4 km/h (~3 mph) and above speeds of 100 km/h (~62 mph).

Make no repairs or alter the specified wiper adjustment in an attempt to change this operation.
