Technical Service Bulletin

Subject: BODY CONTROL MODULE (BCM) OR LOW FREQUENCY CONTROL UNIT (LFU) REPLACEM	Bulletin No.: 09-035/19	
	Last Issued: 09/27/2019

2019 Mazda3 5-door HB (Japan built) vehicles with VINs lower than JM1BP*****142784 (produced before May 28, 2019)

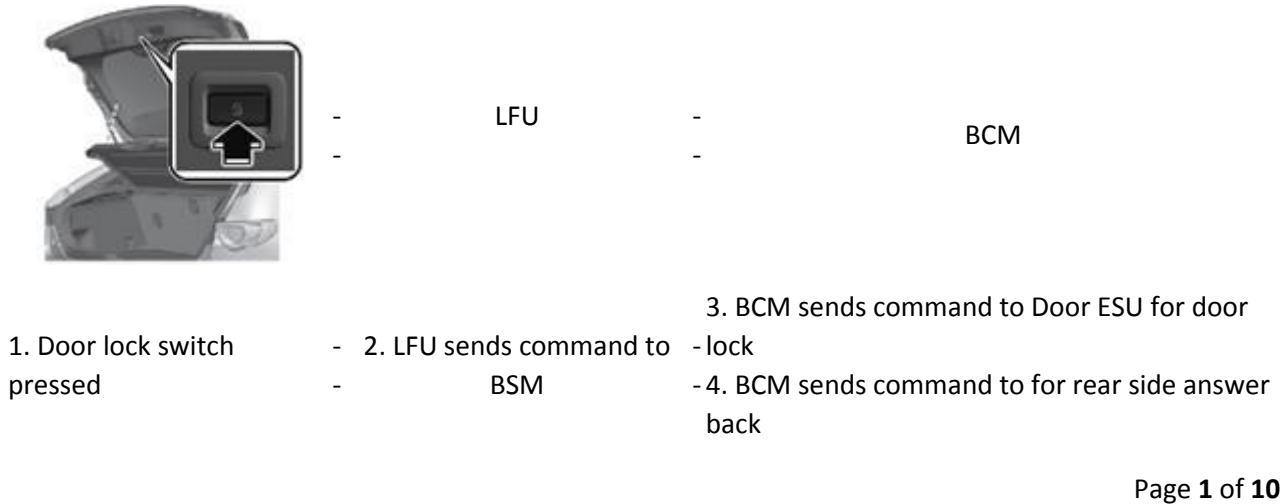
Normal System Operation:

If the body control module (BCM) or the LF control unit (LFU) has been replaced and configuration has been performed, communication between the BCM and the LFU may not work properly due to a difference of the software level.

- If the BCM has been replaced:
- Without a remote transmitter the door lock switch at the liftgate will not lock doors
- With a remote transmitter the door lock switch at the liftgate will lock the doors even when the front or rear door(s) are opened
- If the LFU has been replaced:
 - Without a remote transmitter the door lock switch at the liftgate will lock the doors with the answer back sound
