October 11, 2019

Version 1

2017-18 NSX Wind Noise

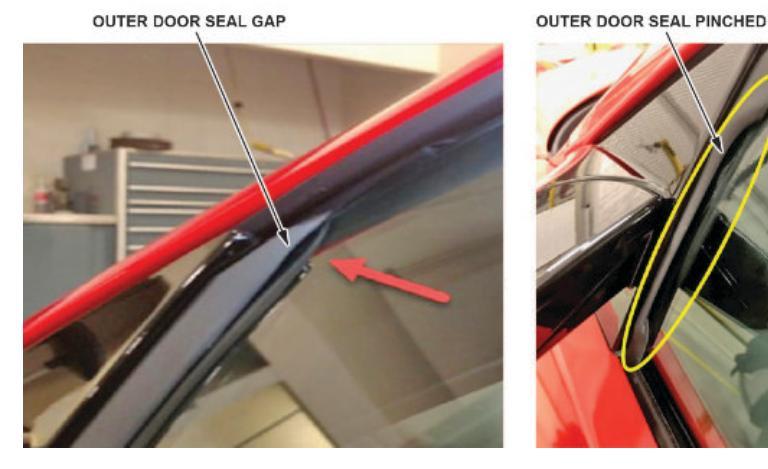
- Heavy cross winds may affect the noise.
- If the wind noise is coming from a different area than the ones shown below, continue with normal system troubleshooting.
- 1. Check to see if there is any noticeable deformation / pinching in the door outer seal. If there is, go to REPAIR PROCEDURE A (OUTER DOOR SEAL AND POWER MIRROR). If not, go to the next step.

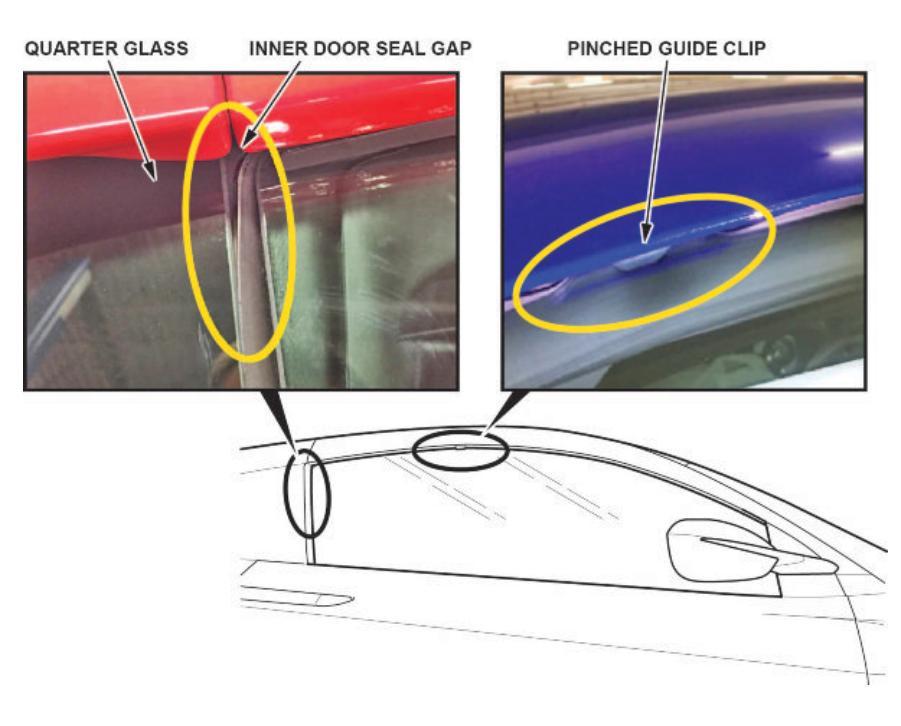
Check to see if the guide clip on the inner door seal is pinched or if there is a gap between the inner door seal and quarter glass. If either of these conditions are found, and/or additional damage is found, go to REPAIR PROCEDURE B (INNER DOOR SEAL). If not, go to the next step.

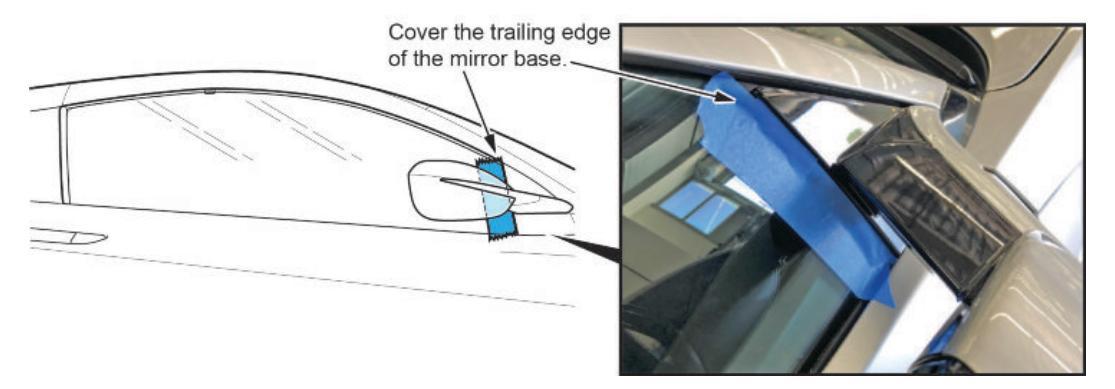
3. Tape the outer door seal / run channel to the door glass, and cover the trailing edge of the mirror base. Then, testdrive the vehicle to verify that the wind noise decreases. If it does, go to REPAIR PROCEDURE A (OUTER DOOR SEAL AND POWER MIRROR). If not, go to the next step.

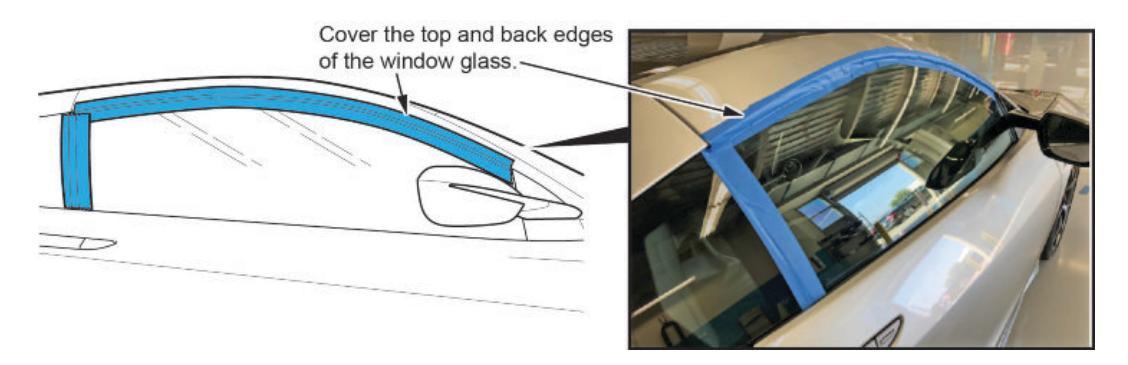
4. Apply tape around the top and back edge of the front window glass, and test-drive the vehicle to verify that the wind noise decreases. If it does, go to REPAIR PROCEDURE B (INNER DOOR SEAL).

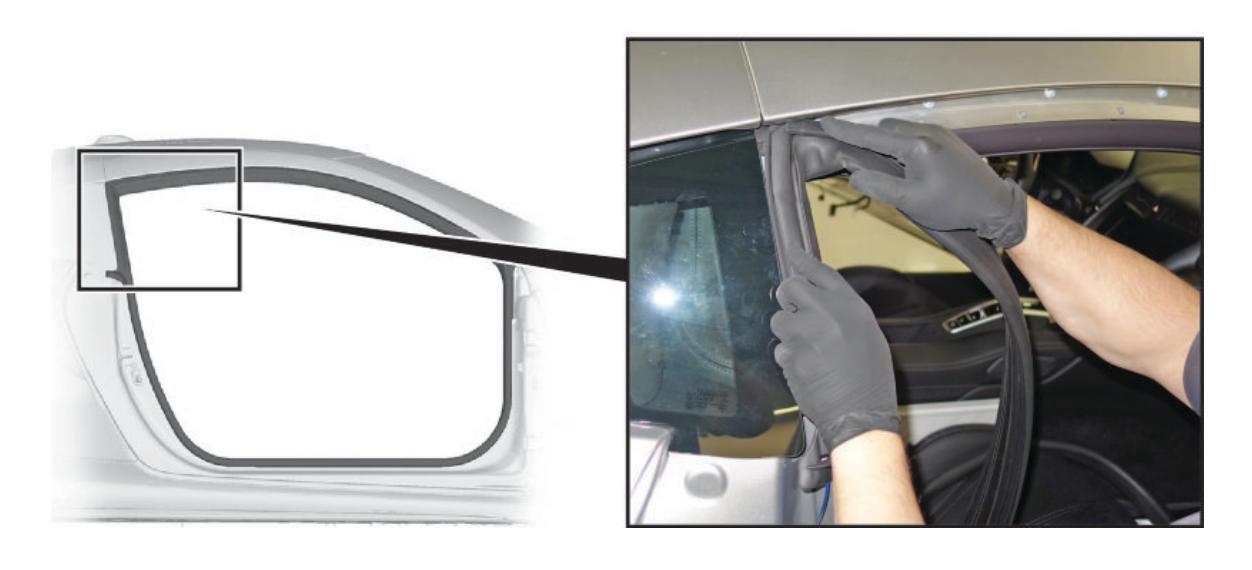
Make sure you properly seat this corner of the seal; otherwise, a gap will form between the seal and the rear quarter glass and possibly cause wind noise.

12. Start at the B-pillar upper corner area of the door opening.

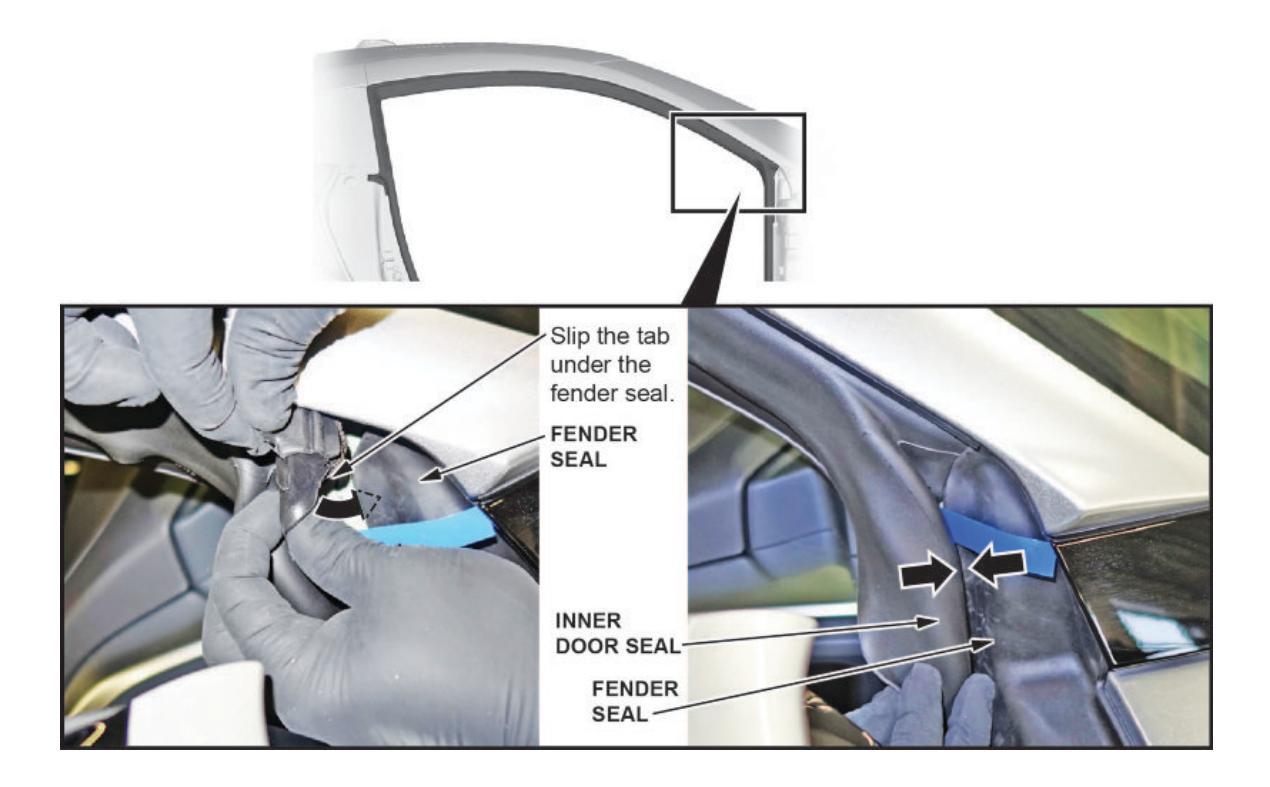
Make sure the inner door seal rests up against the fender seal. A poor seal in this location may result in a water leak.

Position the inner door seal so it evenly fits into the A-Pillar curved area. Then, fully set the inner door seal to the roof retainer. When it is properly set, you will feel the seal lock into place.
