Subaru Service and Technical Support Line Newsletter

ARTICLES CONTAINED IN THIS ISSUE

October 2019 TechTIPS

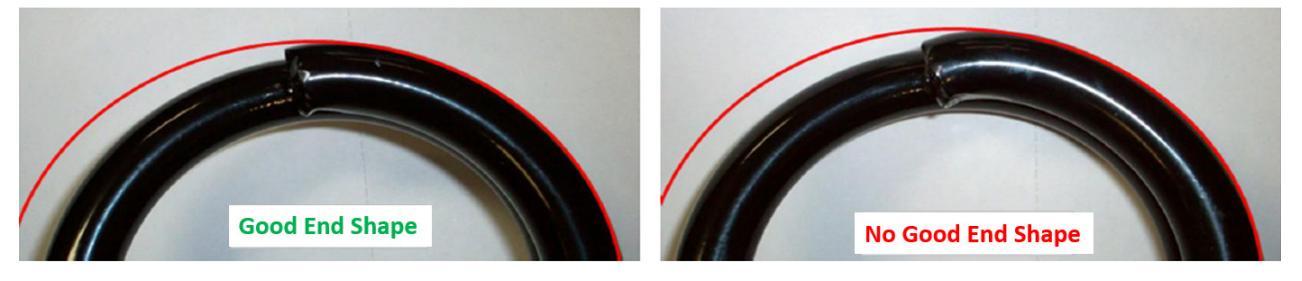
The Techline has received several calls involving customer concerns of sound coming from the rear suspension over bumps. The concern is often described as a creak or squeak and the source can be traced to the rear strut assembly. A close inspection of the coil spring strut contact area should be performed. Coil spring variations may result in the final coil winding having too tight of a diameter. When this occurs, the abnormally formed lip at the end of the spring rubs the strut mount rubber coating causing noise as the suspension operates. Technicians finding this condition should replace the affected spring and strut mount following procedures outlined in the applicable Service Manual. Additionally, a burr on either end of the original or replacement coil spring is normal and **should not** be removed. Strut replacement is not necessary.

NEVER attempt to remove the burr found at the end of the coil by grinding or any other means. It is a normal product of the manufacturing process and on properly formed parts will never make contact with the mount.

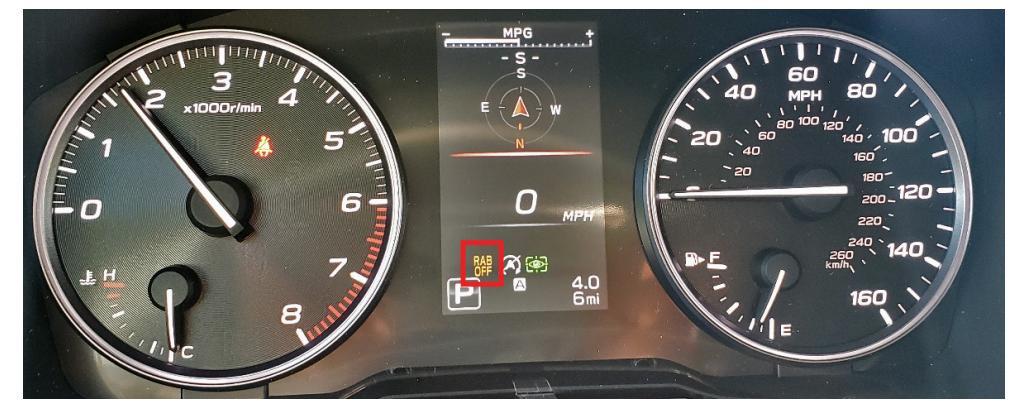
- 1) Start the engine, allow it to idle for 6 seconds or more then shift the CVT into Reverse.
- 2) Confirm if the RAB OFF indicator lamp is illuminated in the combination meter.

NOTE: If the RAB lamp remains illuminated, please check the system as there may be a malfunction.

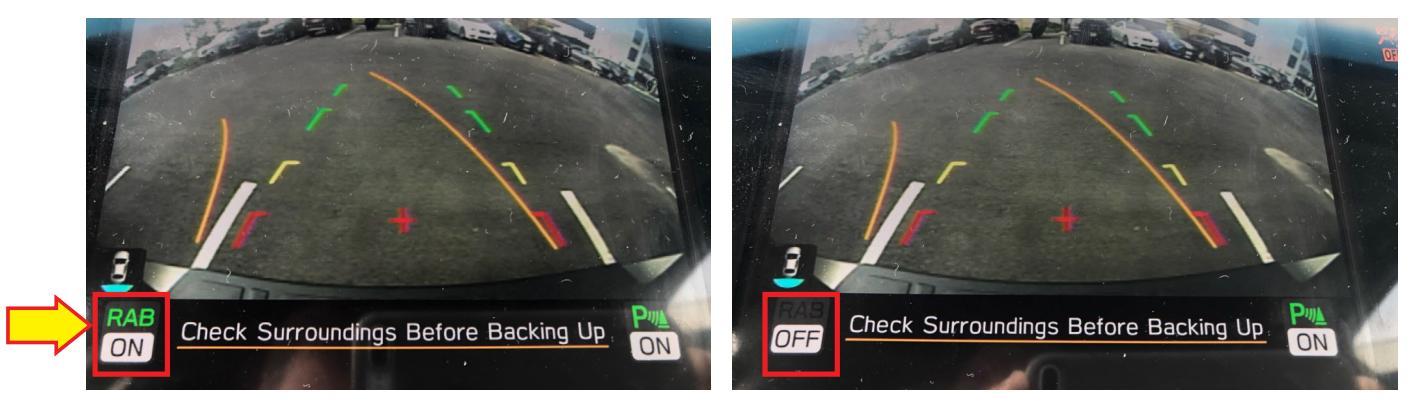
3) Confirm the RAB warning is displayed on the back-up camera display of the navigation system and "RAB" and "PΔ" indicators are illuminated in green. OFF will be highlighted as shown below (right) when RAB has been switched OFF.

4) Press and HOLD the RAB touch switch on the back-up camera display screen for more than 2 seconds to switch RAB from OFF to ON (the same process can be used to turn the RAB feature OFF should the customer request help with making this change). A short "beep" sound confirms the change has been completed successfully.

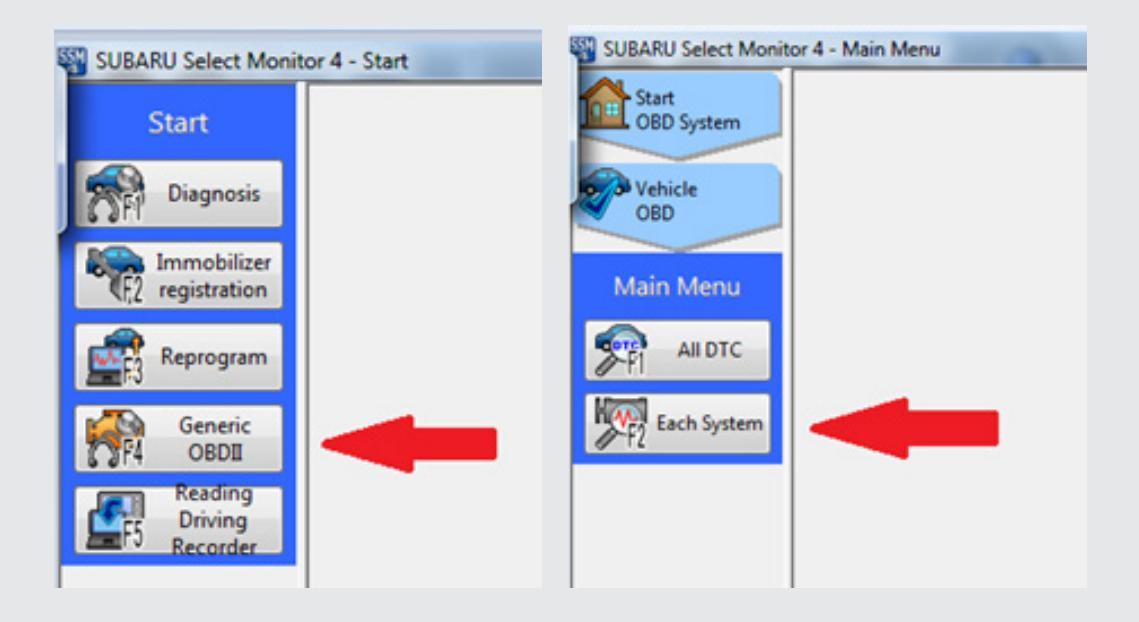
For models using SSM III, specific screenshots are provided in 2011 Forester TRB See below for SSM 4 screenshots of how to access the self-test.

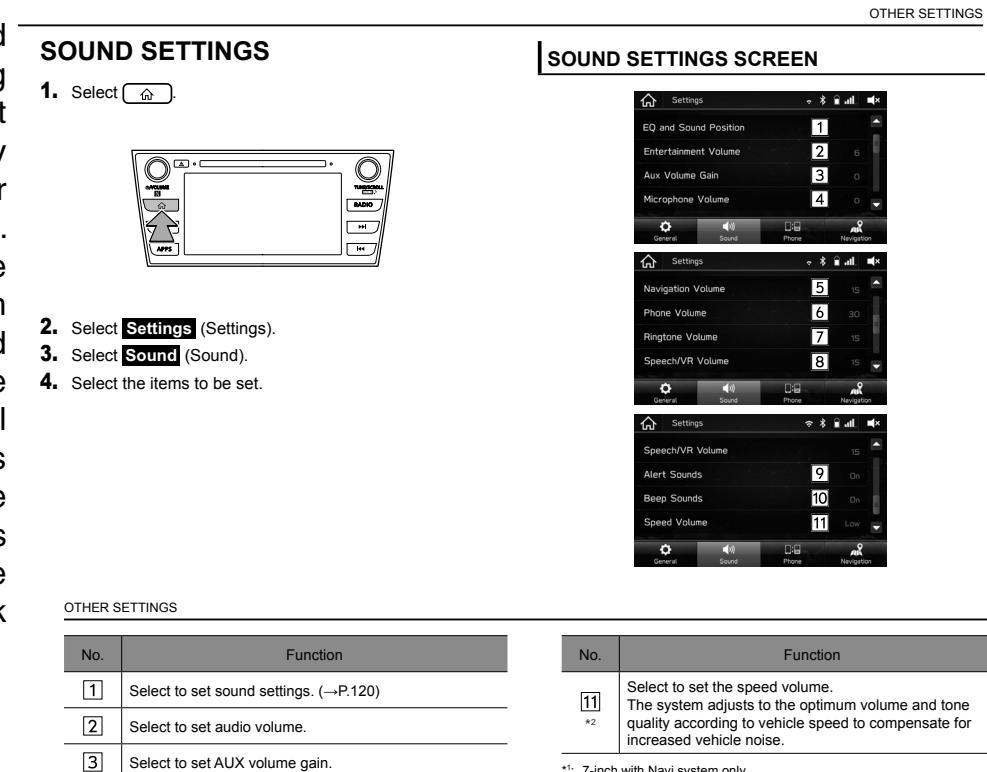
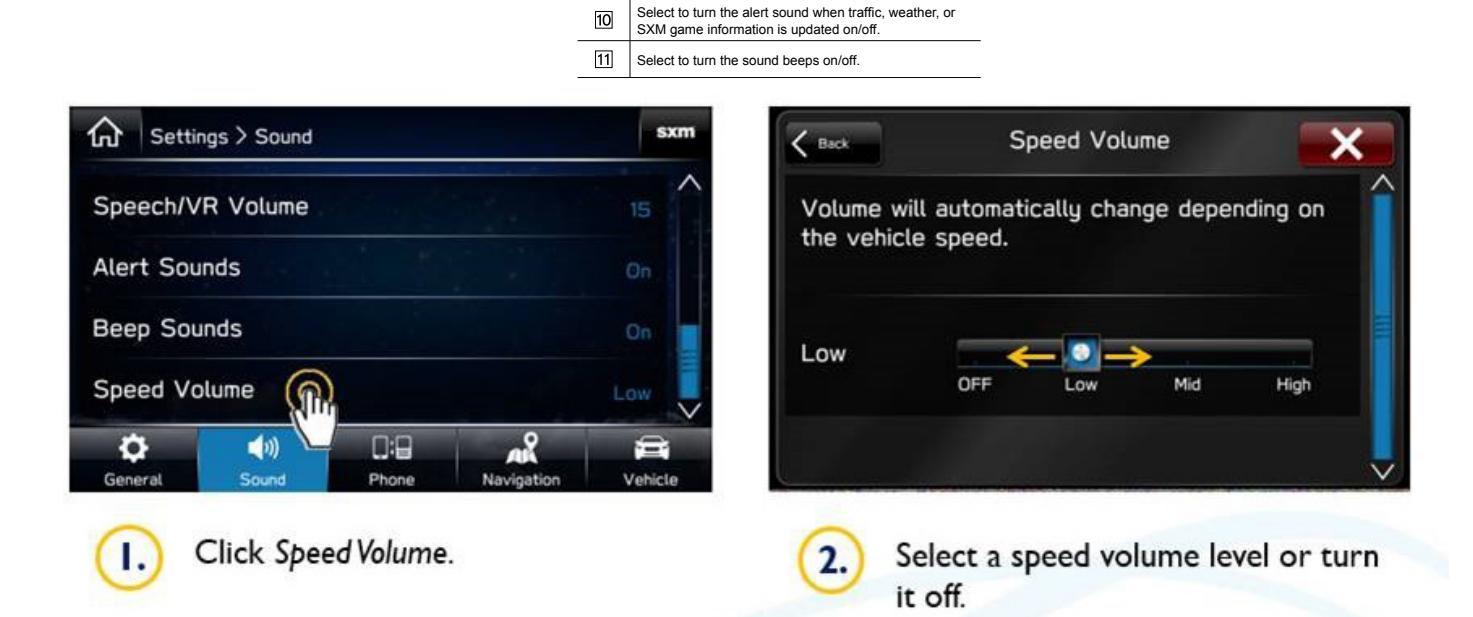
The Techline has received calls recently involving customer concerns about radio volume suddenly changing with an increase or decrease in vehicle speed. Please keep in mind, some non-Harman sound system models still integrate a speed volume control setting. These units contain an internal amplifier which regulates the volume when active. The sequence for turning this feature on and off can be found in the Subaru Starlink Owner's Manual.

Please keep in mind the Speed Volume option is only available for the vehicles not equipped with a HK Amplifier. If the customer installed aftermarket speakers, this feature may not operate correctly. Please reinstall the factory genuine speakers to realize this function operates properly.
