Service Bulletin

Subject: Diagnostic Aid – EV Range Loss on Bolt EV

Brand:	Model:	Model Year:		VIN:		Engine	Tranamiagian
		from	to	from	to	Engine.	Transmission.
Chevrolet	Bolt EV	2017	2020	All	All	All	All

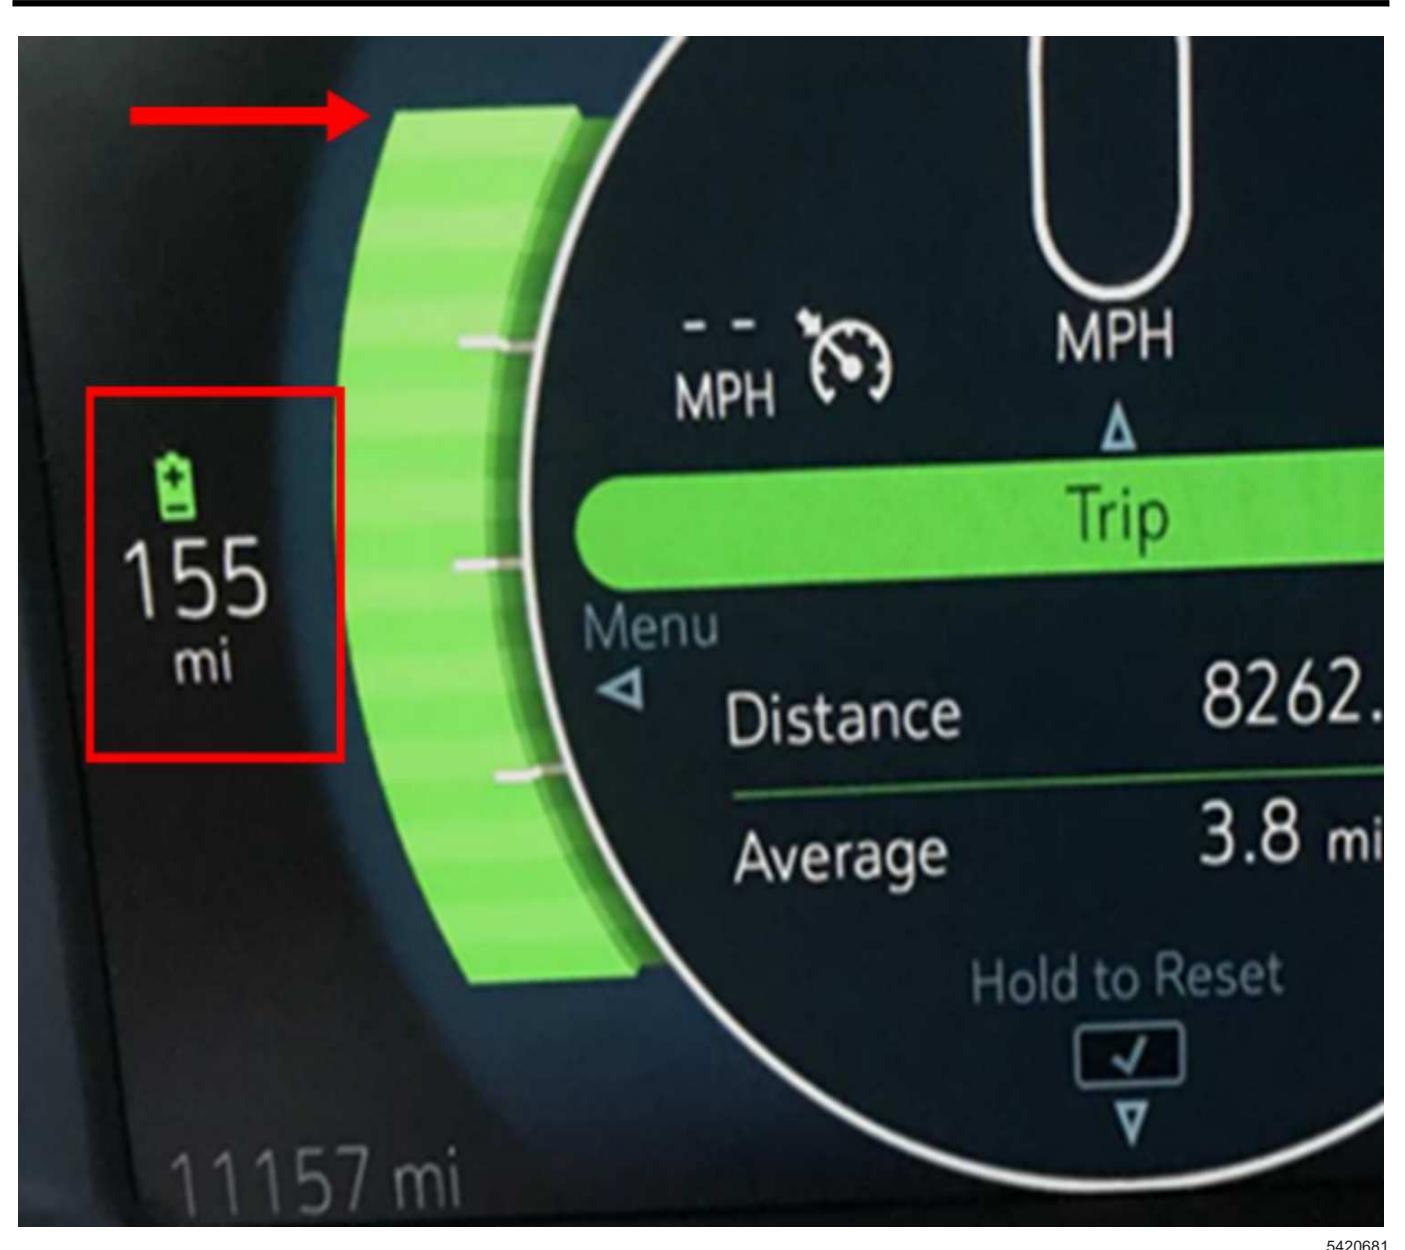
Figure 1: Instrument Cluster showing a full charge and less than EPA label range or the Canada EnerGuide label range.

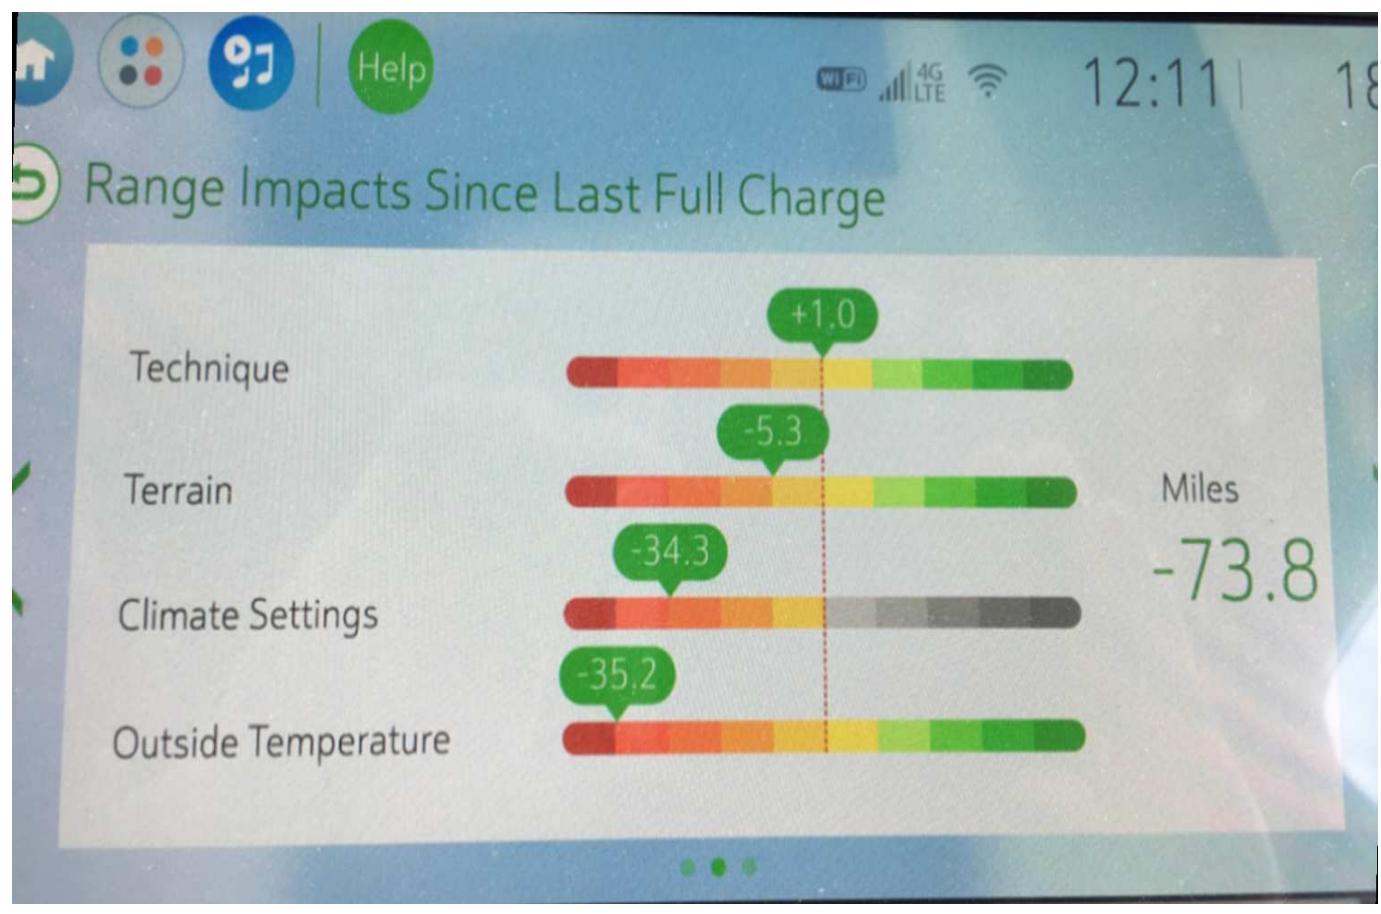
Figure 3: Miles of winter impact on a 2019 Bolt EV with an outside temperature of -8° C (18°F).

Electric vehicles, even in mild climates such as California, can have several miles of seasonal range variation. Encourage the customer to watch these four factors in the energy display on the center screen. The data in this customer display will reset to zero on each full charge event. Note on the repair order if one of these factors from historical GDS2 data is the primary reason for the loss of EV range along with the actual *Total Score _ History 1* value. Perform an EV Range Reset as needed, following the instructions in the SI procedure.

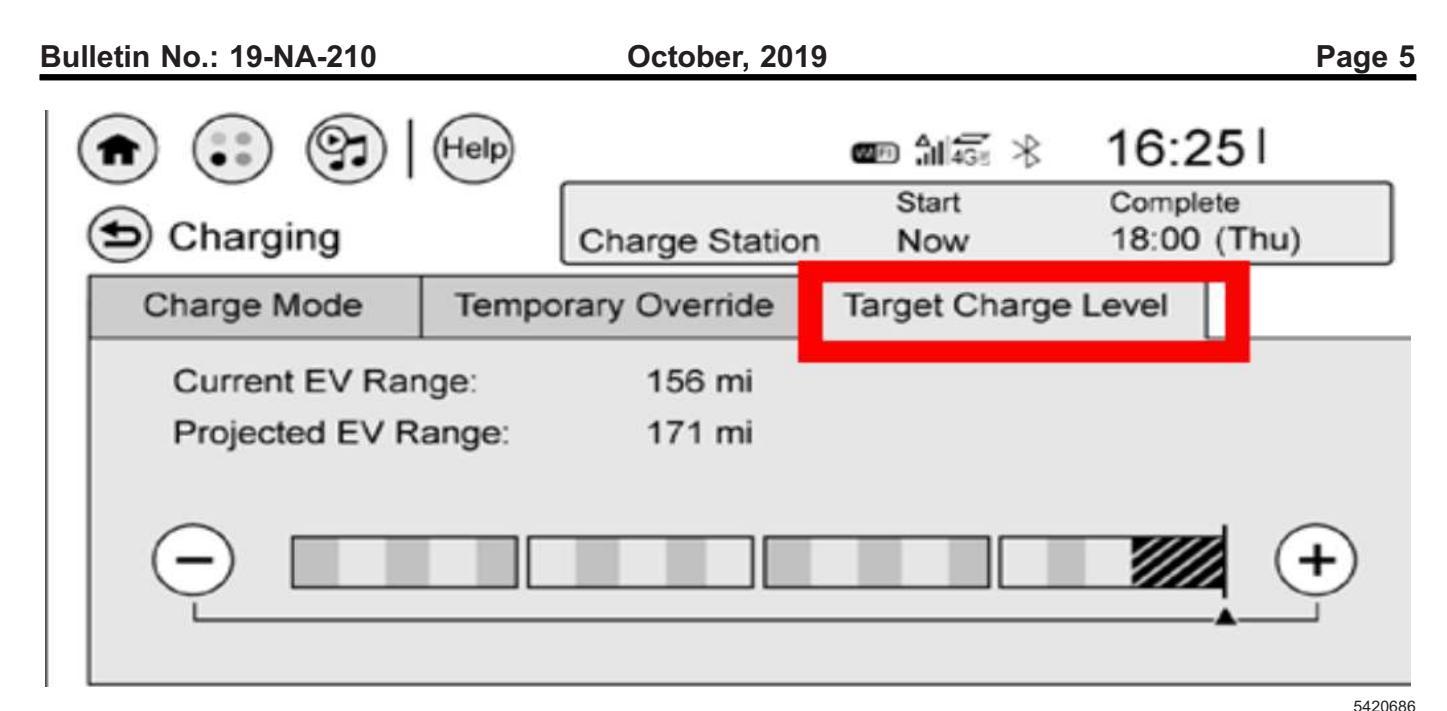
The Bolt EV has a feature to limit the maximum state of charge in the charging settings on the center display. Any setting less than maximum will reduce available EV range. For 2017 and 2018, this was known as Hilltop Reserve. Note the setting for this category on the repair order. 5420685

Figure 4: Target Charge Level screen on a 2019 or newer Bolt EV
