UPDATE FROM WARRANTY OPERATIONS

Satellite Antenna Replacements

Wrangler (JL) and Gladiator (JT) All Weather Floor Mats

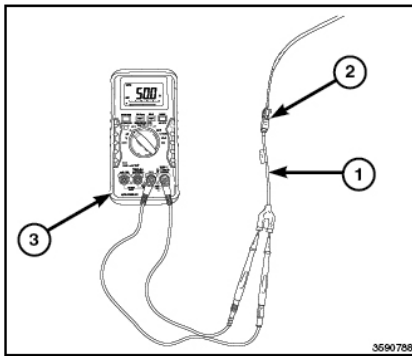
1. Verify the concern and identify if satellite antenna is affected.
2. Verify the antenna is torqued tight and not physically damaged.
3. If SAT/GPS is still not functioning
 - Verify wiring continuity from radio to satellite per the service procedures.
4. Verify if 5V is coming from the radio.

Note: This voltage can drop out due to DTC codes being set

- Attach Adapter 9977-6-3 to a multimeter as shown below (1); connect the other end of the jumper to the inline harness to verify if the required 5V is coming from the radio to power the antenna. 5V is required for Satellite/GPS function.
- If 5V is NOT present, perform a Radio Reset and test again. If 5 volts is now present, attach test antenna and verify the correction of the concern.

5. For Satellite Antenna DTC's, perform a radio reset if antenna is reconnected/swapped.
6. Additionally Refer to Service Bulletin 08-003-19 for 19 DT, 18/19 JL.

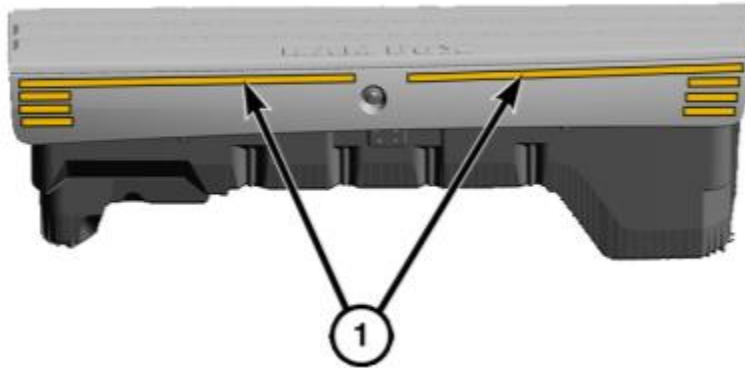
We have seen some repeat claims for appliques following the performance of RRT 19-044 on the 2019 DS and DJ.

A review of the repair with the technicians has found the procedure is not always being followed as outlined in Service Library: 23 - Body / Exterior / RAM BOX / Removal and Installation.

1. Clean/remove all old tape and adhesive with a general purpose adhesive cleaner.

2. Prep the Ram Box Lid and applique surface with alcohol, apply 3M® Adhesion Promoter 4298 and let it set up 90 seconds until dry and

immediately install new 3M™ Acrylic Plus Tape EX4011 (1) in the locations indicated.

Using a laminate roller or equivalent, apply consistent and uniform pressure over the entire length of the applique to wet out the applique and assure a complete bond to all tape applied.

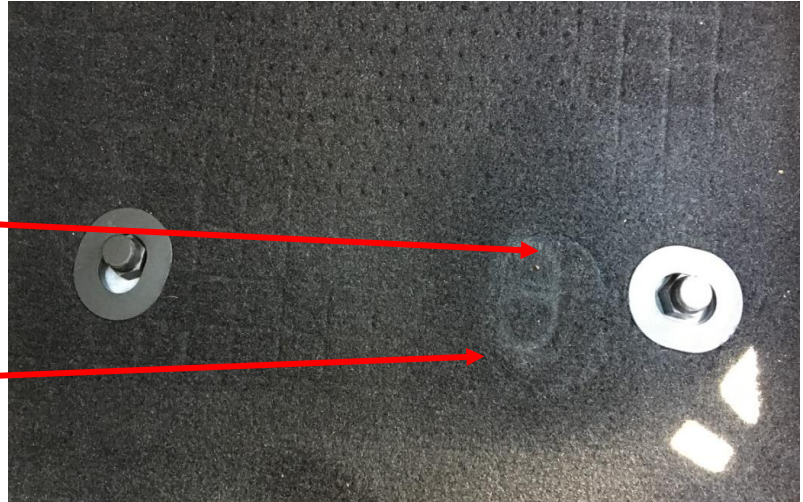
All-weather mat was not installed as designed.

The mat drain feature has left the floor carpet flattened from sitting on top of the carpet.

The floor carpet plug is still present. The outline of the plug is visible in this photo.

Floor Carpets returned with this sort of imprint and a damaged floor mat retainer will be charged back as improper installation that is not a defect in material or workmanship.

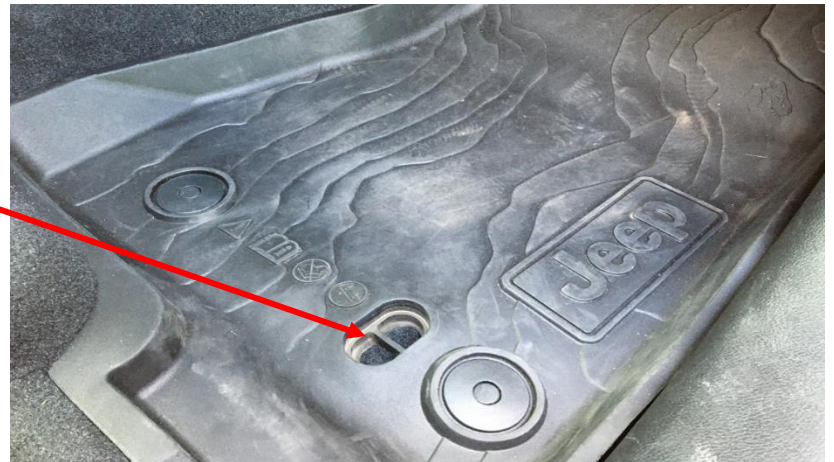
All-weather mat not installed as designed.

Can see the carpet plug is still present.

Mat bulges up and does not attached correctly to the pegs in the floor. Retainer is skewed relative to the peg.

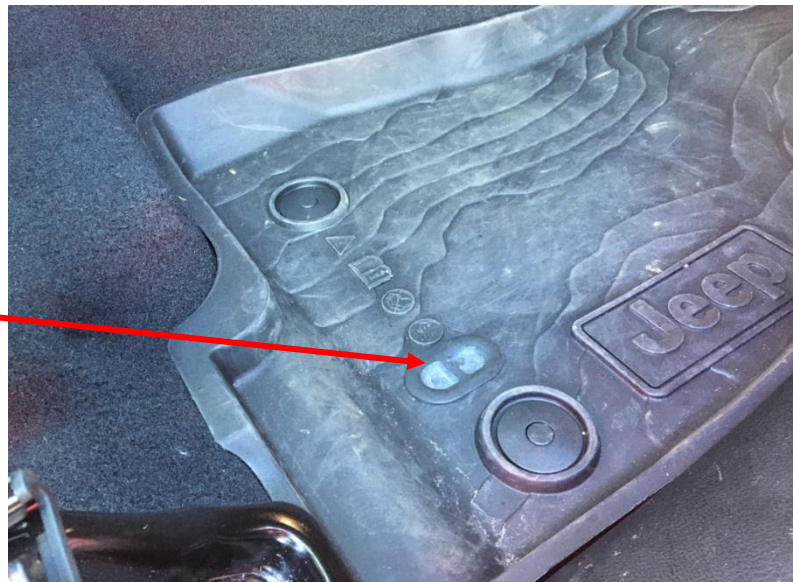
All-weather mat installed as designed.

Floor pan plug has been removed and inserted into the mat as shown in the installation instructions.

Floor mat does not have a hump in it.

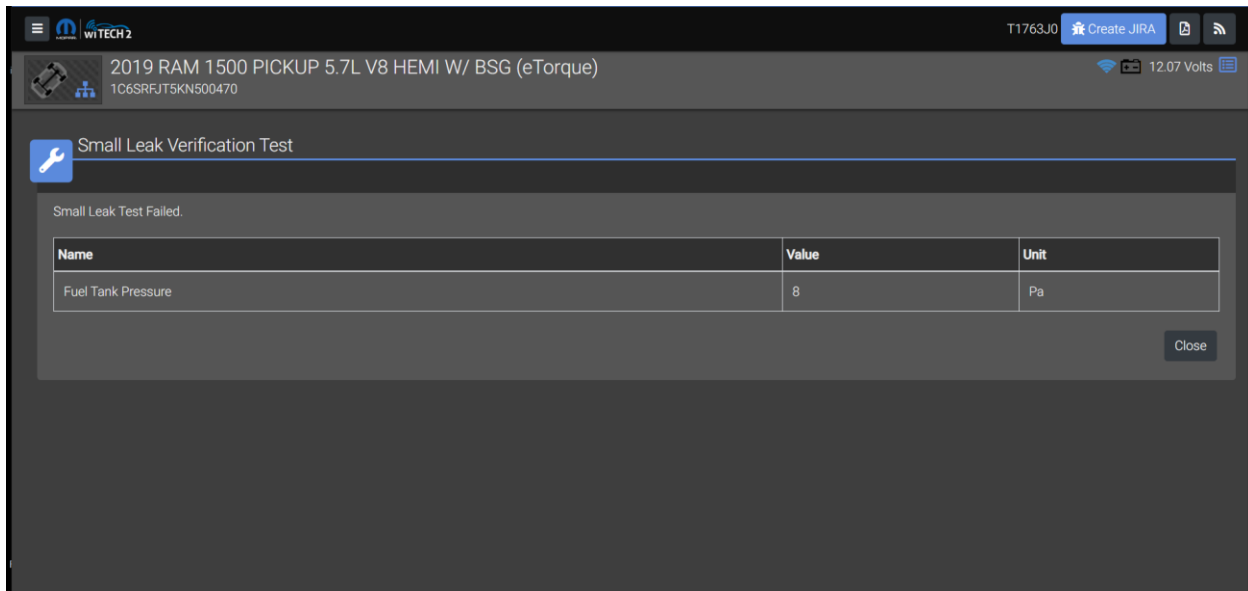
Failed Test Screen (with VIN)

Across the FCA suite of vehicle families, we have seen a large number of warranty part returns for Evaporative System Integrity Monitors (ESIM) and Purge Solenoids for a P0456 Evap System Small Leak DTC. A large percentage of these returned parts test Trouble Not Found (TNF) by engineering and our suppliers.

Small Leak Test Failed.

- The Small Leak Verification Test should always be run first to verify a leak is present.
 - The Small Leak Verification Test must also be run after repairing or replacing any components, to verify the fix.
 - Any kind of road test will not confirm the repair, as P0456 is only set with multiple engine off and drive cycles, which cannot be reproduced during a dealer visit.
 - The Small Leak Verification Test is the only tool currently available to confirm a fix after the repair to assure the vehicle was “Fixed-First-Visit”.
- For any vehicle that has a DTC P0456 and the WiTech SLVT is available, the SLVT must be run both before **and** after diagnosis and repair to be eligible for warranty reimbursement. Any warranty repair or diagnosis that is performed without a before and after SLVT will be subject to chargeback. FCA will monitor SLVT usage through wiTECH data to enforce the policy.

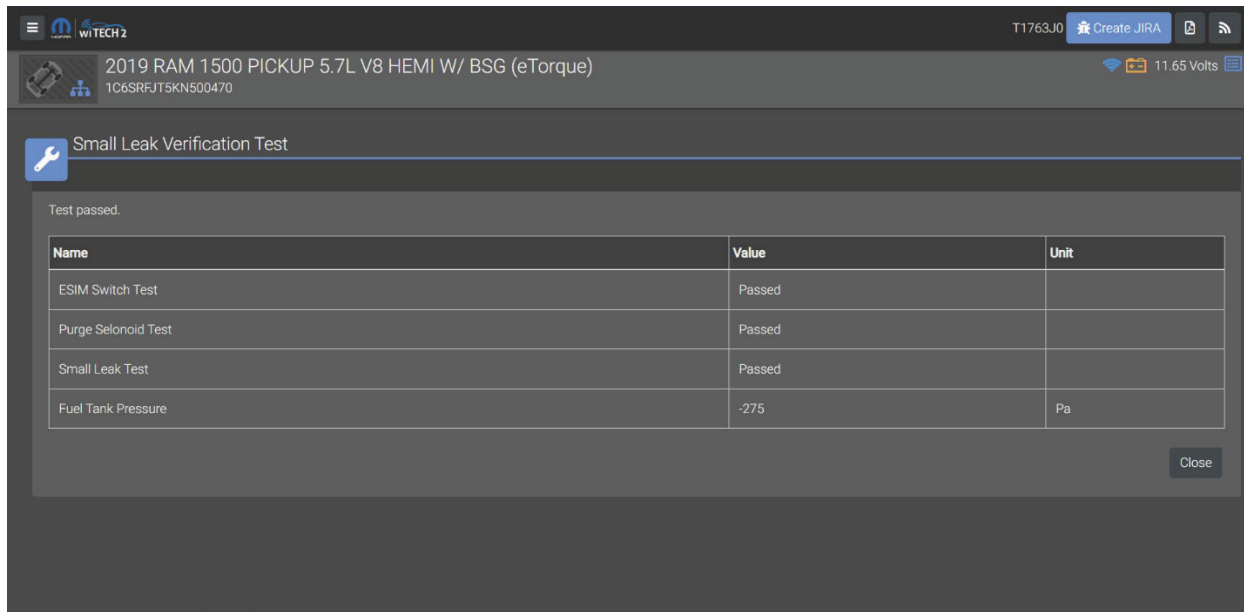
Passed Test Screen (with VIN)

Test passed.
