TOYOTA Technical Service Bulletin

Corrosion on the Back Door Steel Reinforcement Panel Around the Opener Switch and Rear Camera

YEAR(S)	MODEL(S)	ADDITIONAL INFORMATION
2017 - 2018	Prius Prime	Engine(s): 2ZR Drive Type(s): 2

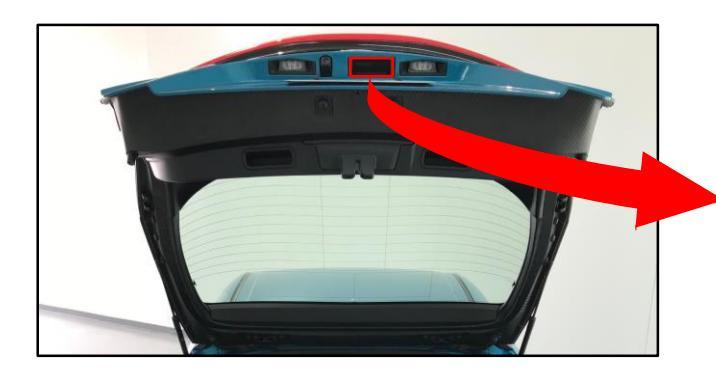
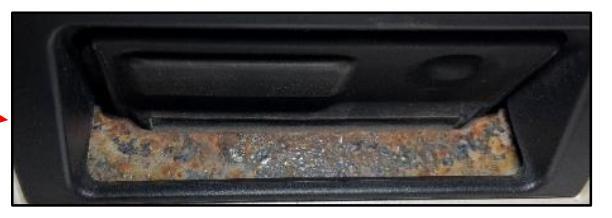
Some 2017 – 2018 model year Prius Prime vehicles may exhibit corrosion on the back door sub-assembly steel reinforcement panel visible below the opener switch and rear camera. Follow the Repair Procedure in this bulletin to address this condition.

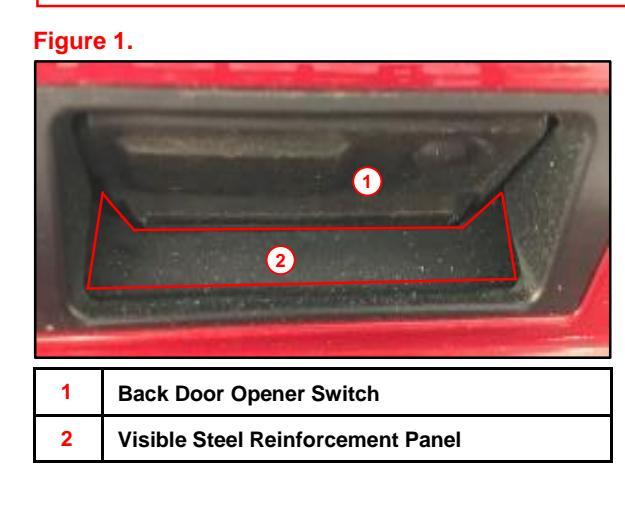
- Only a small portion of the steel reinforcement panel is visible below the back door opener switch when assembled (Figure 1).
- Coat the part of the steel reinforcement panel that is NOT visible with wax (Figure 2).

- 2017 2018 Prius Prime: Vehicle Exterior – Door / Hatch – "Door / Hatch: Back Door: Disassembly"
- 2017 2018 Prius Prime: Vehicle Exterior – Door / Hatch – "Door / Hatch: Back Door Opener Switch: Removal"
- 2017 2018 Prius Prime: Vehicle Exterior – Door / Hatch – "Park Assist / Monitoring: Television Camera: Removal"
- 3. Apply wax to the hidden portion of the back door steel reinforcement panel.

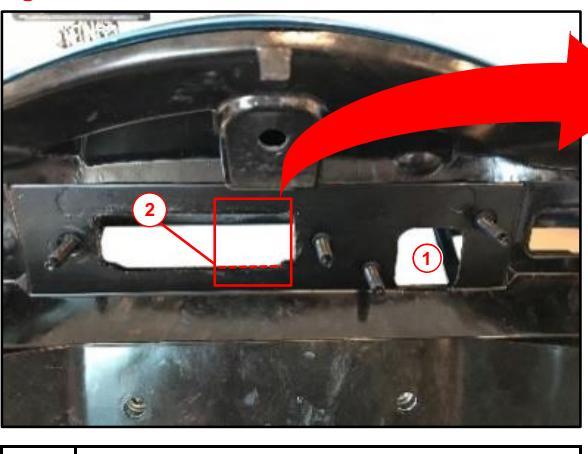
Figure 3.

1	Hole for Rear Camera
2	Cavity Between the Steel Reinforcement Panel and Interior CFRP Panel

- A. Lightly pry the interior CFRP and steel reinforcement panel apart with a small pry tool (Figure 4).
- B. Use an applicator wand kit to spray cavity wax in the cavity between the steel reinforcement panel and the Interior CFRP panel (Figure 4).

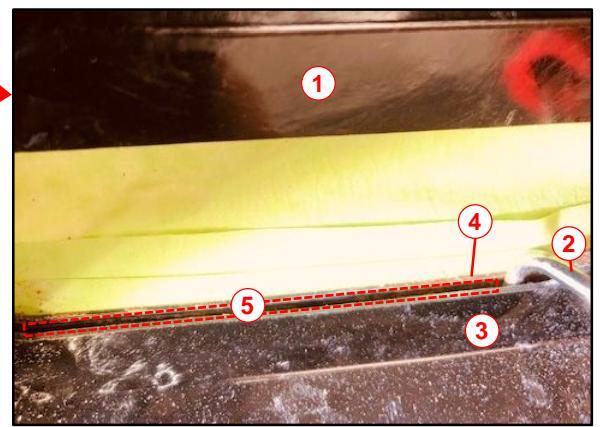
Figure 4.

1	Exterior CFRP Panel
2	Pry Tool
3	Interior CFRP Panel
4	Steel Reinforcement Panel
5	Cavity Between the Steel Reinforcement Panel and Interior CFRP Panel

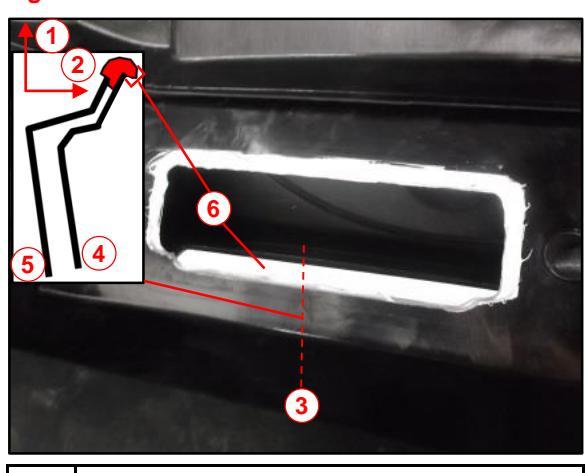
1	Up
2	Rear
3	Cross Section
4	Steel Reinforcement Panel
5	Interior Panel
6	Sealer ≤ 1.5 mm Thick

- 6. Seal the gap between the back door interior panel and steel reinforcement panel.
 - A. Use urethane seam sealer to fill the edge gap between the interior CFRP panel and the steel reinforcement panel (Figure 7) to prevent water entry between the two panels. Allow the sealer to dry per the manufacturer's recommendations.

To ensure proper fit of the back door opener switch and rear camera to the reinforcement panel when reassembling, the sealer should be no more than 1.5 mm thick. Figure 7.
