In This Issue

Vehicle Technical Info

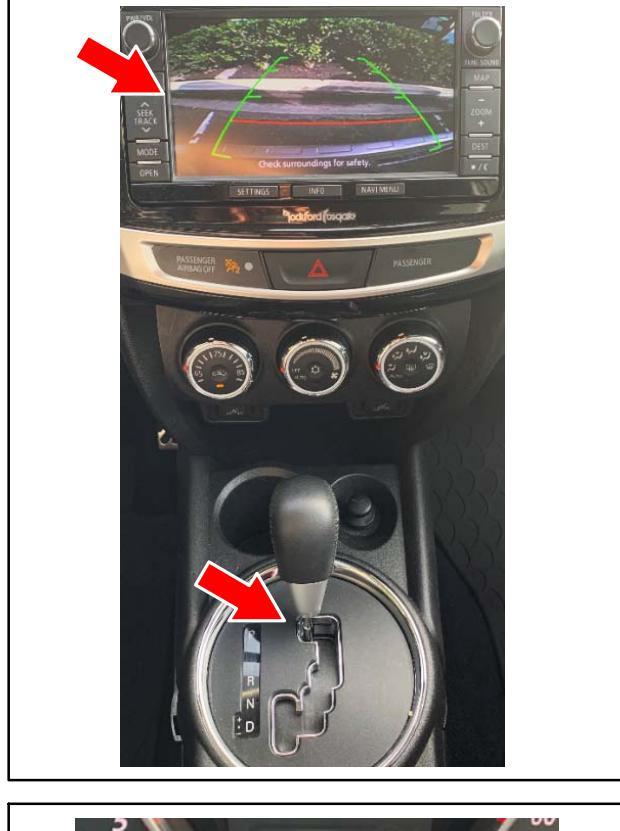
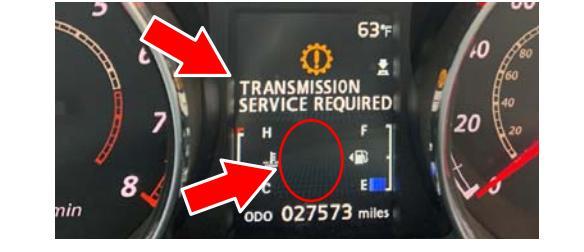
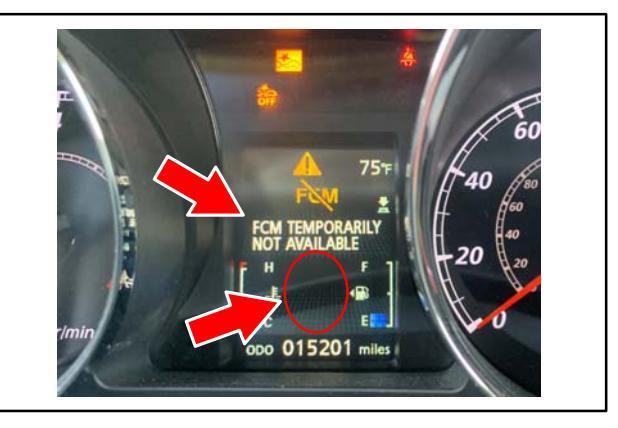
<u>CVT WILL NOT SHIFT OUT OF PARK, DTC</u> <u>P0705, ETACS FUSE #18 (7.5A) BLOWN, SRS</u> <u>LIGHT ON</u> – 2012 & newer Outlander Sport/RVR.

Customers may complain that they cannot shift out of "P" (PARK), transmission warning light is ON, selector lever indication (P, R, N, D) is not displayed on the instrument panel screen, and reverse camera is ON (even though selector lever is in "P"). This condition may be occurring intermittently or may be present all the time. Upon diagnosis, you may find DTC PO705 present in the TCM, and C1747 present in the FCM (for 18MY and newer vehicles with FCM).

In other cases, you might have additionally the SRS warning light ON due to DTC B1477 in the SRS ECU, audio display inoperative (black screen), ETACS fuse #18 (7.5A) blown and/or fuse #16 blown (10A).

When working on vehicles showing some of the above symptoms, be sure to inspect the inside mirror connector. Use the electrical circuit diagram in the Service Manual for the automatic anti-dazzling mirror, Group 90, for further details.

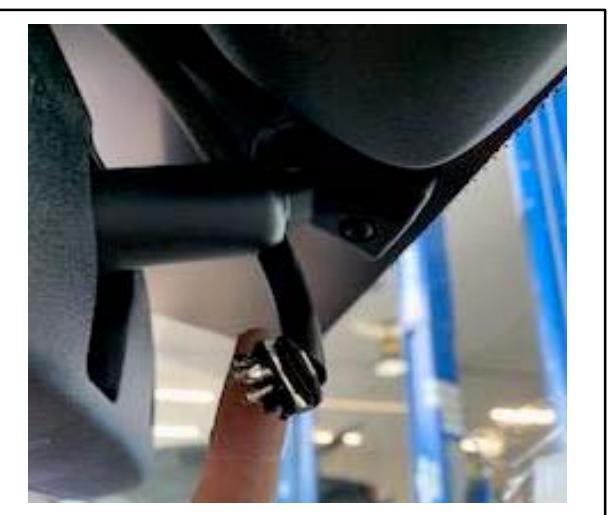
The above symptoms could occur on vehicles equipped with auto-dimming (anti-dazzling) inside rearview mirror due to a short in its electrical connector. The auto-dimming mirror is using the reverse signal from the CVT to disable the dimming in the mirror when the driver is backing up. The short circuit in the connector might occur due to various reasons:

1) Connector damage after windshield or inside mirror replacement.

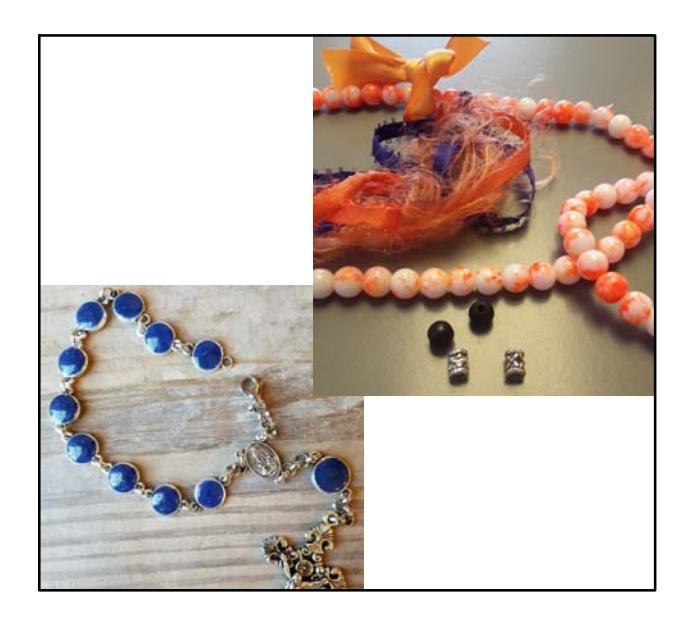
2) Pins are backed out due to objects hanging on the mirror and pulling the wiring harness

3) Metal parts or strands from objects such as necklaces, beads, etc., that are suspended on the mirror, are getting in the connector.

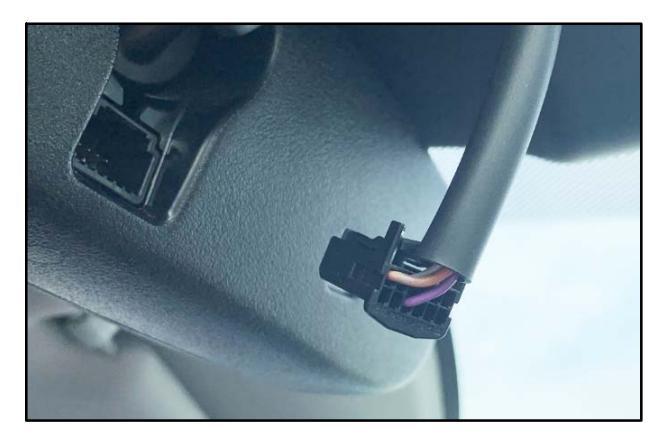
Depending on the trim level the inside mirror connectors will vary. Some vehicles will have a universal garage door opener integrated into the mirror and will have the connector shown below.

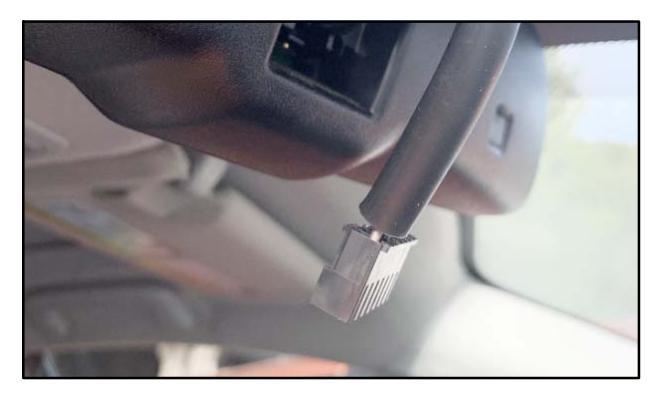
Others will only have the auto-dimming function and will have this connector below.

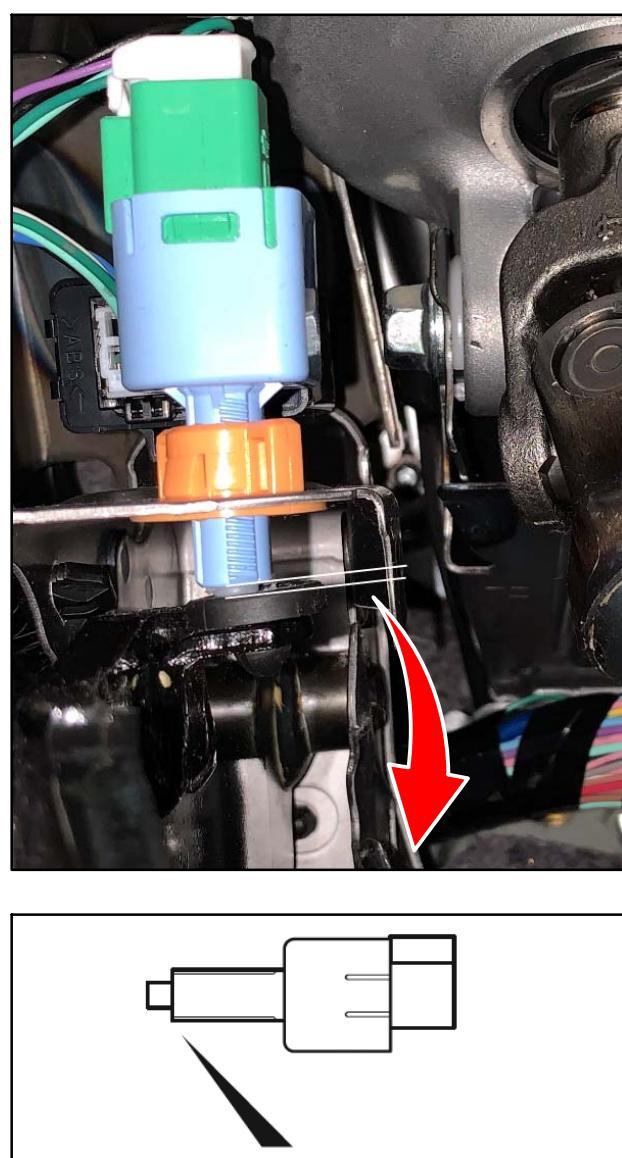
2) Check stoplight switch adjustment.

(An out of adjustment stoplight switch can cause other concerns and DTCs.) Refer to Group 35A, Brake Pedal inspection in the Service Manual. (See the following illustrations.)

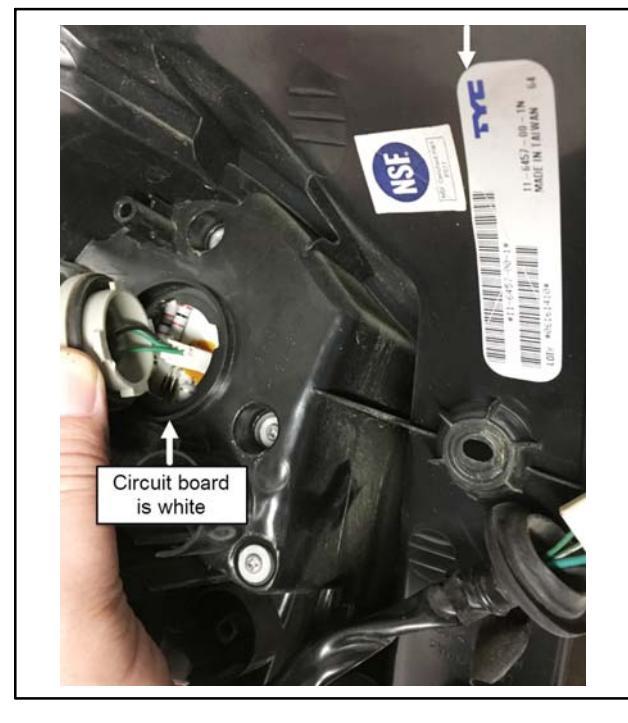
Some aftermarket parts are made by TYC and Seanlty (see example below of a "TYC" part).

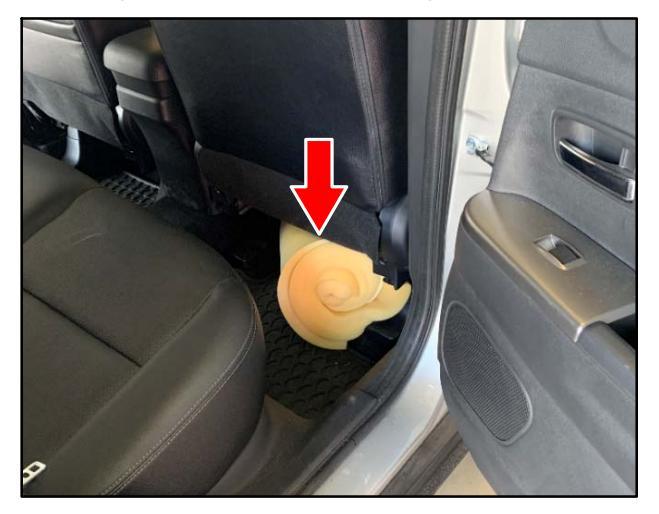
1) Large object is placed under the front passenger seat and is pushing it upwards.

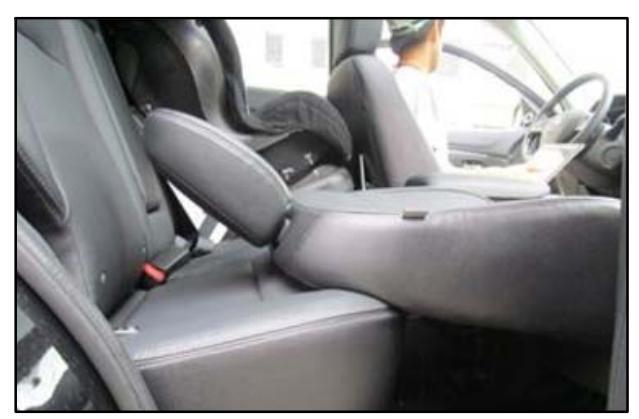
2) Reclined front passenger seat back interferes with the rear seat cushion.

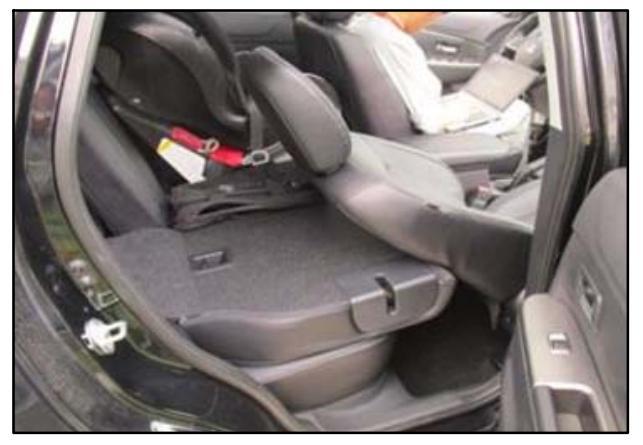
3) Reclined front passenger seat back interferes with the rear seat back (folded flat position).

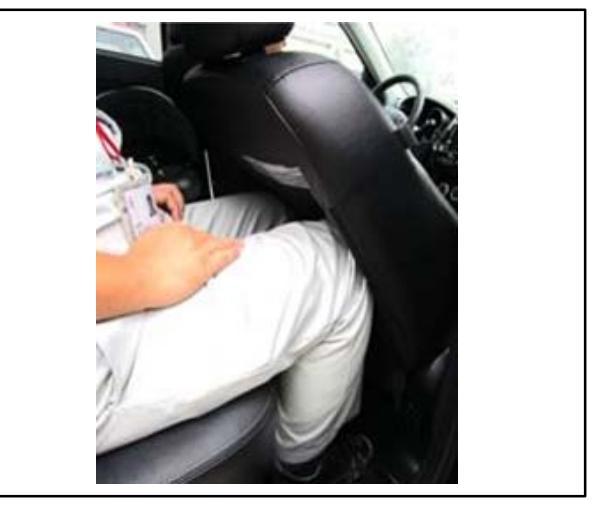
4) Front passenger seat back interferes with passenger in back seat.

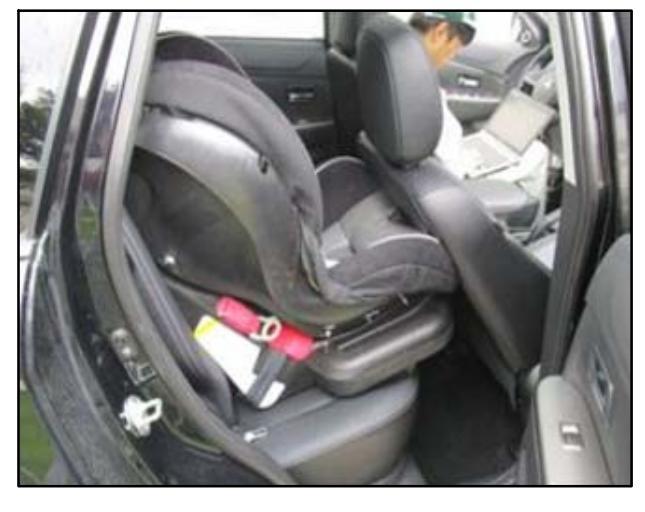
5) Front passenger seat back interferes with child safety seat installed in rear seat.
