# HONDA

Version 2

# Audio-Navigation Unit Display Flickers for 2 Seconds or 10 Seconds

Year	Model	Trim	VIN Range
2016-17	Civic 2-Door and 4-Door	EX, EX-T, Touring	ALL

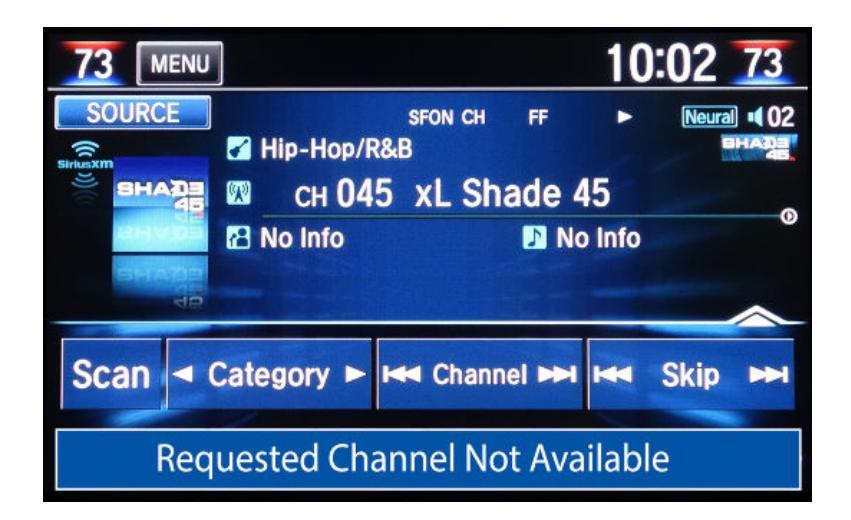
- The audio-navigation unit screen randomly flickers for 2 seconds or 10 seconds.
- The message Requested Channel Not Available appears when selecting a SiriusXM<sup>®</sup> Radio preset.

There is an issue within the current software.

Update the audio-navigation unit software.
